**Kaktovik Tank KAK-70 ULSD Release**

**SITREP # 3**

**SPILL #:** 17399900901

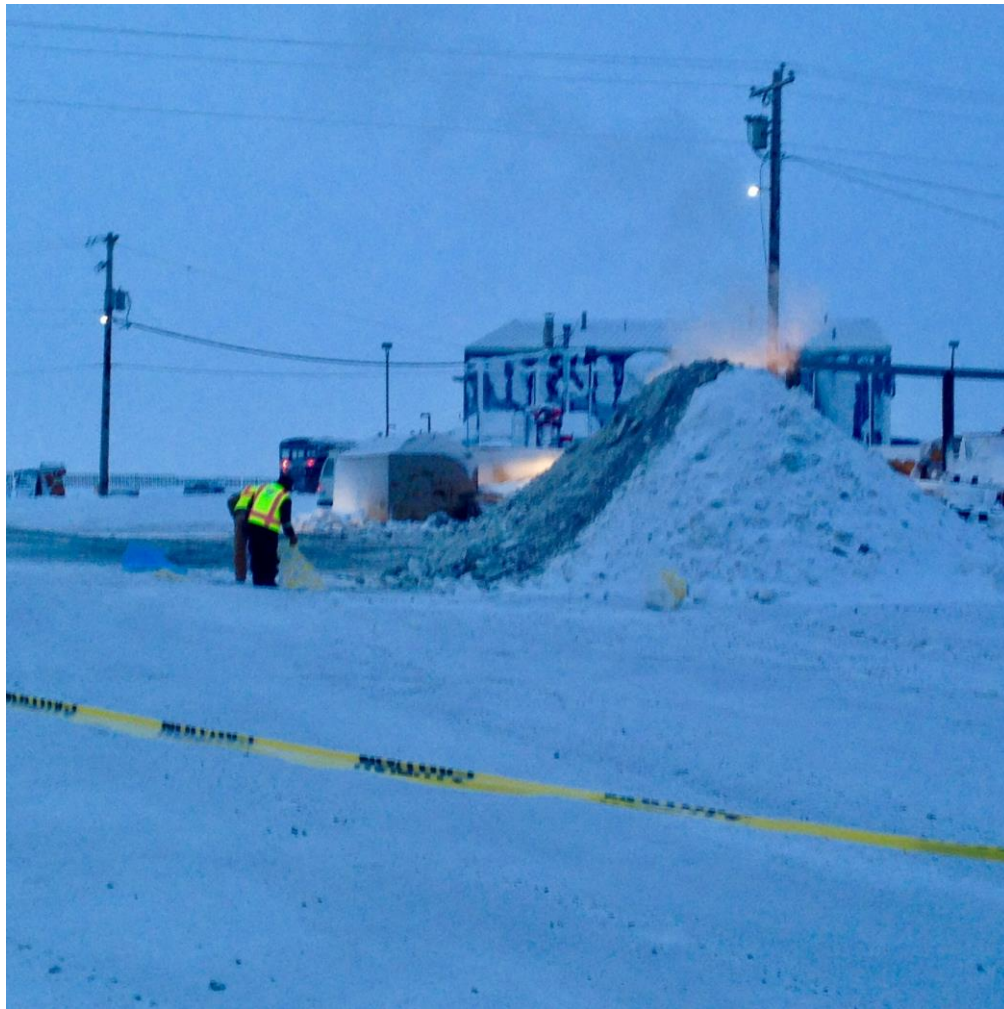
Photo showing response contractors collecting sorbent material from contaminated snow stockpile within the delineated area January 13, 2017. (Photo/ADEC)
