ALASKA DEPARTMENT OF ENVIRONMENTAL CONSERVATION  
Division of Spill Prevention and Response  
Prevention Preparedness and Response Program  
**SITUATION REPORT (SITREP)**

## Tug *Ocean Eagle* Grounding

SITREP #: 2

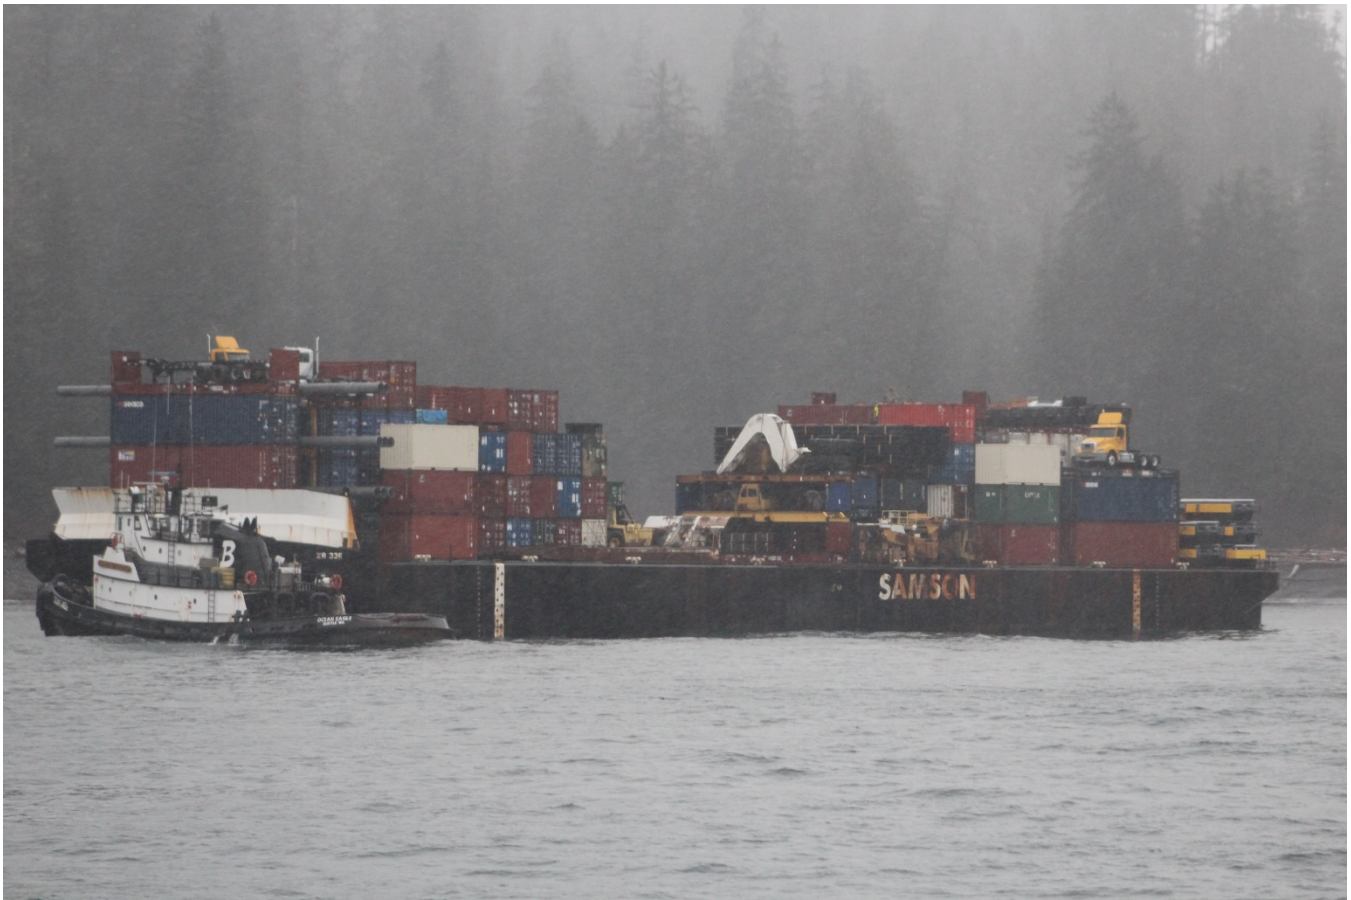
Tug *Ocean Eagle* and barge ZB335 at their current location near Alvin Bay. Photo provided by USCG.
