SITE CHARACTERIZATION AND CORRECTIVE ACTION REPORT

**NAPA FACILITY
1937 VAN HORN ROAD
FAIRBANKS, ALASKA**

JANUARY 22, 2013

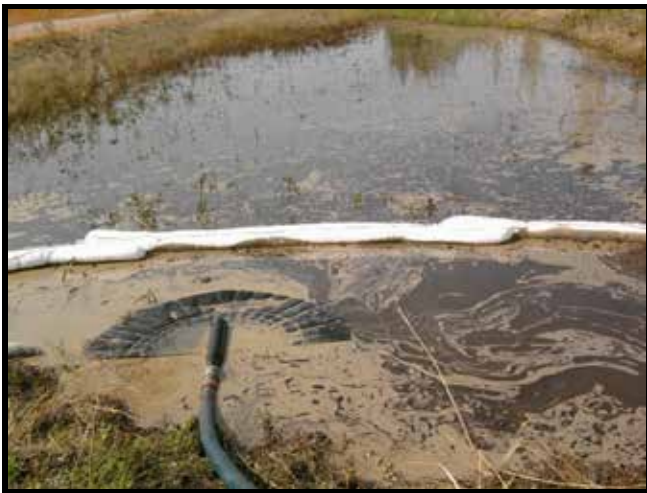
Photo 9: 5/28/2011 – “Stinger” collecting floating phase contaminants from the South Ditch.

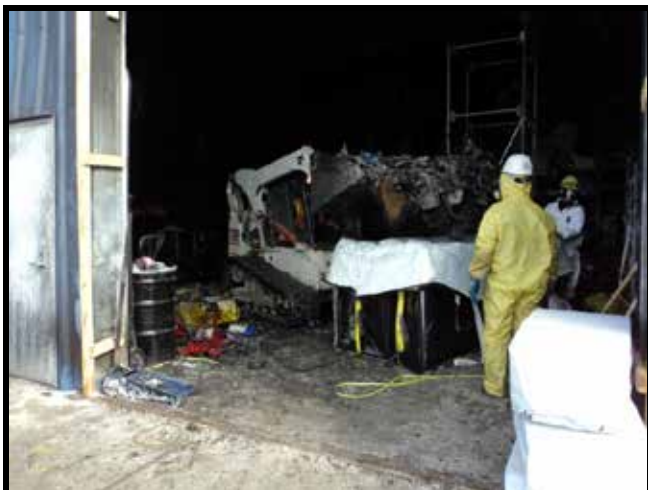
Photo 23: 6/11/2011 – Interior warehouse cleanup efforts.

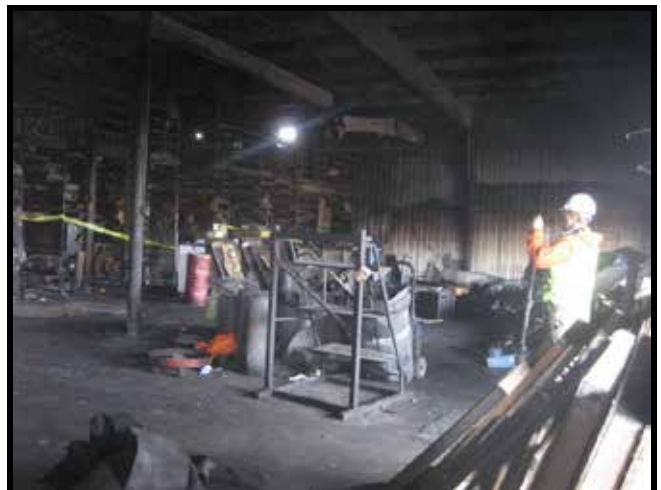
Photo 24: 6/20/2011 – Interior retail area cleanup efforts.

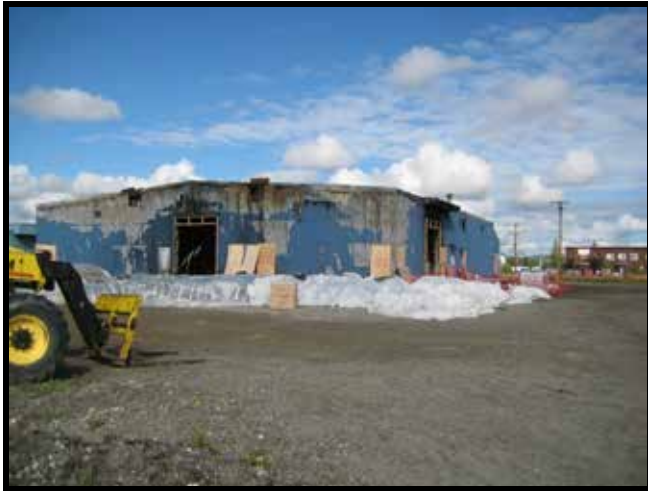
Photo 25: 8/18/2011 - 5Y sack storage area with containerized building waste.

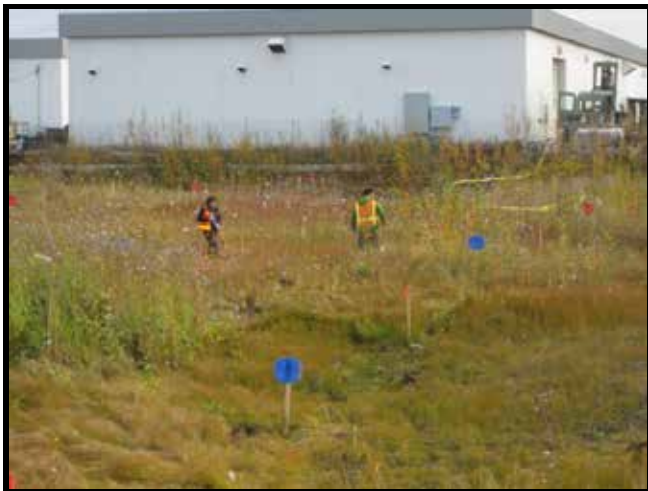
Photo 27: 9/20/2011 - Southeast Ditch characterization.

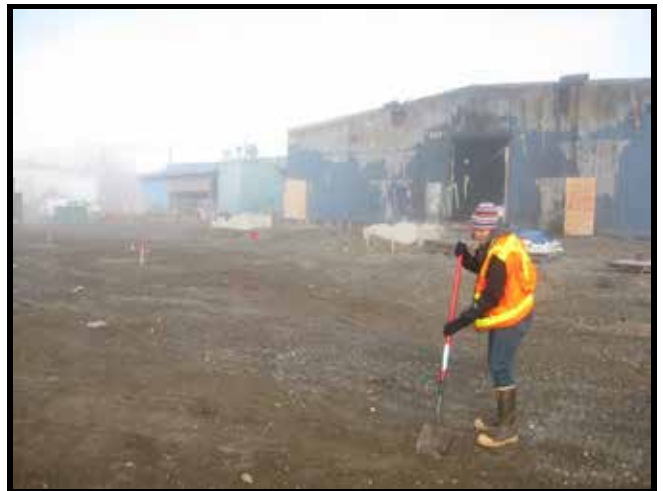
Photo 28: 9/25/2011 - South Driveway and waste storage area characterization.
