Building Condition Assessment/Materials Investigation

Torpedo Bombsight and Utility Shop, Unalaska Airport, Dutch Harbor, Alaska

**Alaska Department of Transportation
& Public Facilities
Anchorage, Alaska**

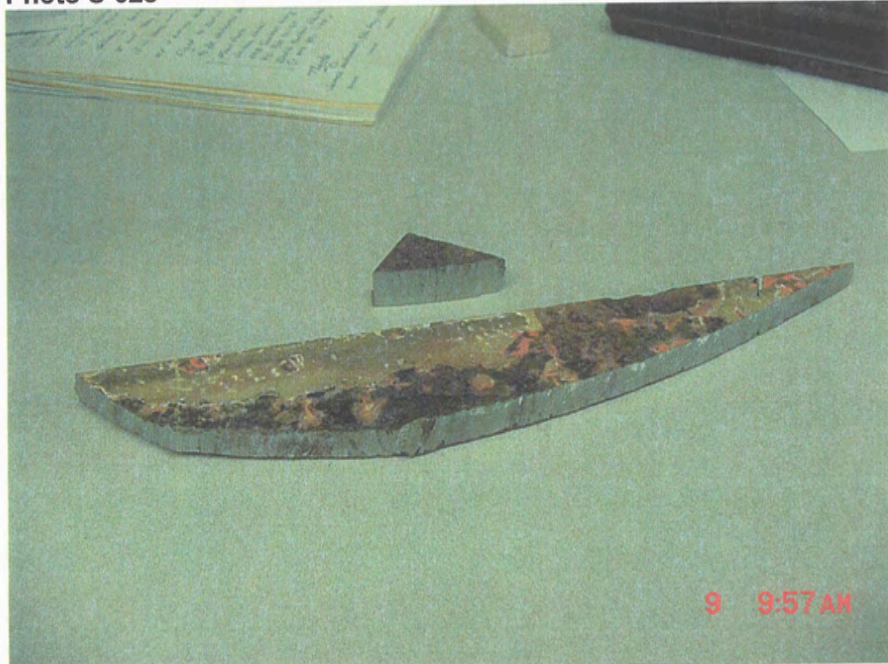
Photo S-023

Grid 7/C – Curved sample removed from beam, bottom flange, June 2003

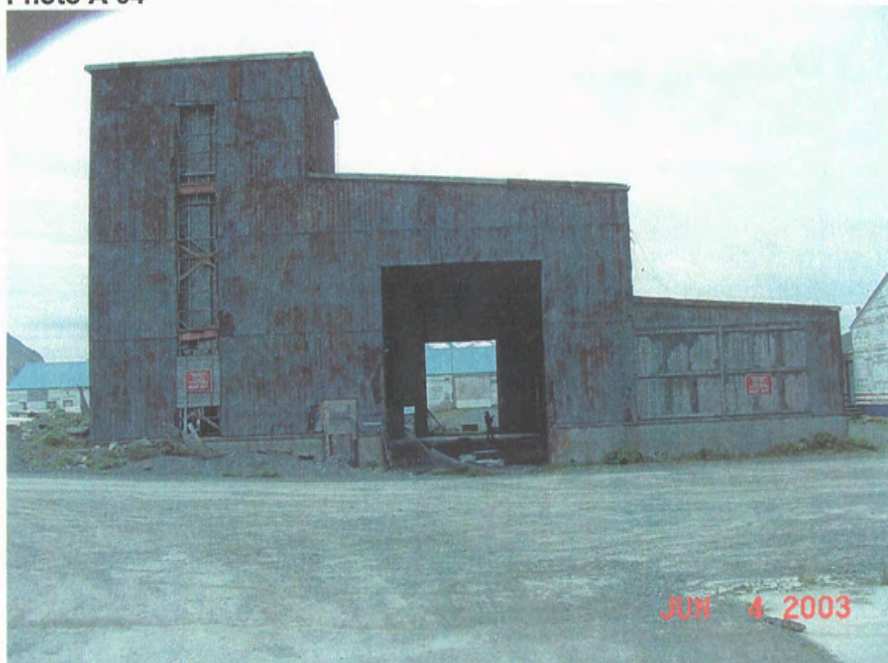
Photo A-04

East elevation of building, June 2003

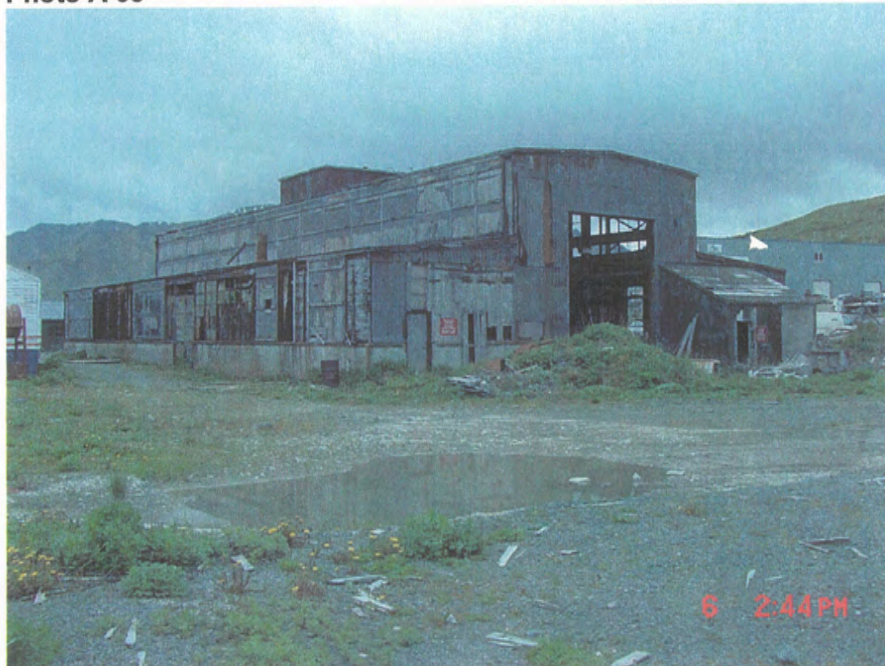
Photo A-05

Southeastern corner of building, June 2003

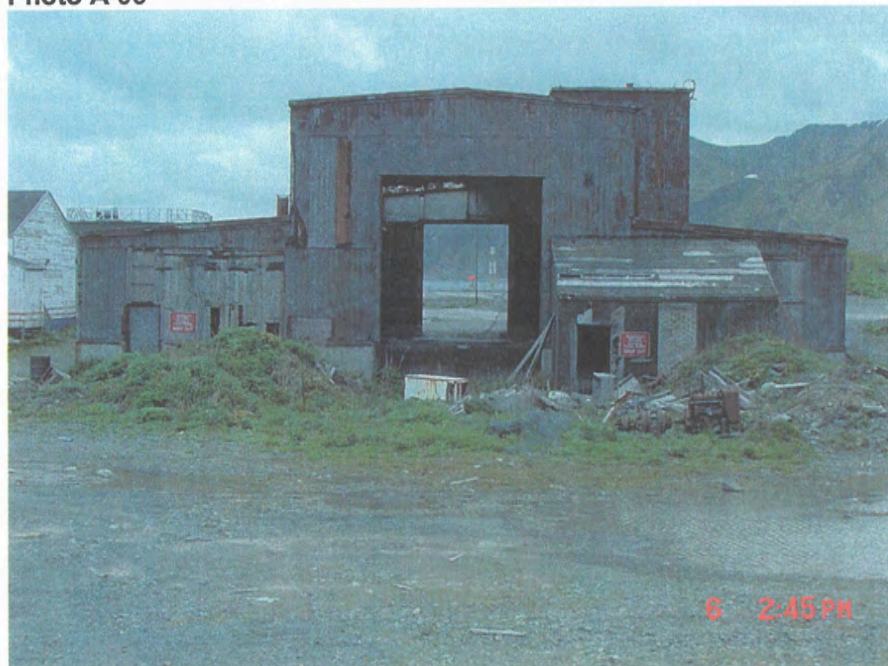
Photo A-06

West elevation of building, June 2003
