THIRD CERCLA FIVE-YEAR REVIEW AND THIRD NON-CERCLA PERIODIC REVIEW REPORT FOR SITES DP011, LF003, SS010, SS013, SS014, SS015, SS016, SS017, AND ST009 AT CAPE ROMANZOF LONG RANGE RADAR STATION, ALASKA

Final November 2018

United States Air Force Joint Base Elmendorf-Richardson, Alaska

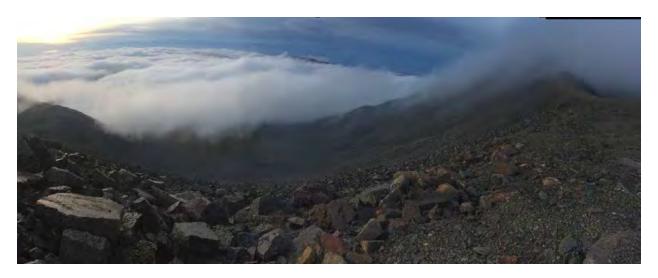
DP011 view east. Photograph shows site in its entirety and general topography.

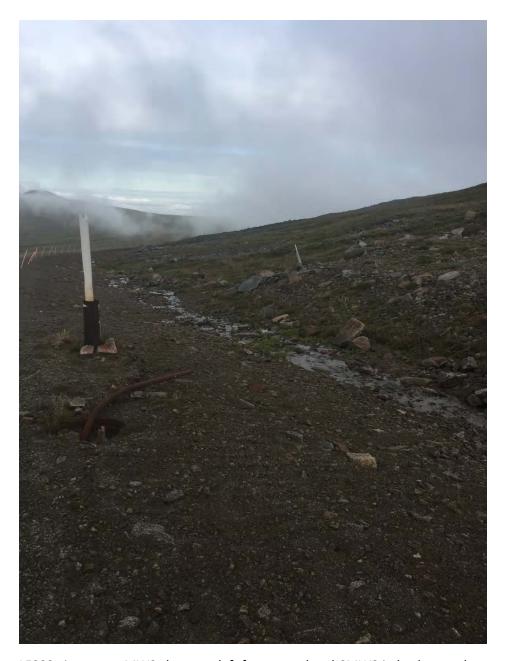
LF003 view west. MW2 shown at left foreground and CMW3 in background.

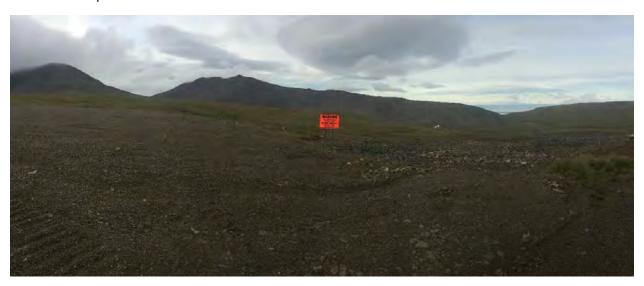
LF003 view south. Western LUC signage and landfill cap shown.

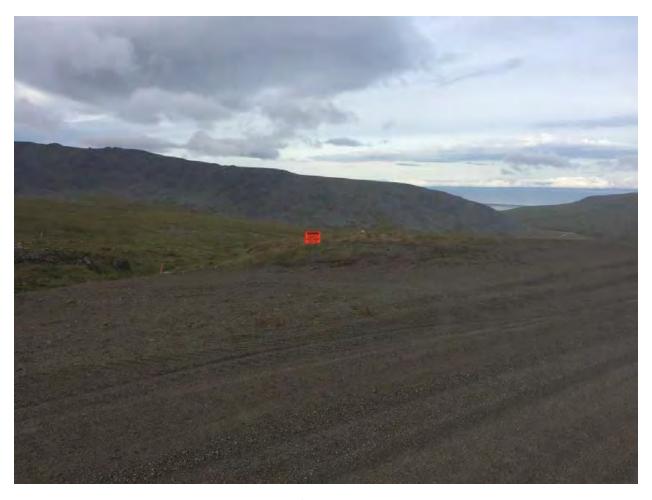
LF003 view south. Eastern LUC signage and landfill cap shown.

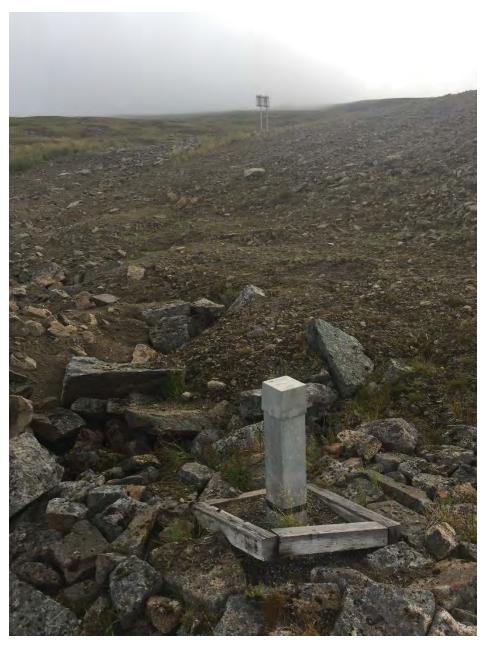
LF003 view north. CMW5 shown at toe of landfill.

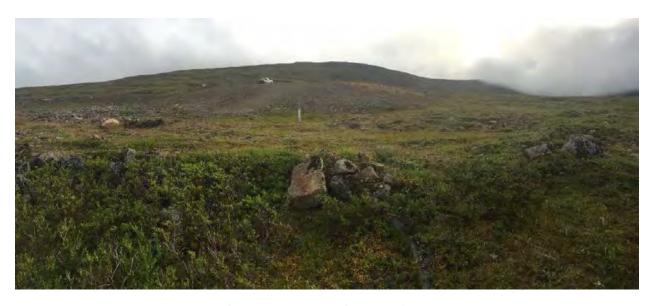
LF003 view north. CMW4 shown in foreground at toe of the landfill.

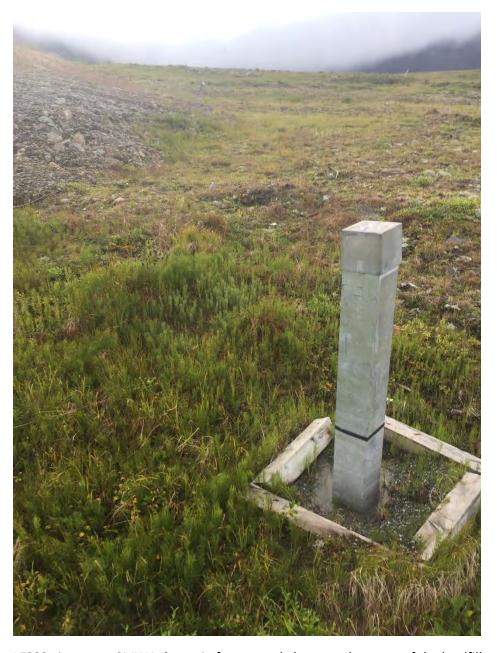
$\ \, \text{LF003 view east. CMW4 shown in foreground along southern toe of the landfill.}$

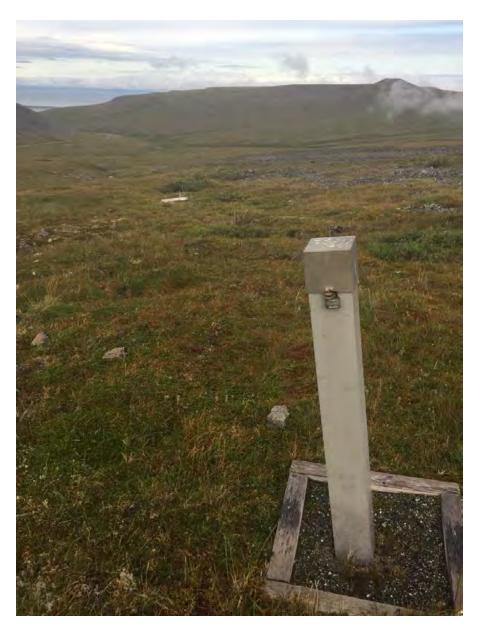
LF003 view west. Close-up of CMW6.

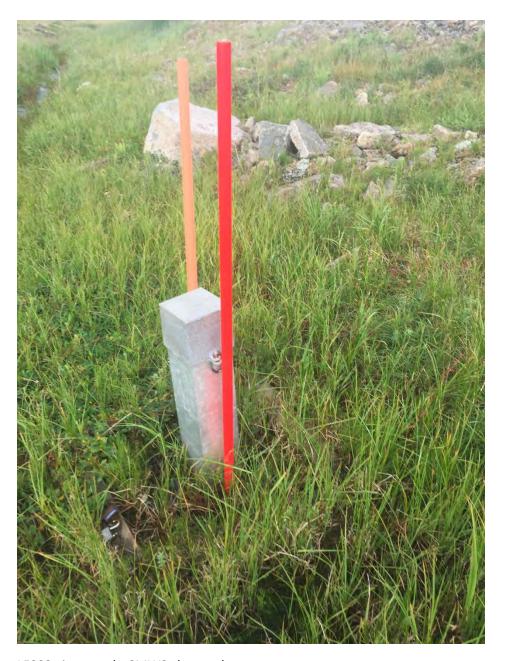
LF003 view south. CMW2 shown along stream.

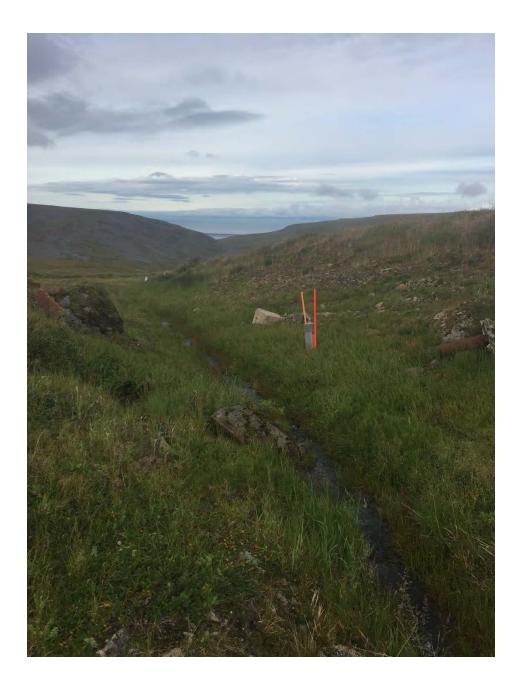
LF003 view west. CMW2 shown along eastern toe of the landfill.

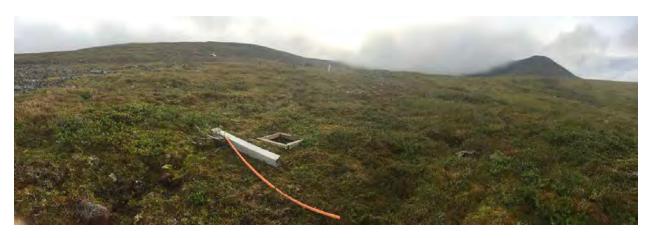
LF003 view northeast. CMW7 shown in foreground.

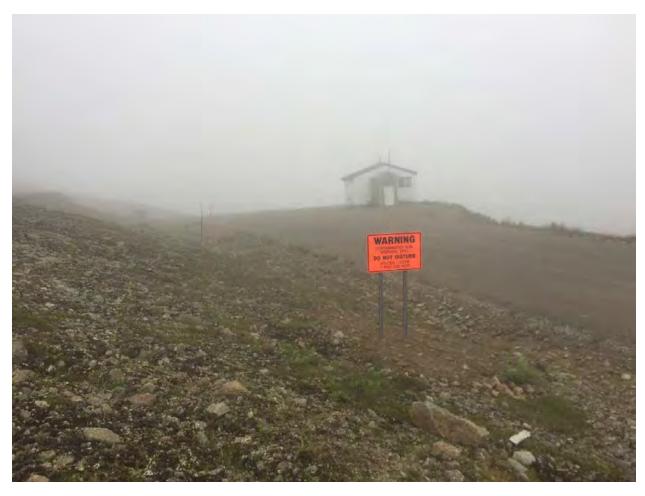
SS010 view south. LUC signage shown in foreground along site access road and Building 4104 shown in background.

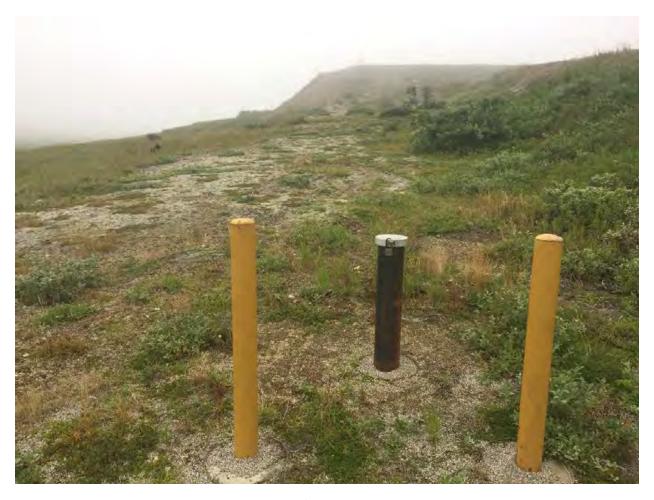
SS010 view northeast. MW1 shown below pad of Building 4101.

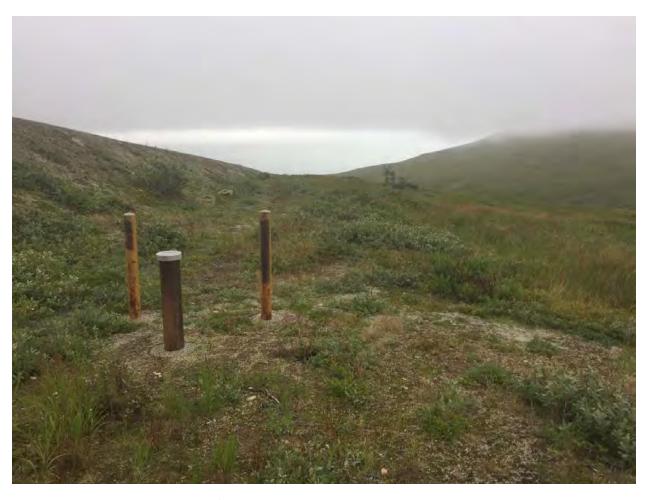
SS010 view south. MW1 shown in foreground.

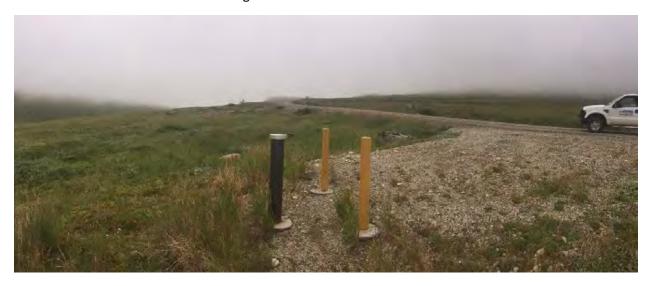
SS010 view north and east. MW2 shown in foreground.

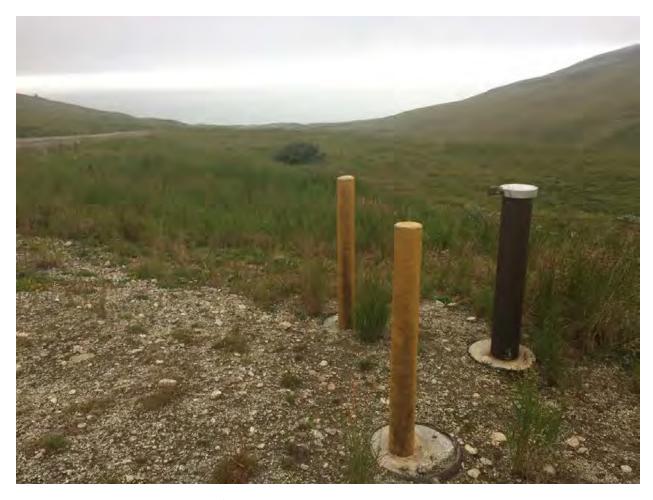
SS010 view south. MW2 shown in foreground.

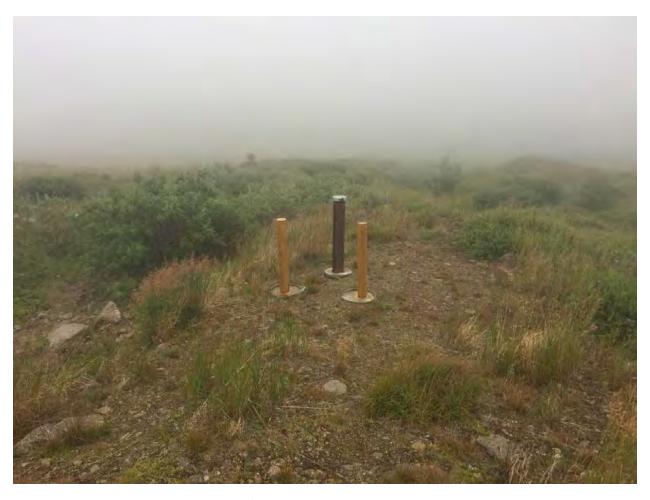
SS010 view south west. MW3 shown in foreground.

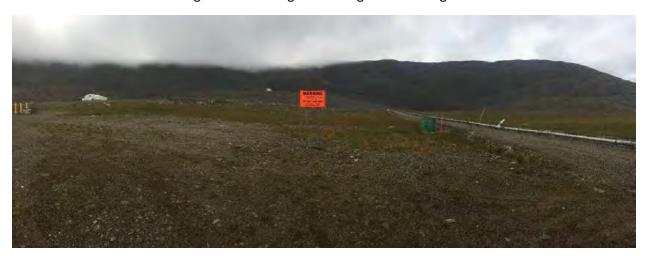
SS013 view east along water transmission line. LUC signage shown.

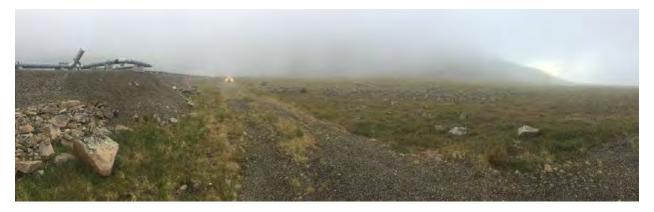
SS013 view south and east. Site overview.

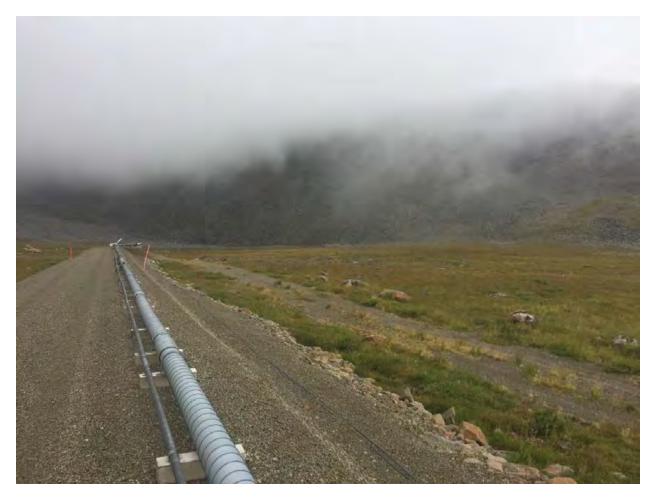
SS013 view north east. Site overview.

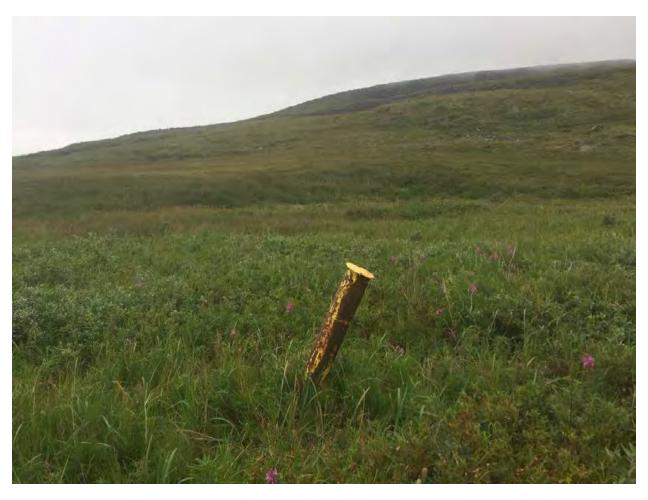
Site SS014 view west. MW3 shown in foreground.

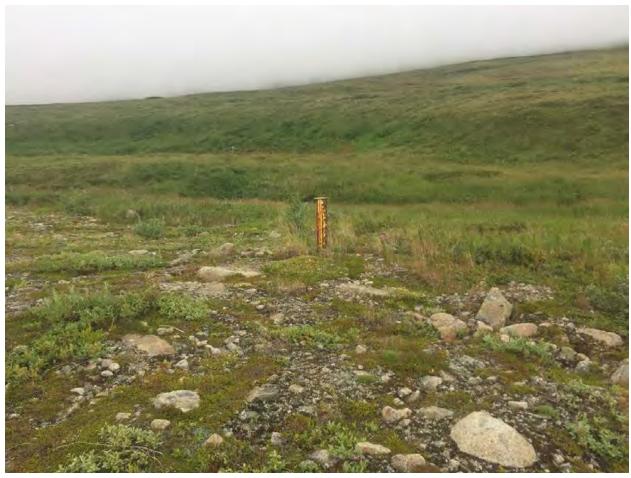
Site SS014 view east. MW2 shown in foreground.

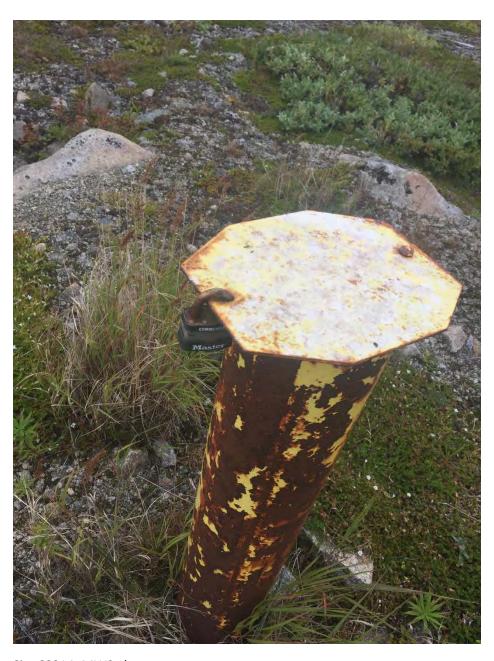
Site SS014. MW2 close-up.

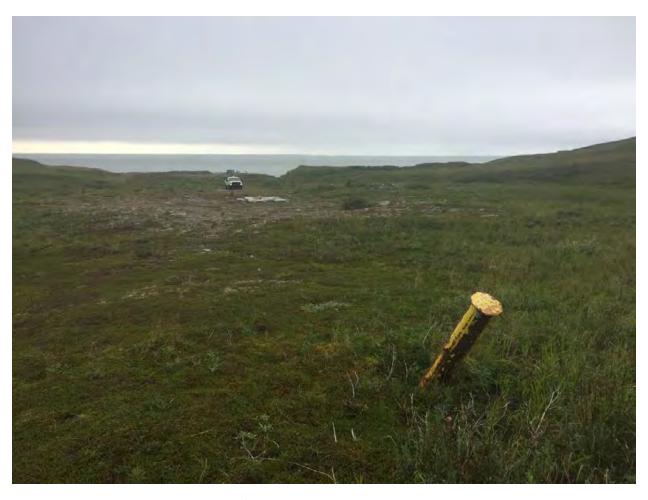
Site SS014 view south. MW1 shown in foreground with main LUC area shown in background.

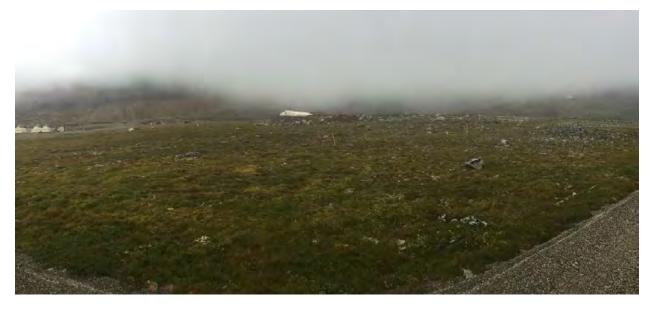
Site SS015 view north from water transmission line pad. Cold storage facility shown in backdrop.

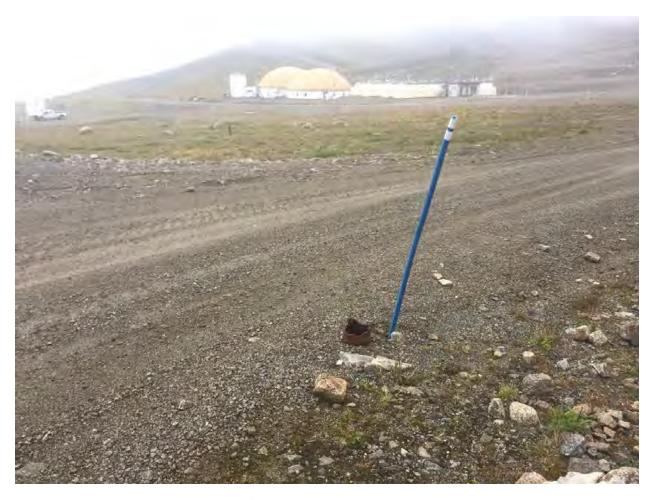
Site SS015 view west. WW01 shown in foreground.

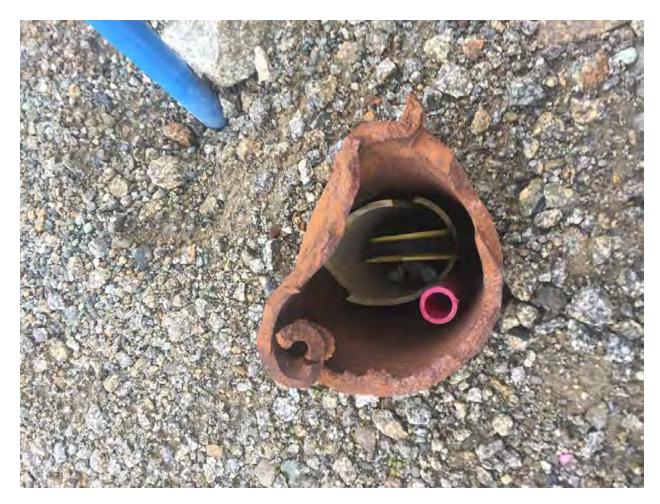
Site SS015. WW01 close-up.

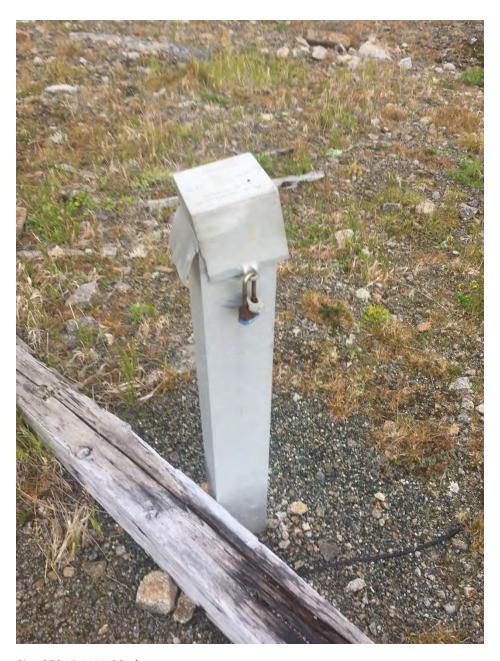
Site SS015. WW03 close-up.

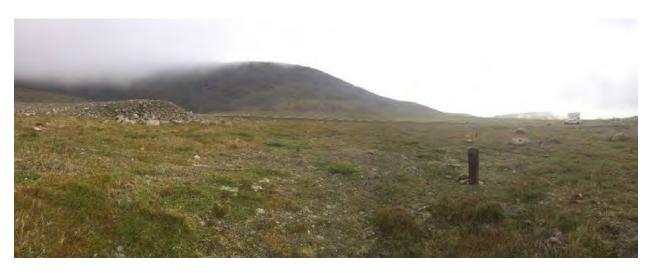
Site SS015 view south. WW5 shown in foreground.

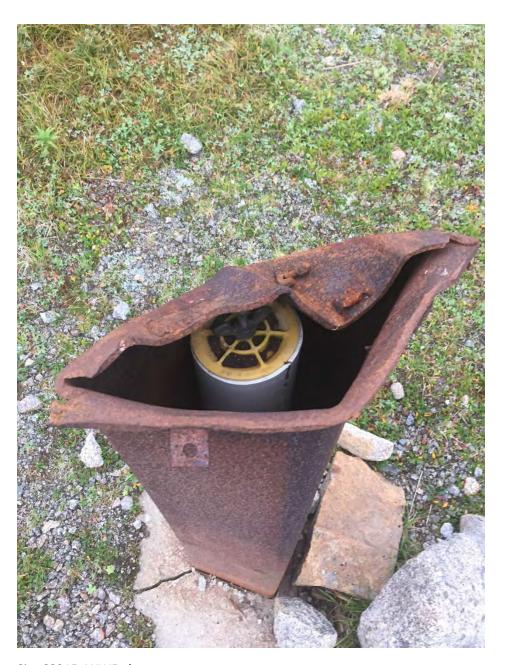
Site SS015. WW5 close-up.

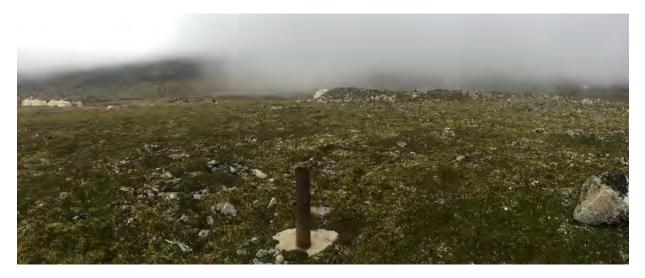
Site SS015 view north. WW6 shown in foreground.

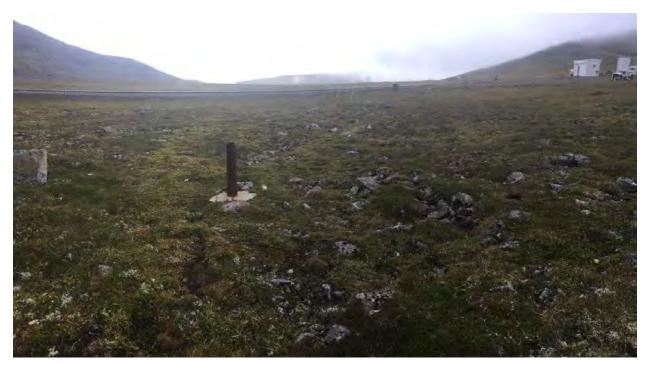
Site SS015 view south west. WW6 shown in foreground. Water transmission line pad and pump building shown in background.

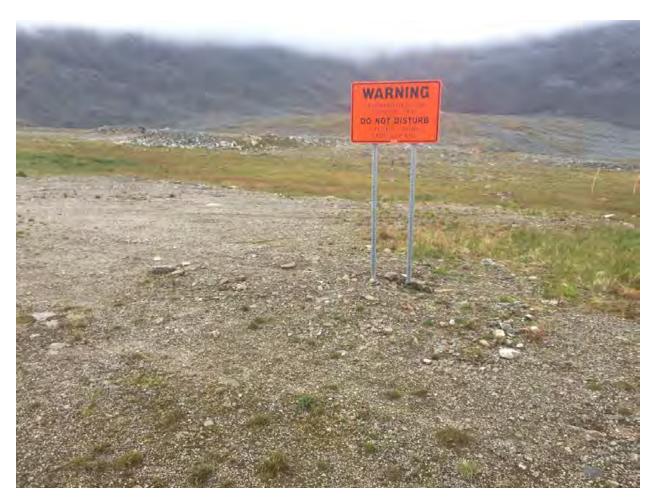
Site SS015 view east. LUC signage in foreground with SS015 in background.

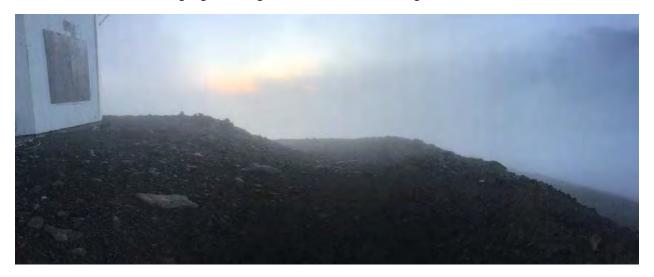
SS016 view north east below radome.

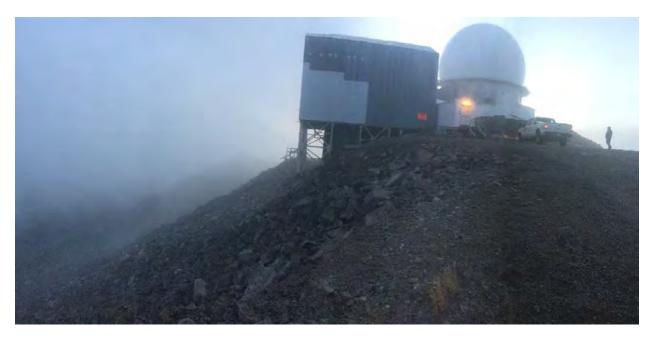
SS016 view north. LUC signage (orange) shown mounted to the upper tram building.

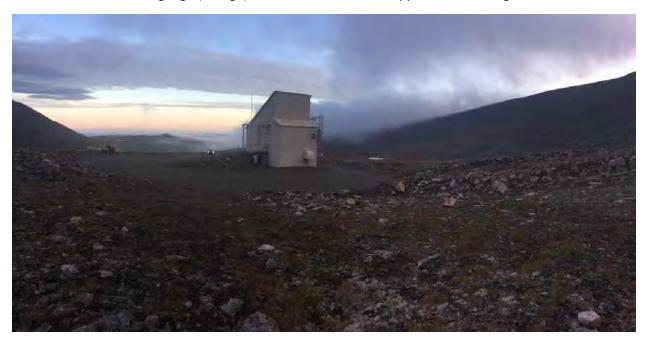
SS017 view west. Lower tram building shown.

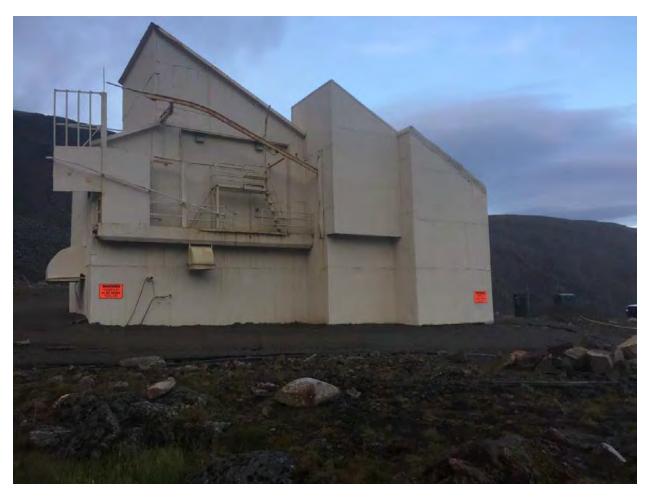
SS017 view south. LUC signage shown mounted to the lower tram building.

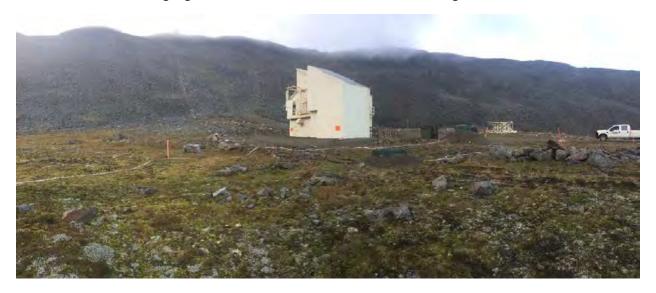
SS017 view east. Lower tram building and LUC signage shown.

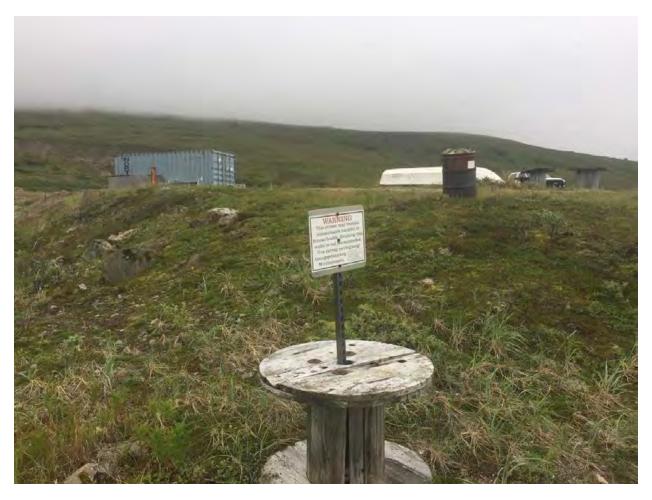
ST009 view east. LUC signage shown along beach access to the site.

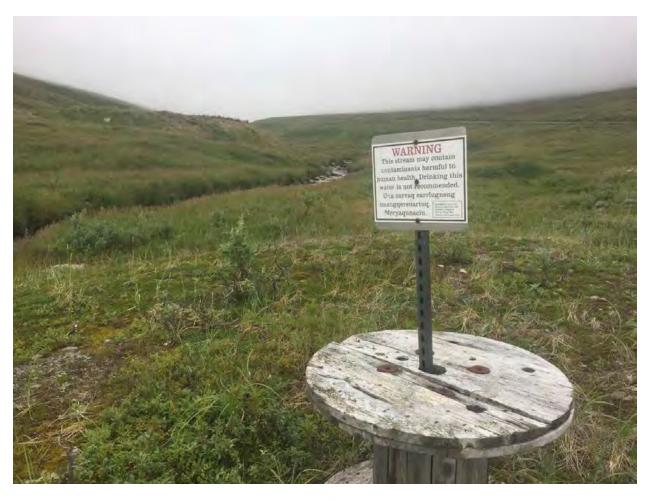
ST009 view north along Fowler Creek. LUC signage in foreground.

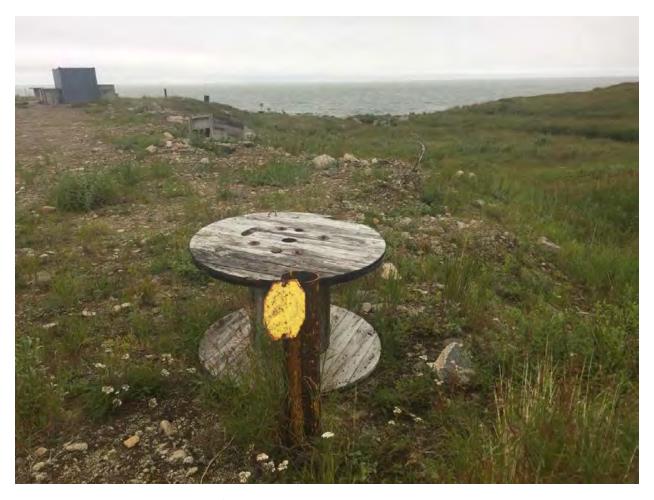
ST009 view south. MW4 shown in foreground and Fowler Creek outlet in background.

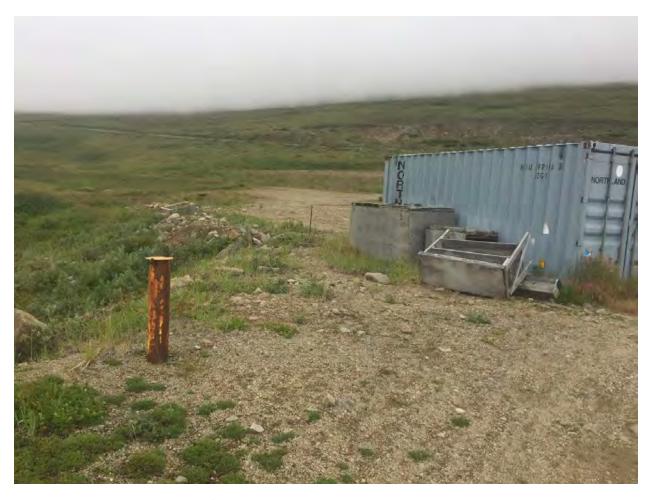
ST009 view east. MW6 shown in foreground.

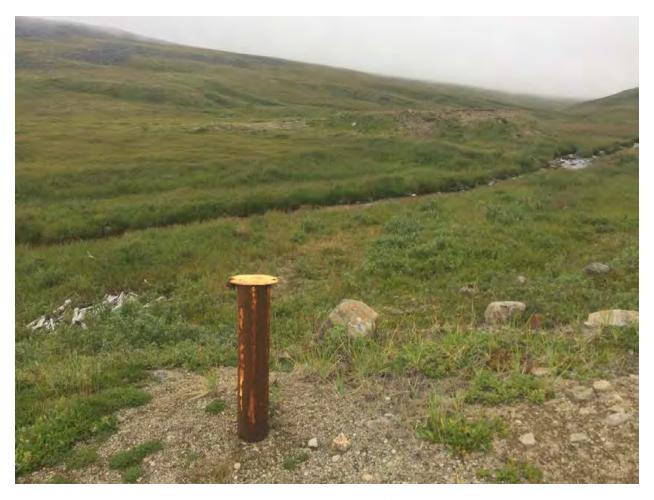
ST009 view west. Fowler Creek in background. MW6 shown in foreground.

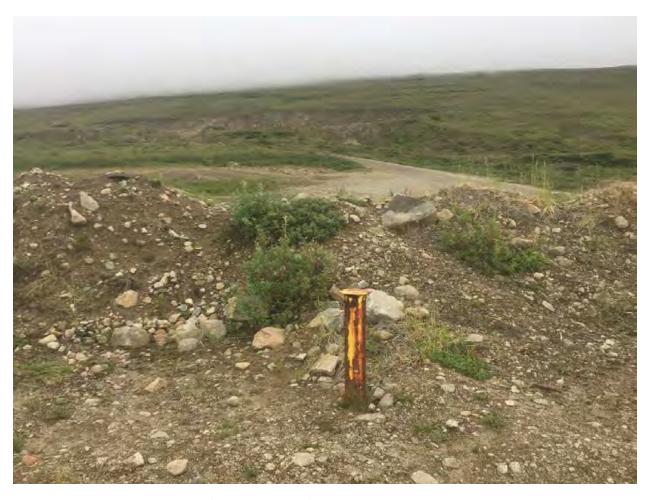
ST009 view east. MW7 shown in foreground and former borrow pit in background.

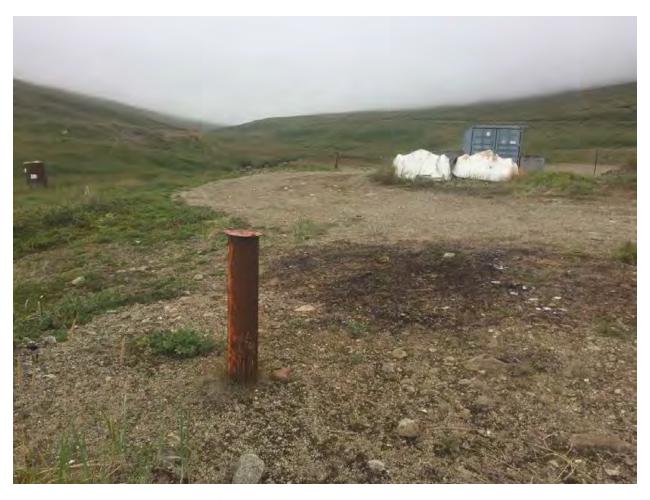
ST009 view north. MW8 shown in foreground. MW6 shown in background.

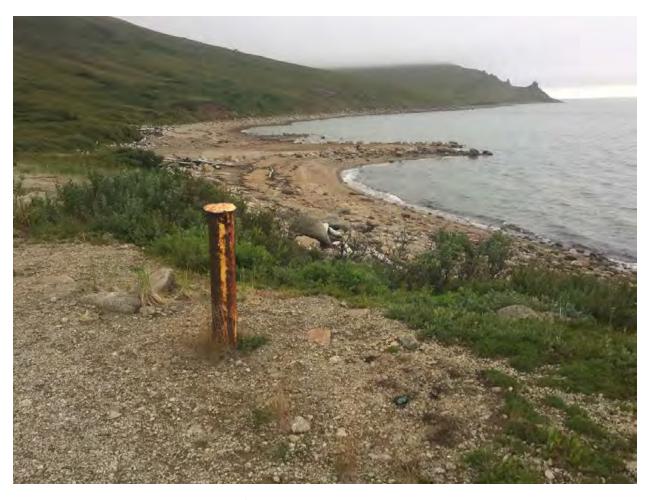
ST009 view southeast. MW9 shown in foreground, Kokechik Bay in background.

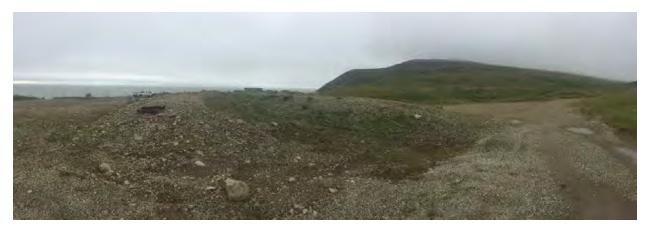
ST009 site overview from south to north.
