# SITE CHARACTERIZATION, CORRECTIVE ACTION AND DECOMMISSIONING REPORT

**HIPAS OBSERVATORY  
7795 CHENA HOT SPRINGS ROAD  
FAIRBANKS (TWO RIVERS), ALASKA**

**MARCH 5, 2013**

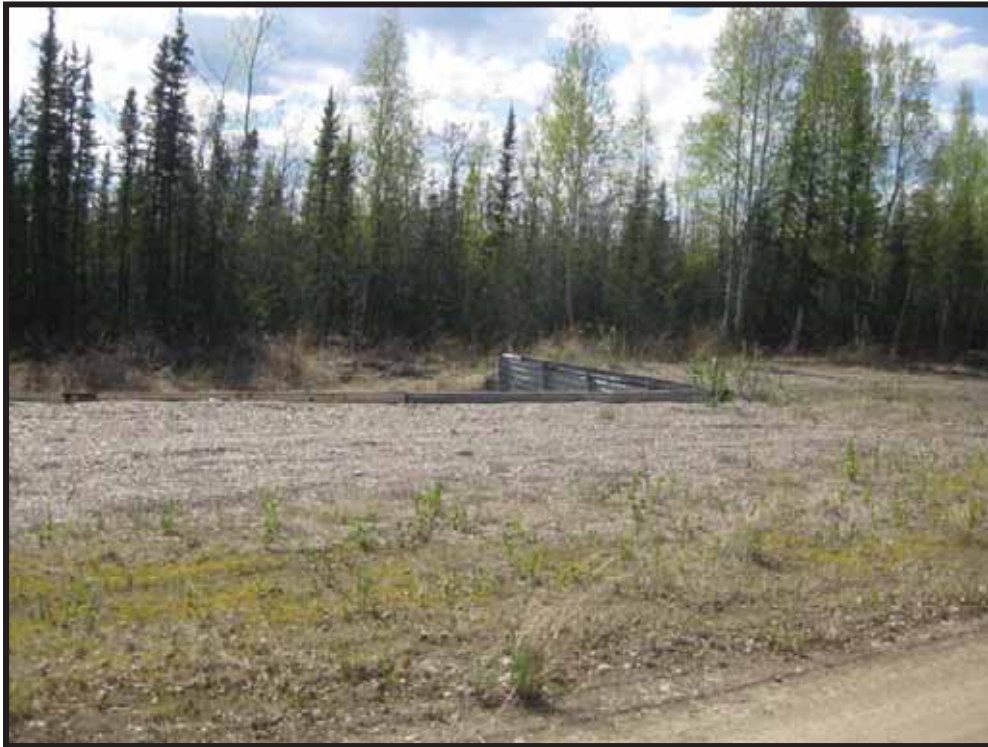
**Photo 7:** Looking south at loading dock area south of main driveway (2011)

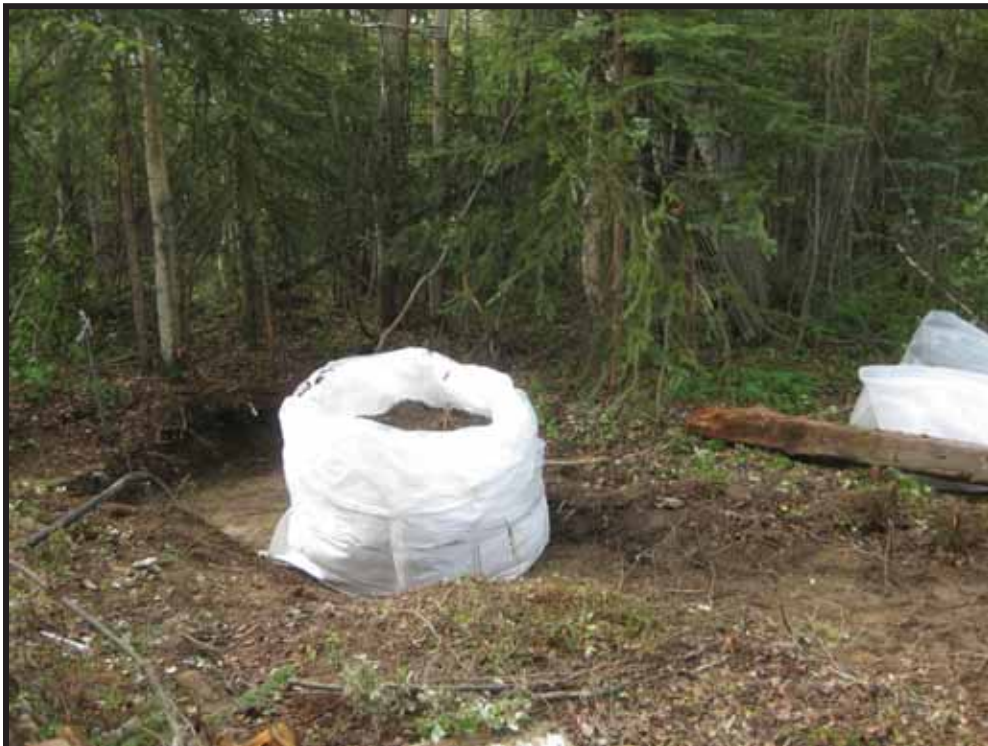
*Photo 2: Looking southeast at limits of hand excavation in 2010.*
