THIRD CERCLA FIVE-YEAR REVIEW AND THIRD NON-CERCLA PERIODIC REVIEW REPORT FOR SITES DP011, LF003, SS010, SS013, SS014, SS015, SS016, SS017, AND ST009 AT CAPE ROMANZOF LONG RANGE RADAR STATION, ALASKA

Final November 2018

United States Air Force Joint Base Elmendorf-Richardson, Alaska

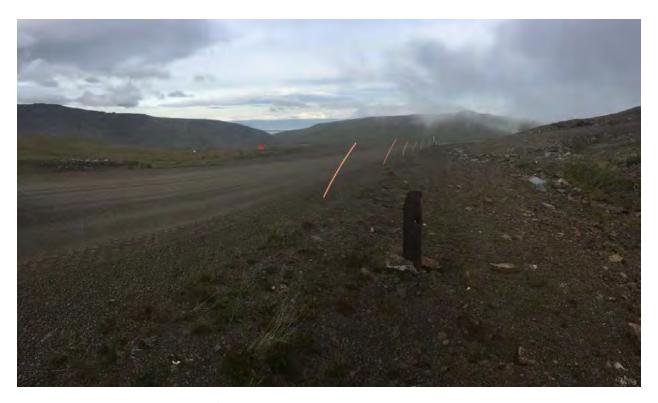
LF003 view west. MW1 shown in foreground along site access road.

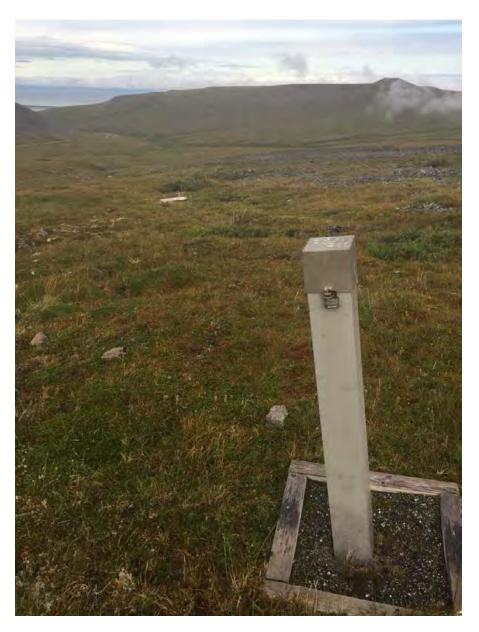
LF003 view west. Close-up of CMW6.
