**Site Assessment and Remediation Plan  
Pelican Seafood Processing Facility  
Pelican, Alaska**

May 2015

By:  
**Shannon & Wilson, Inc.**  
5430 Fairbanks Street, Suite 3  
Anchorage, Alaska 99518  
Phone: 907-561-2120  
FAX: 907-561-4483

32-1-17673

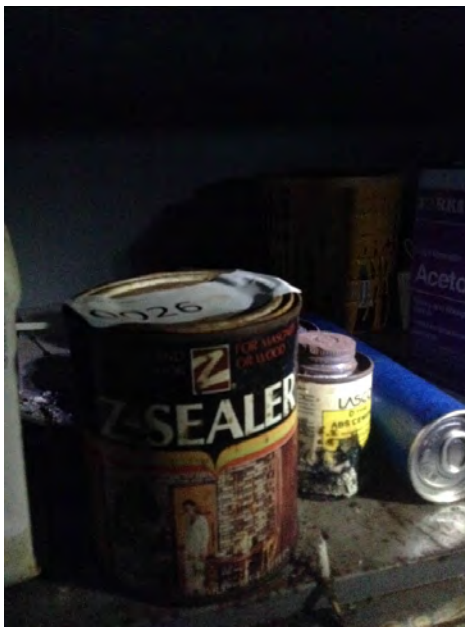
Label ID: Z-sealer

Container Condition: Intact with rust

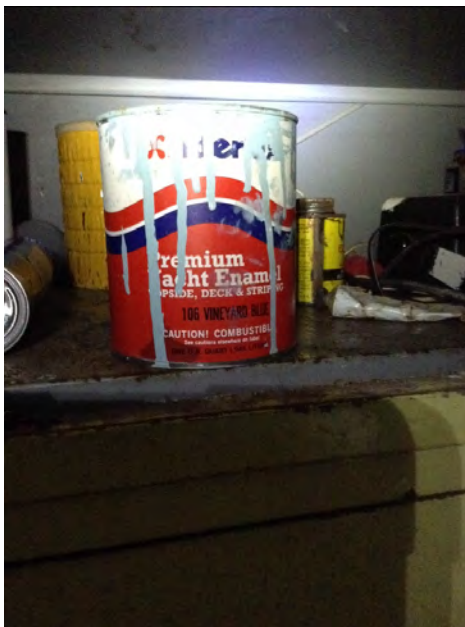
Label ID: Premium yacht enamel

Container Condition: Intact with rust

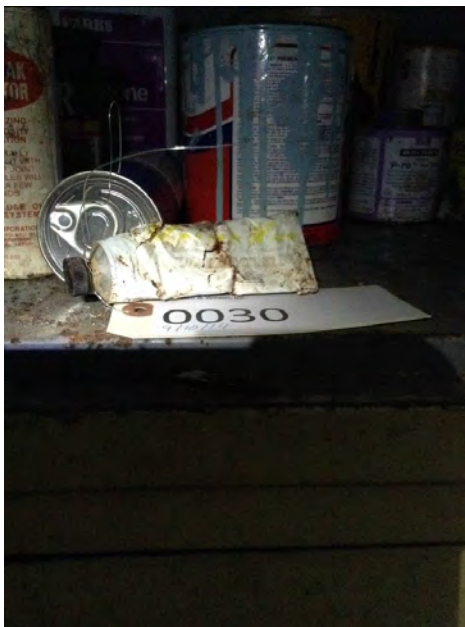
Label ID: Kolor kut water finding paste

Container Condition: Leaking

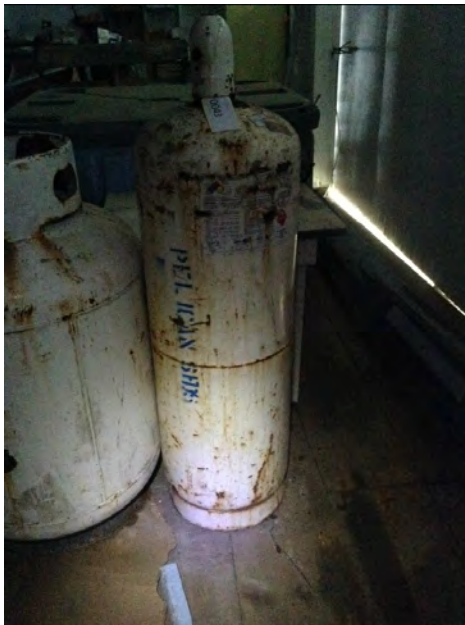
Label ID: Propane

Container Condition: Intact with rust

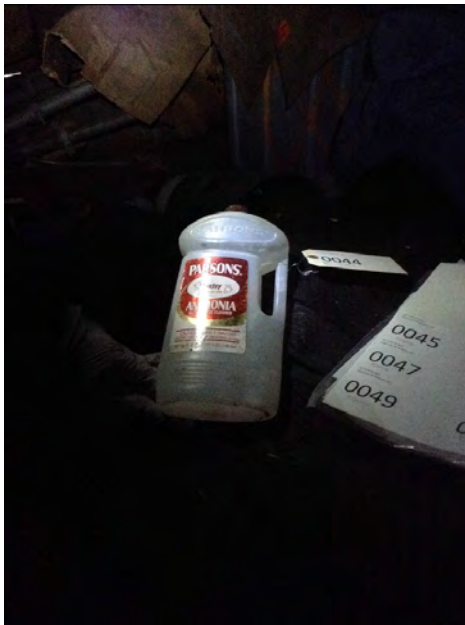
Label ID: Parsons sudy ammonia

Container Condition: Other (see addt'l details)

Additional Details: 56 oz container is good, rusty lid

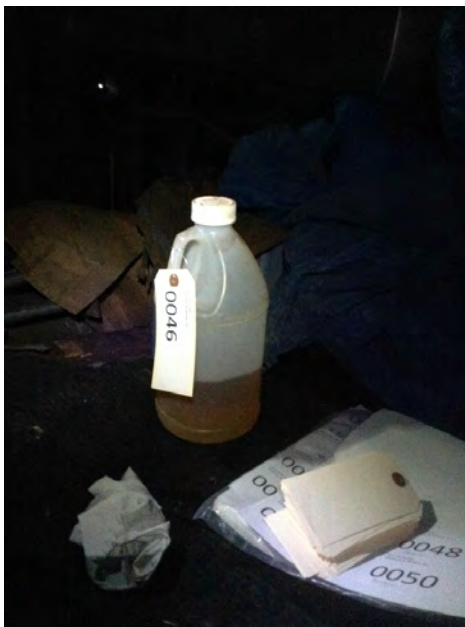
Label ID: Unlabeled

Container Condition: Fair

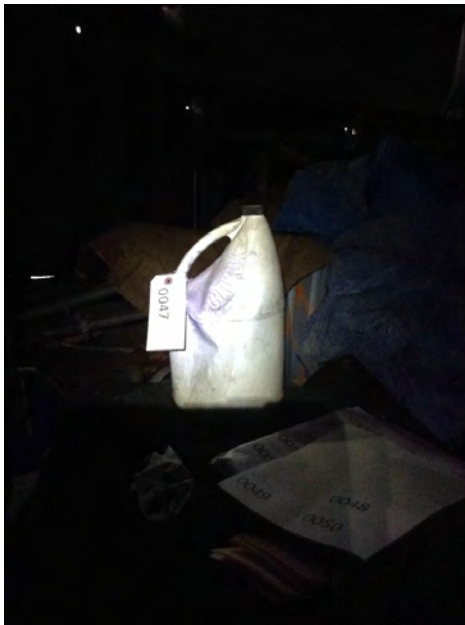
Label ID: Clorox

Container Condition: Fair

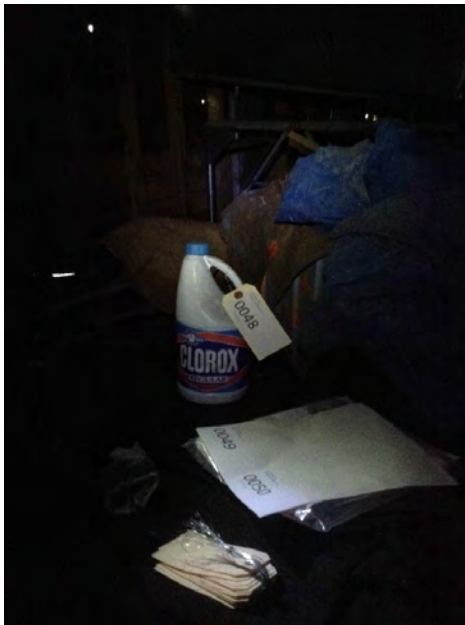
Label ID: Clorox Bleach

Container Condition: Fair

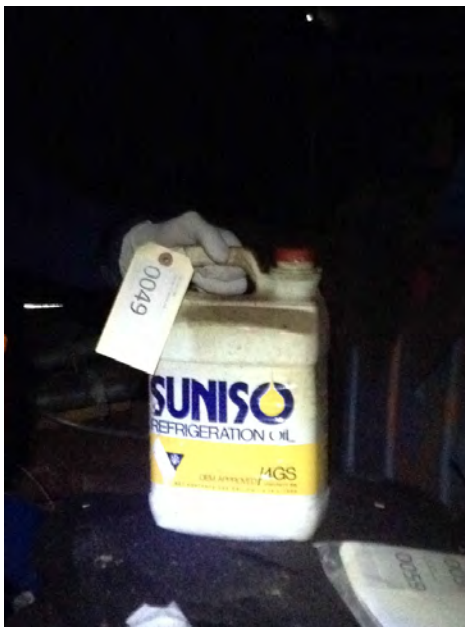
Label ID: Suniso refrigeration oil

Container Condition: Fair

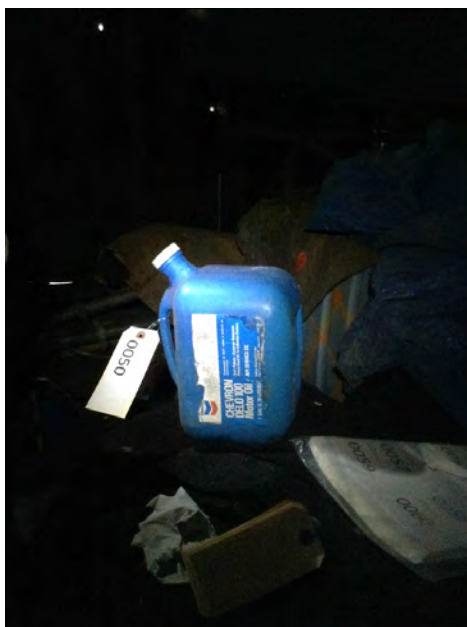
Label ID: Chevron delo 100 motor oil

Container Condition: Fair

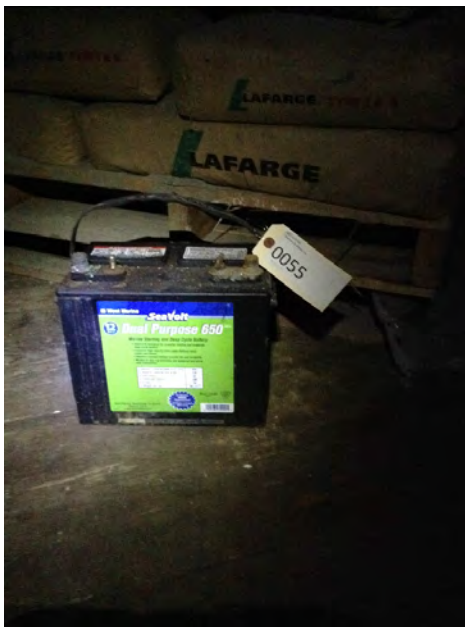
Label ID: SeaVolt Dual purpose 650

Container Condition: Fair

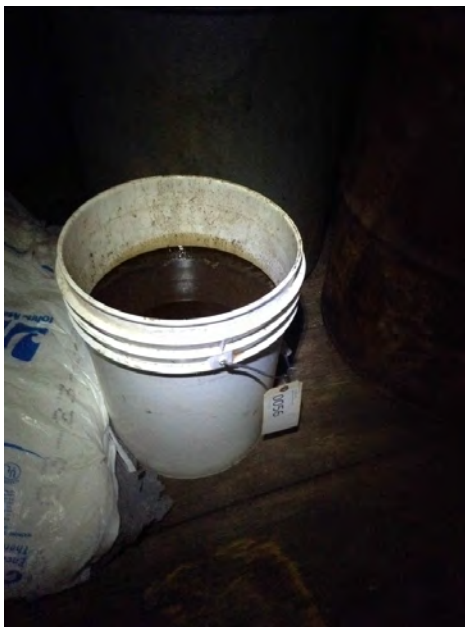
Label ID: No label

Container Condition: Open (no cover)

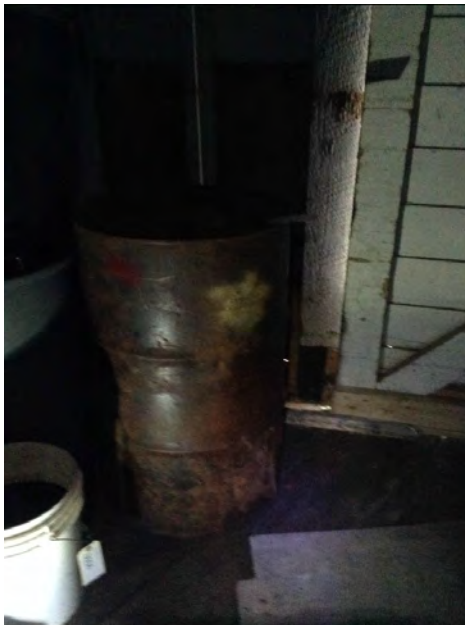
Label ID: No label

Container Condition: Intact with rust

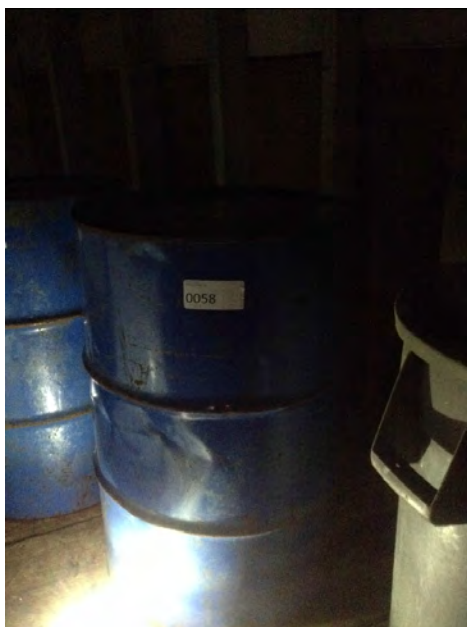
Label ID: AVGAS 100 LL

Container Condition: Intact with rust

Additional Details: Label states fuel is subject to contamination due to improper handling

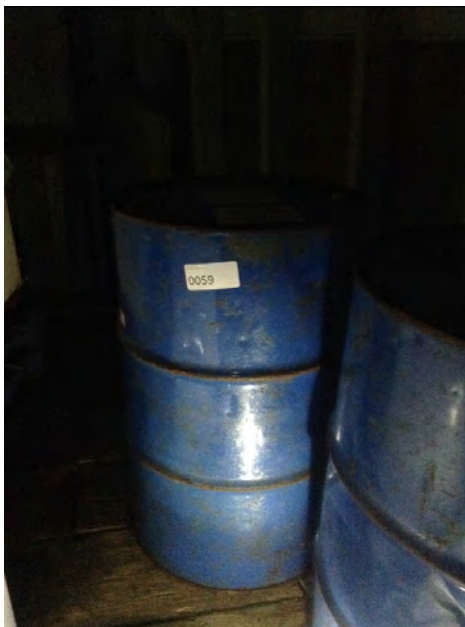
Label ID: AVGAS 100 LL

Container Condition: Intact with rust

Additional Details: Label states fuel is subject to contamination due to improper handling

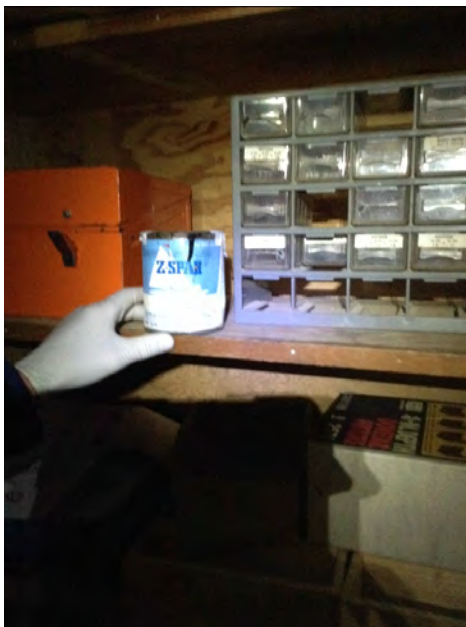
Label ID: Z-Spar gloss black marine enamel

Container Condition: Intact with rust

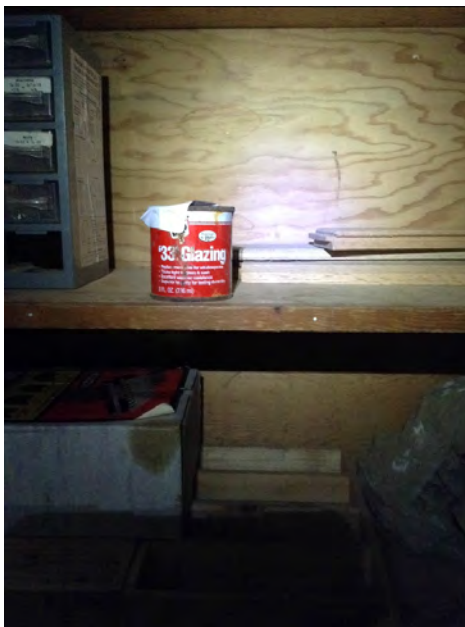
Label ID: Dap 33 Glazing

Container Condition: Intact with rust

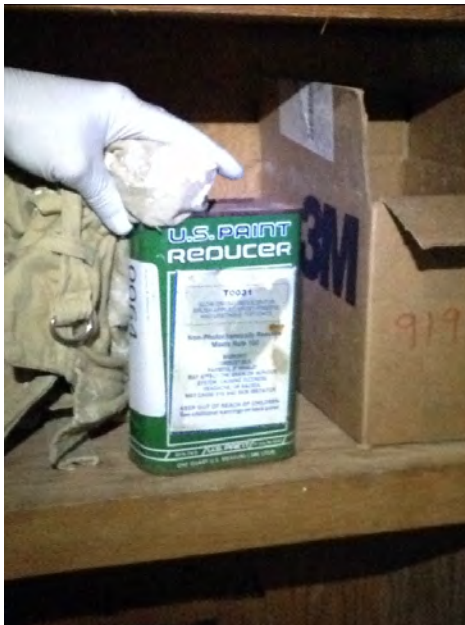
Container Condition: Open (no cover)

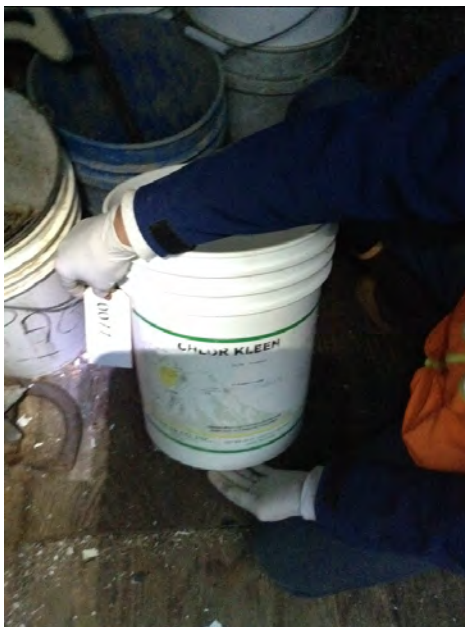
Container Condition: Open (no cover)

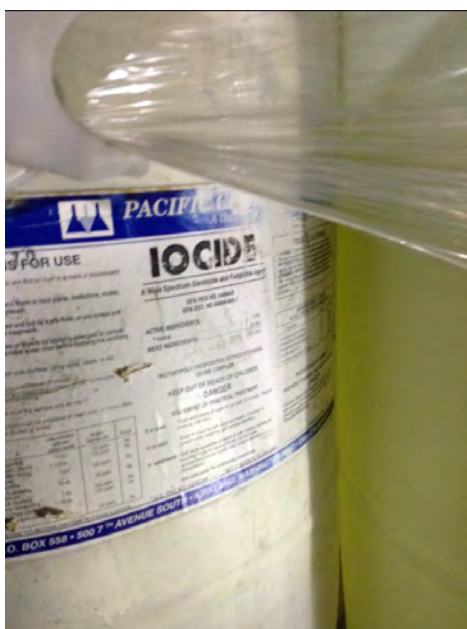
Additional Details: Not tightly capped, corrosive

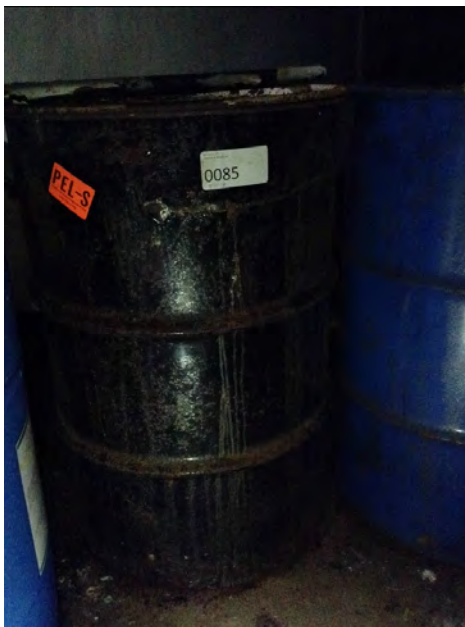
Container Condition: Intact with rust

Additional Details: Lid not secure, corrosive solid

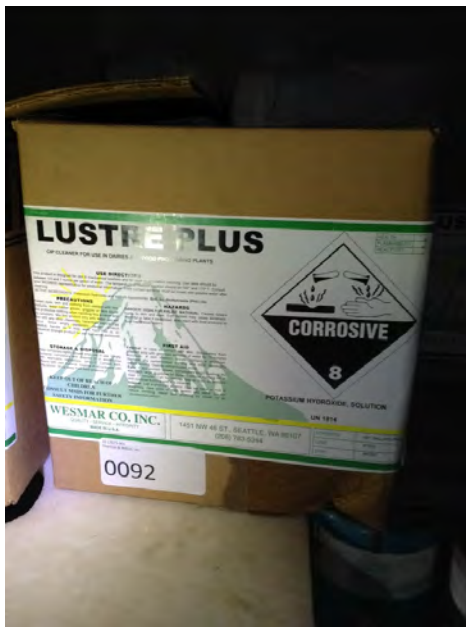
Additional Details: Box with 4 1 gal unopened poly jugs, stains on side of box

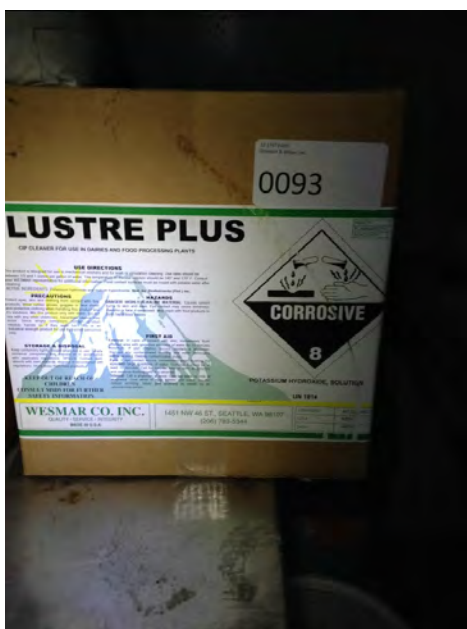
Container Condition: Poor

Additional Details: Box with 4 1 gal unopened poly jugs, hole and staining in back

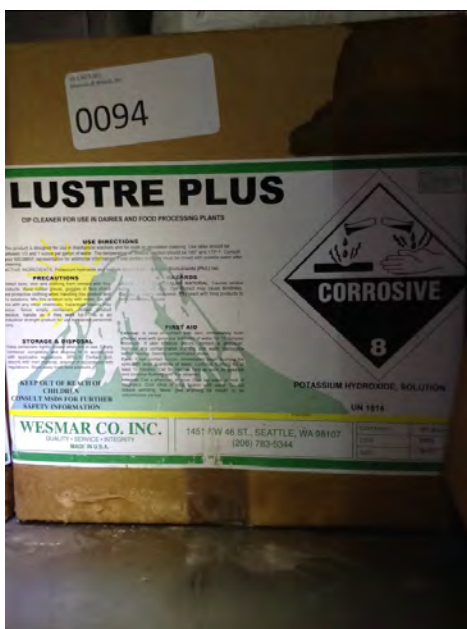
Container Condition: Other (see add'l details)

Additional Details: Box with 4 1 gal unopened poly jugs, stains on side of box

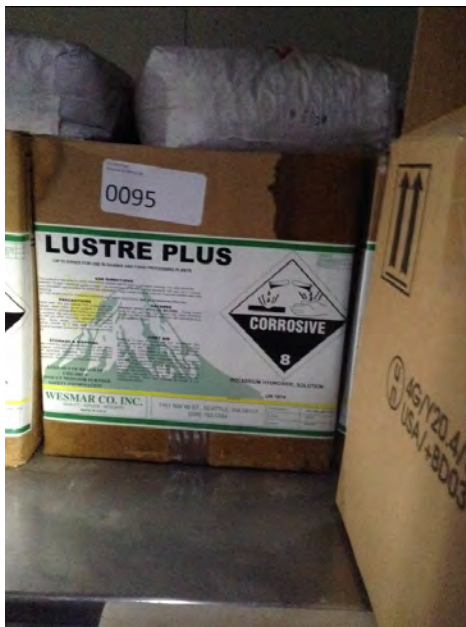
Container Condition: Other (see add'l details)

Additional Details: Box with 4 1 gal unopened poly jugs, stains on side of box

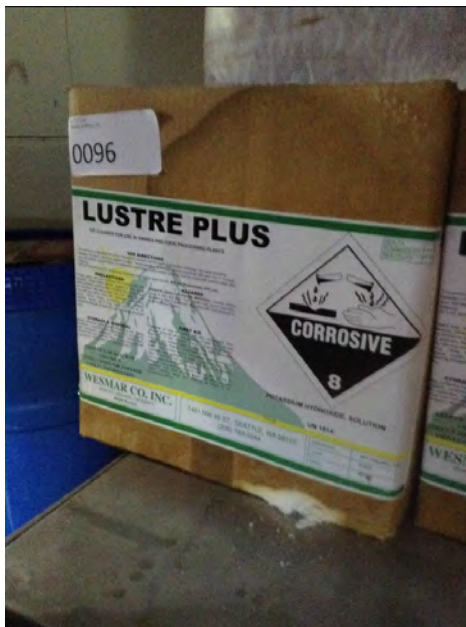
Container Condition: Poor

Additional Details: Box with 4 1 gal unopened poly jugs, stains on side of box, leaking at bottom

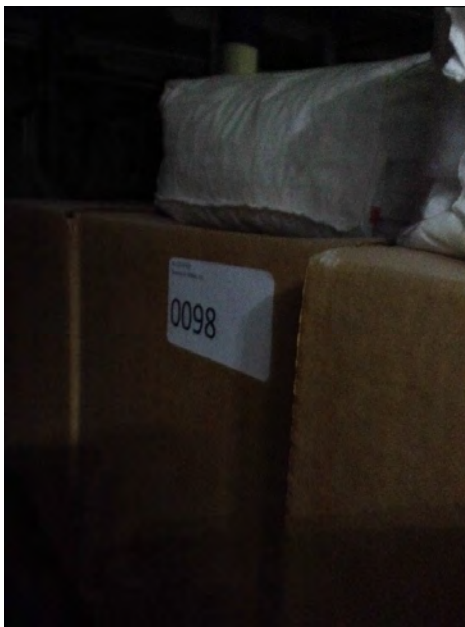
Label ID: Lustre plus

Container Condition: Good

Additional Details: Box with 4 1 gal unopened poly jugs, stains on side of box

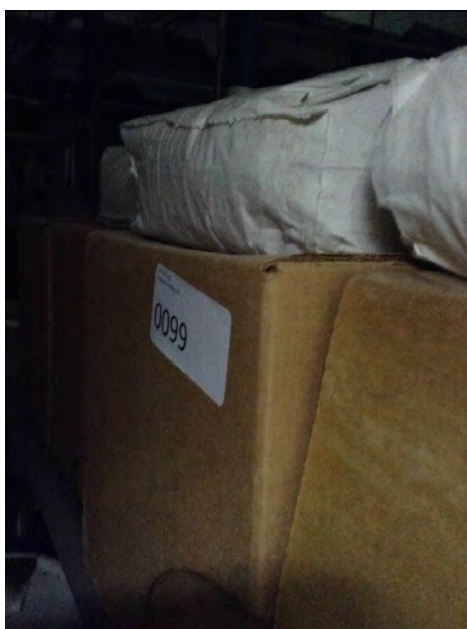
Label ID: Lustre plus

Container Condition: Fair

Additional Details: Box with 4 1 gal unopened poly jugs, stains on side of box

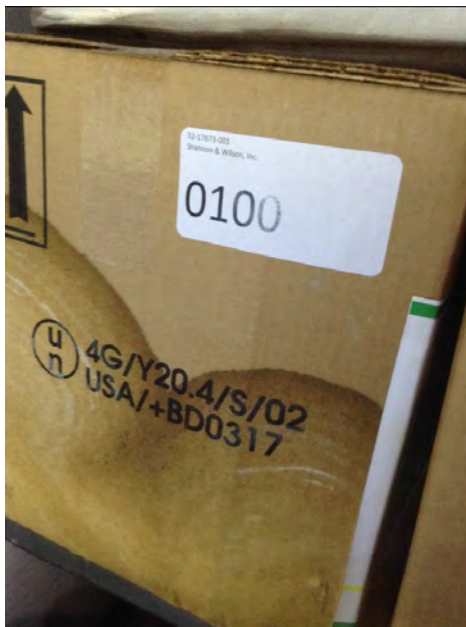
Label ID: Lustre plus

Container Condition: Fair

Additional Details: Box with 4 1 gal unopened poly jugs, stains on side of box

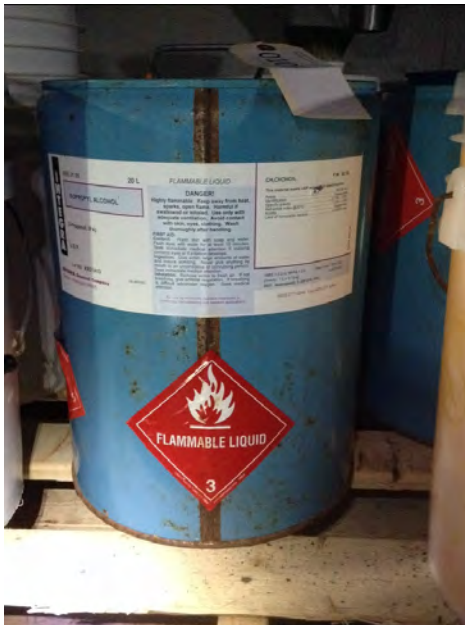
Label ID: Integra isopropyl alcohol

Container Condition: Intact with rust

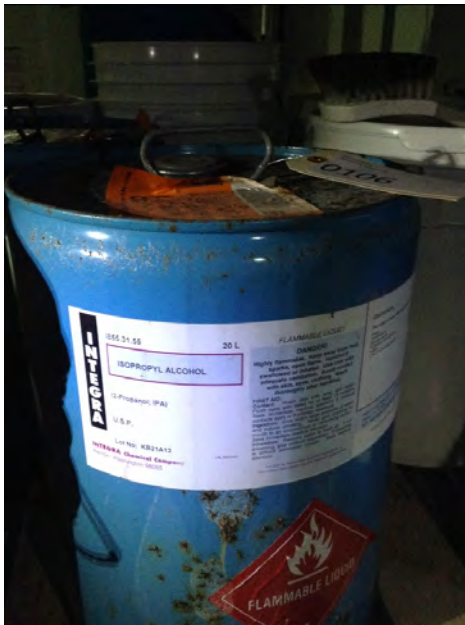
Label ID: Integra isopropyl alcohol

Container Condition: Intact with rust

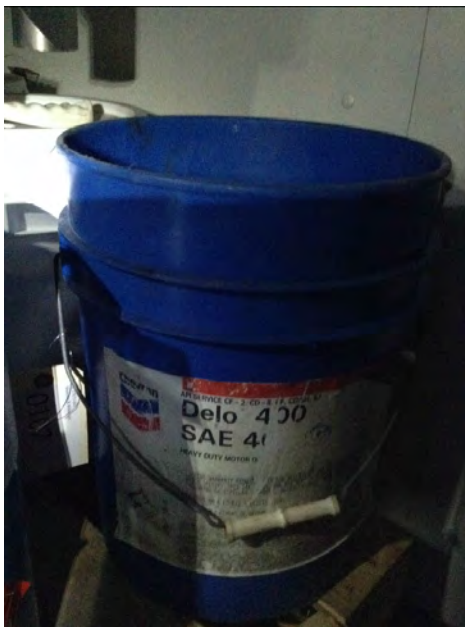
Label ID: Chevron delo 400 sae 40

Container Condition: Open (no cover)

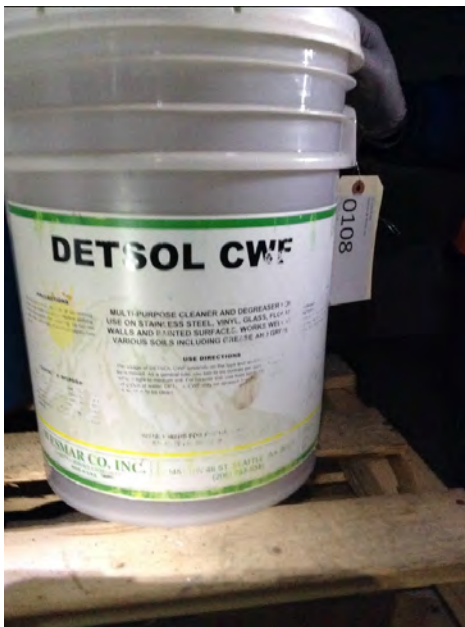
Label ID: Detail cwf

Additional Details: Cap is rusted

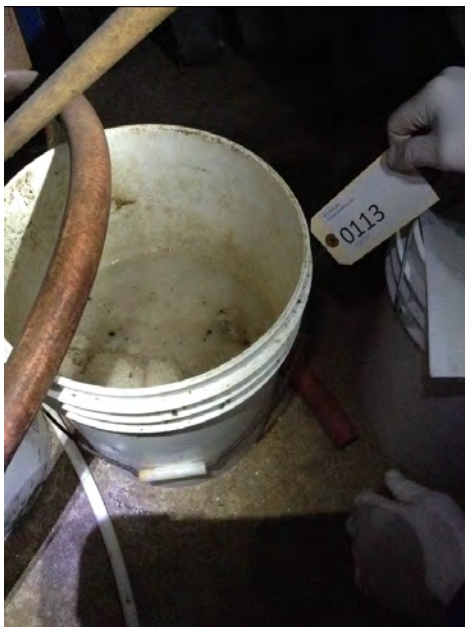
Label ID: None

Container Condition: Open (no cover)

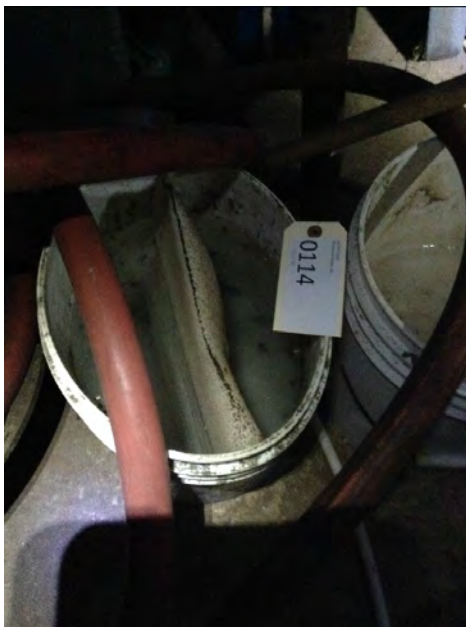
Label ID: No label

Container Condition: Open (no cover)

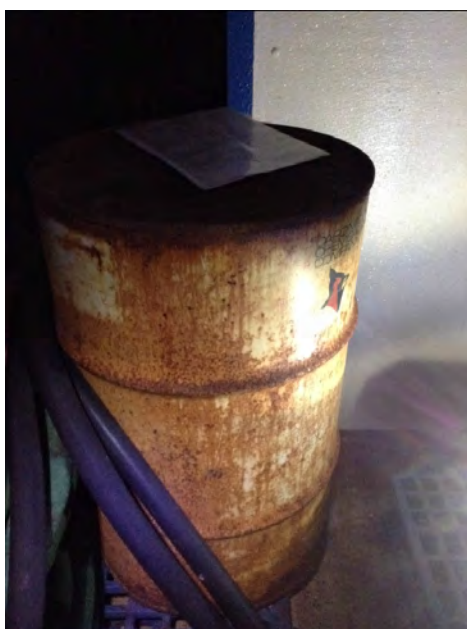
Label ID: No label

Container Condition: Intact with rust

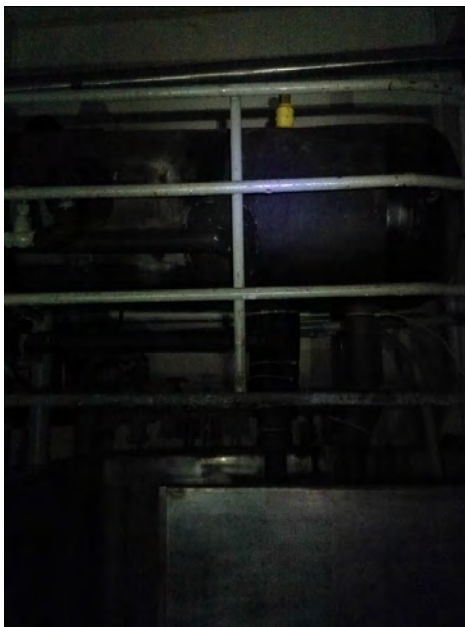
Label ID: No label

Container Condition: Intact with rust

Waste constituents: Unknown if material is present, ammonia condensate?

Additional Details: 120 gal tank, likely ammonia condensate tank

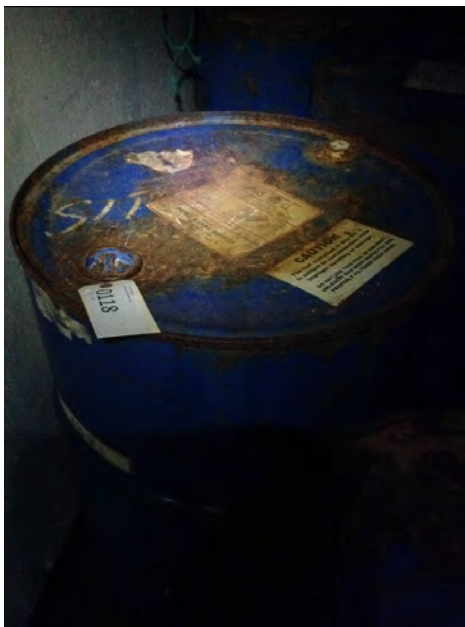
Label ID: Avgas 100 LL

Container Condition: Intact with rust

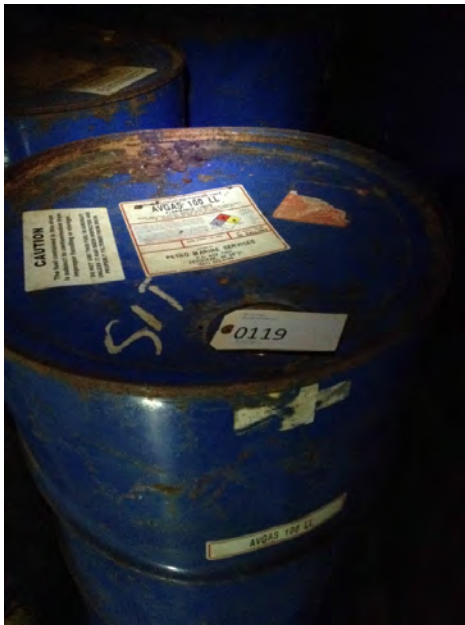
Label ID: Avgas 100 LL

Container Condition: Intact with rust

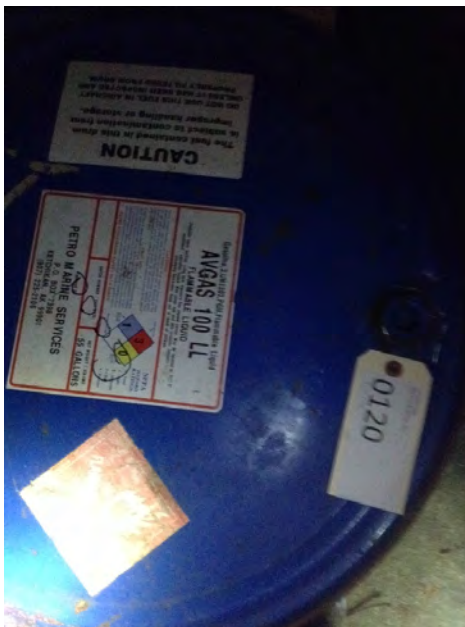
Label ID: Avgas 100 LL

Container Condition: Intact with rust

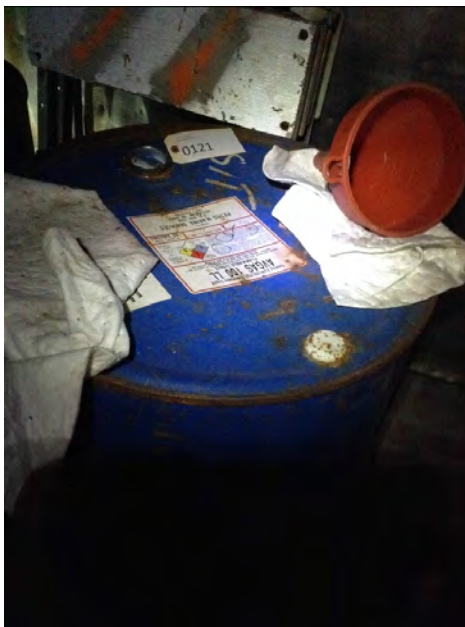
Label ID: Avgas 100 LL

Container Condition: Intact with rust

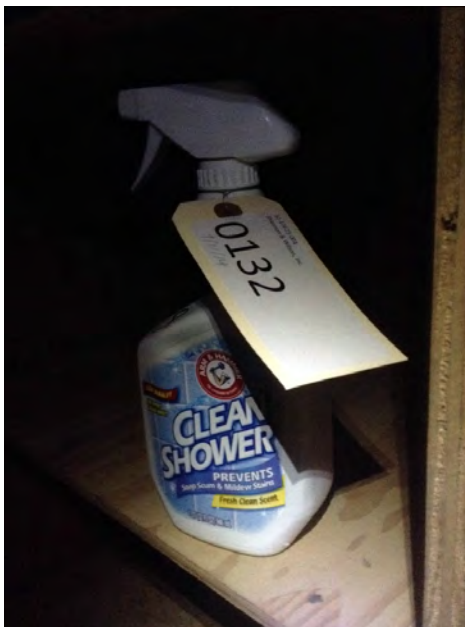
Container Condition: Good

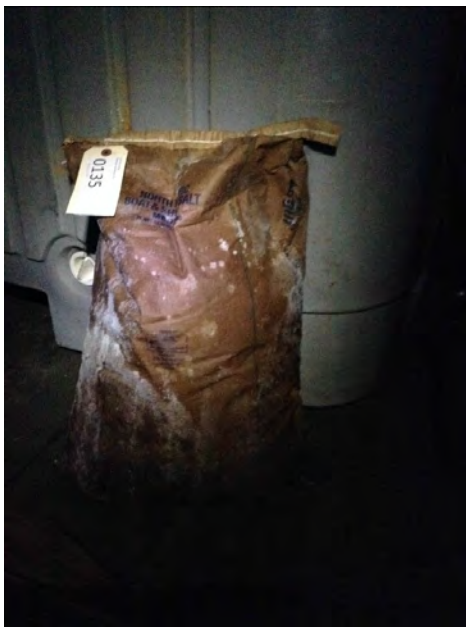
Container Condition: Fair

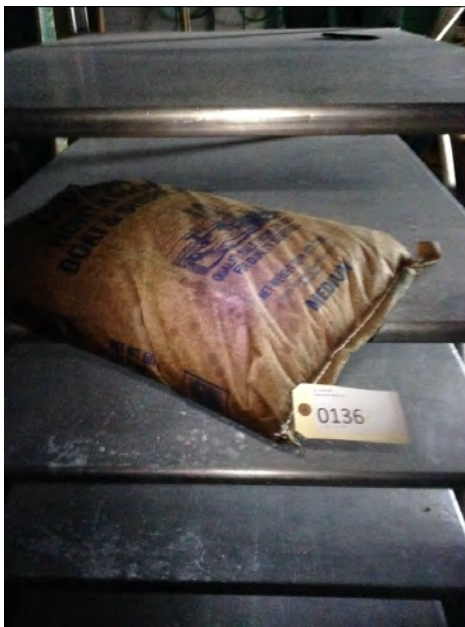
Container Condition: Fair

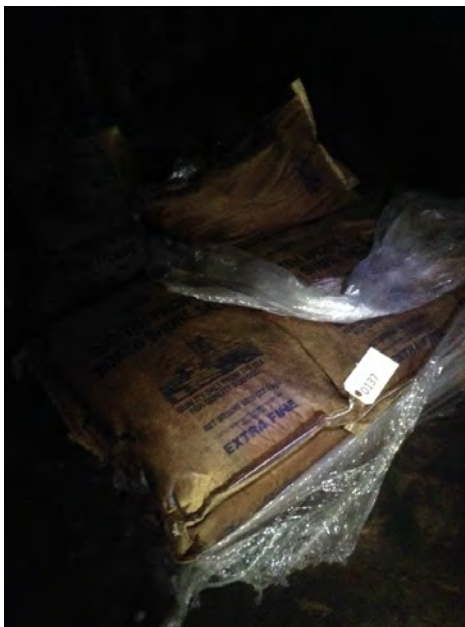
Container Condition: Fair

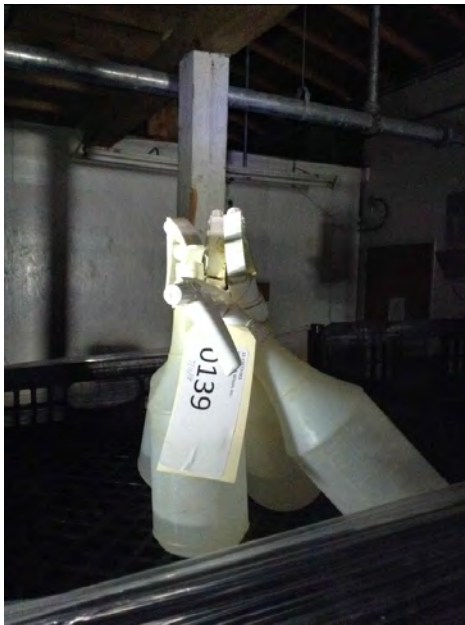
Container Condition: Good

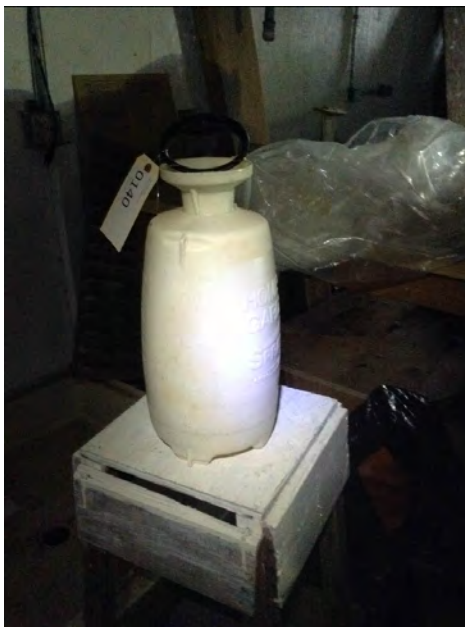
Container Condition: Good

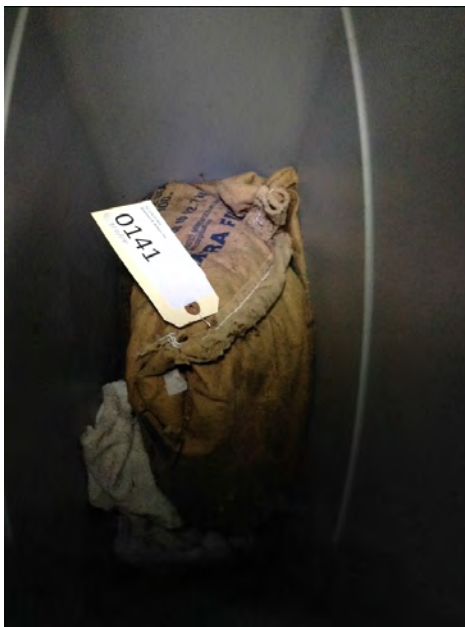
Container Condition: Fair

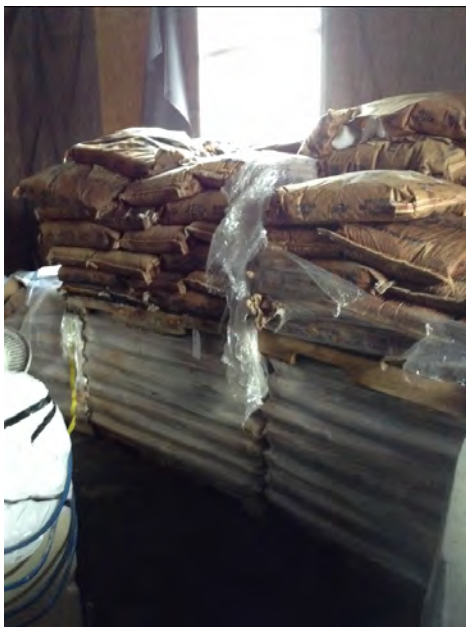
Container Condition: Fair

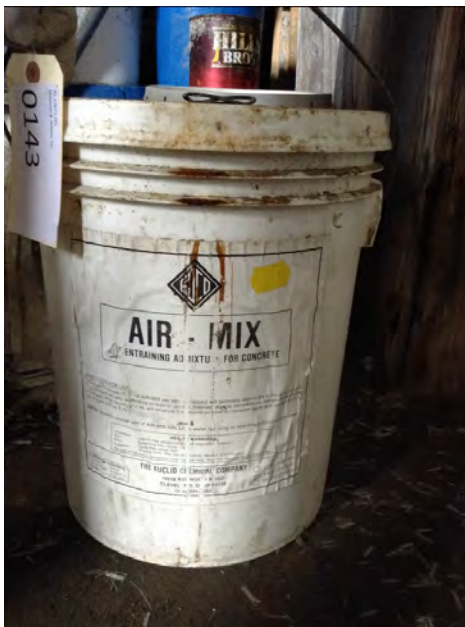
Container Condition: Good

Additional Details: Cap is rusting

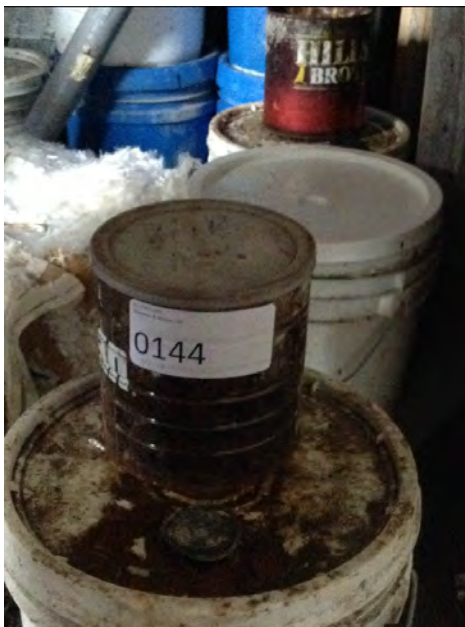
Container Condition: Fair

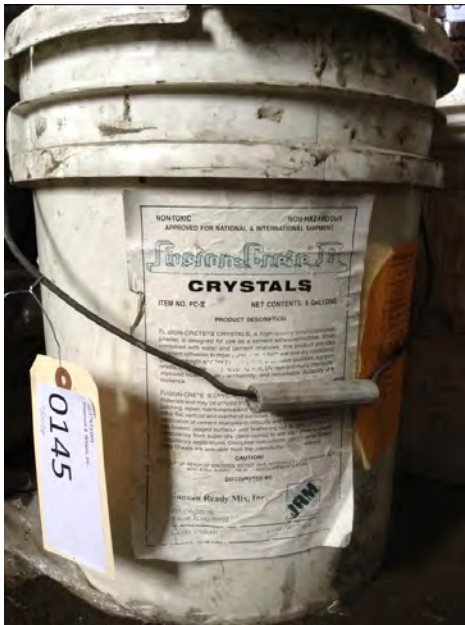
Container Condition: Good

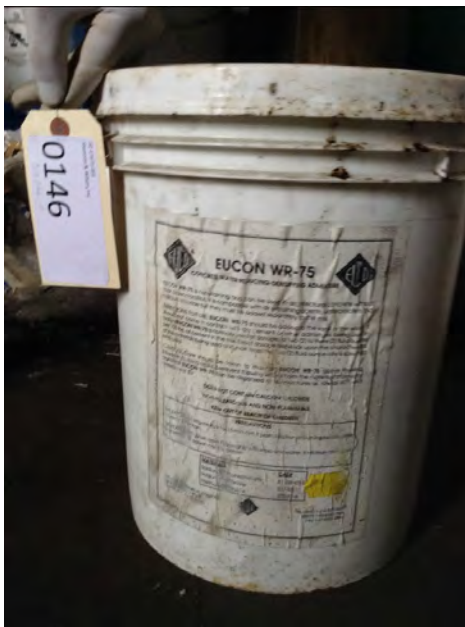
Container Condition: Good

Additional Details: Cap is rusty

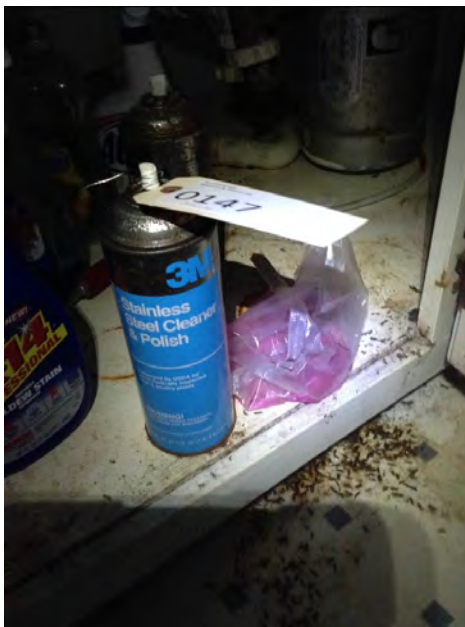
Container Condition: Intact with rust

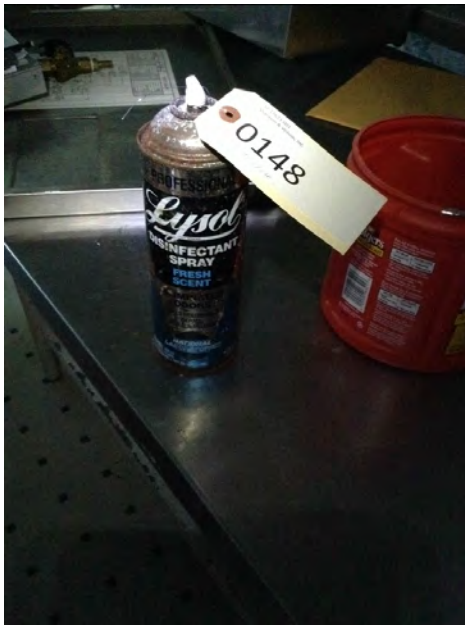
Container Condition: Intact with rust

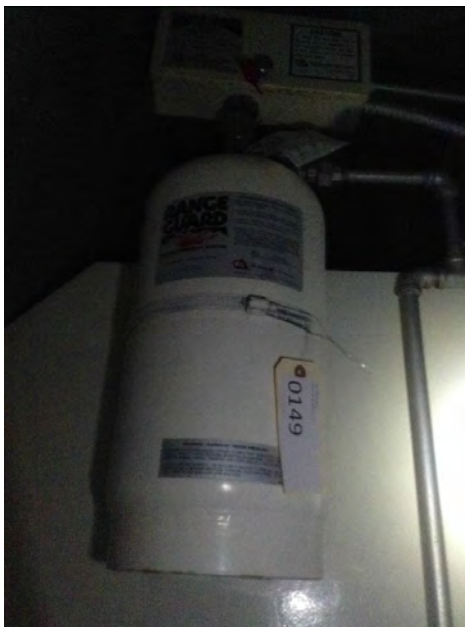
Container Condition: Good

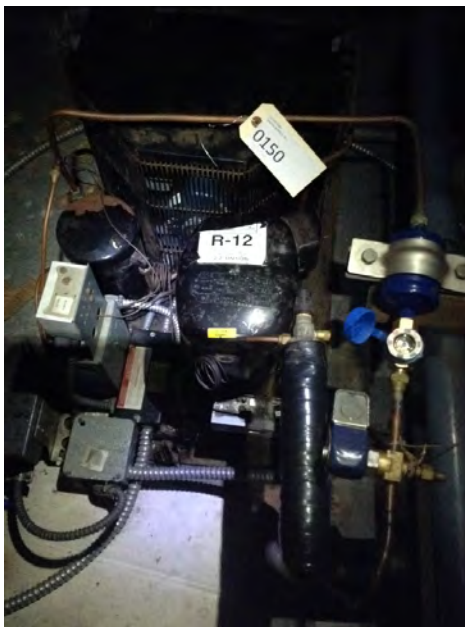
Container Condition: Good

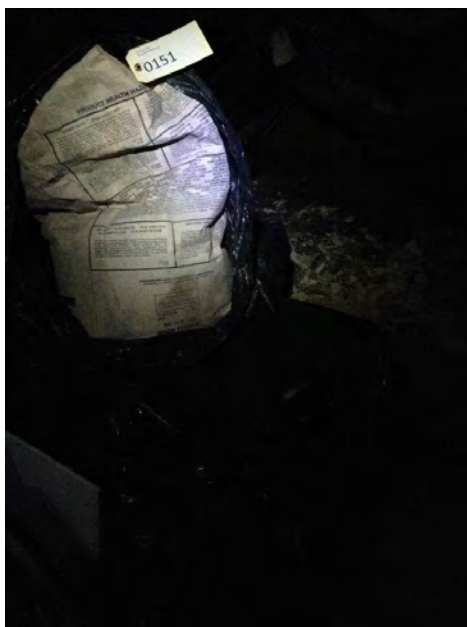
Container Condition: Fair

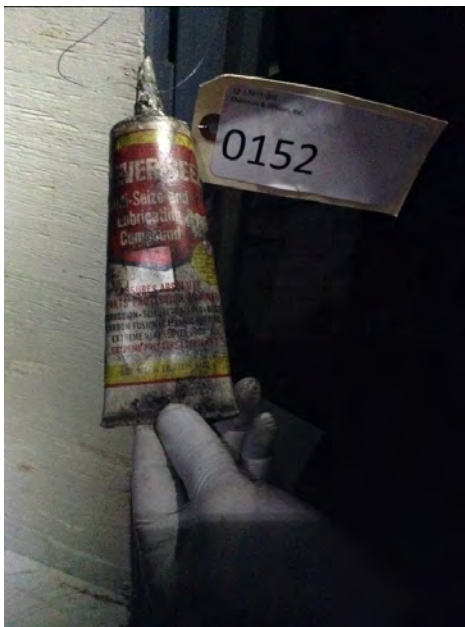
Container Condition: Open (no cover)

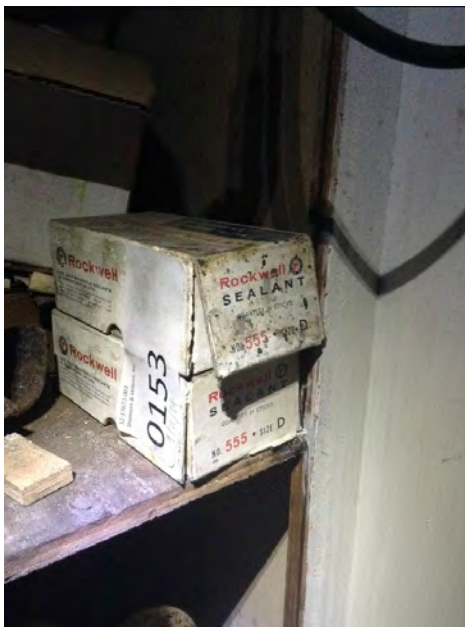
Container Condition: Good

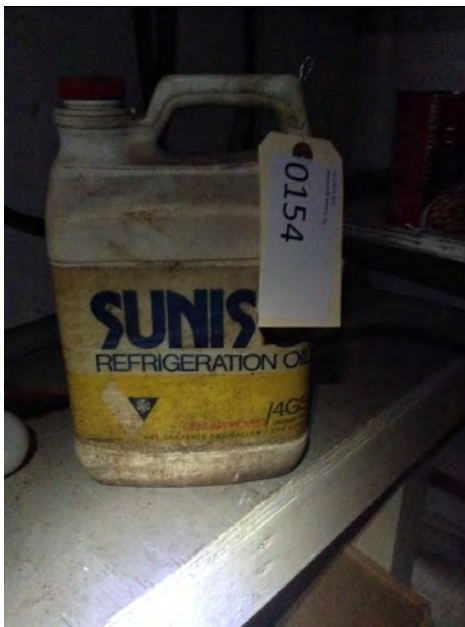
Container Condition: Good

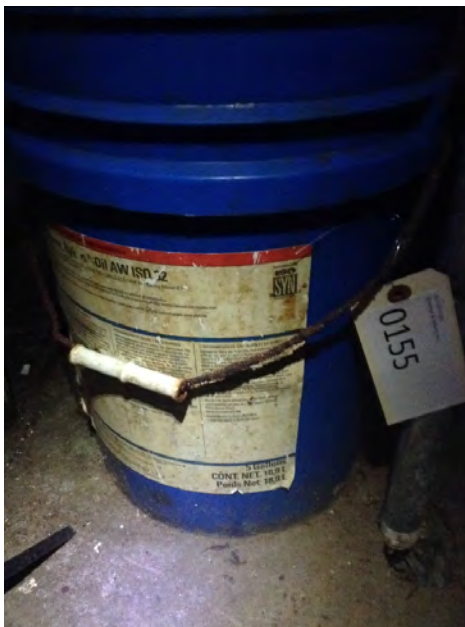
Container Condition: Open (no cover)

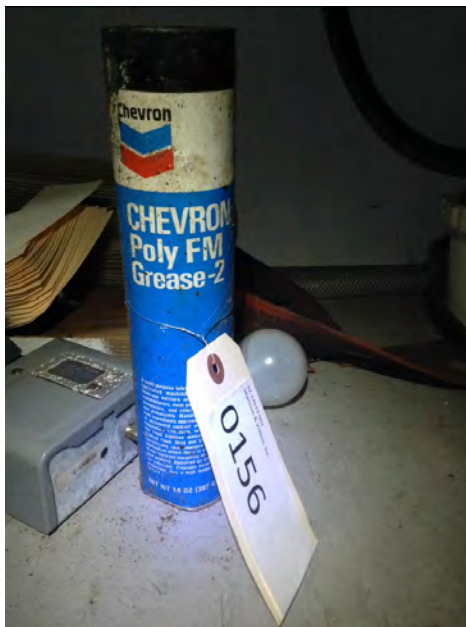
Container Condition: Open (no cover)

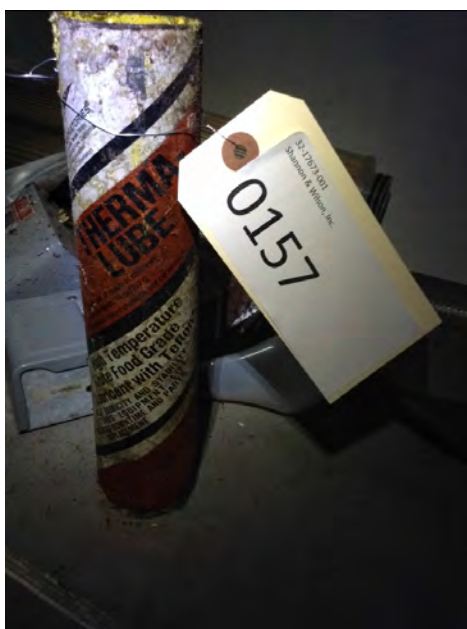
Container Condition: Open (no cover)

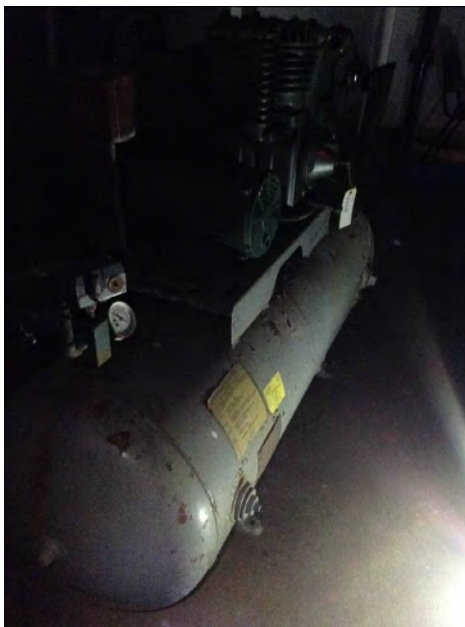
Container Condition: Intact with rust

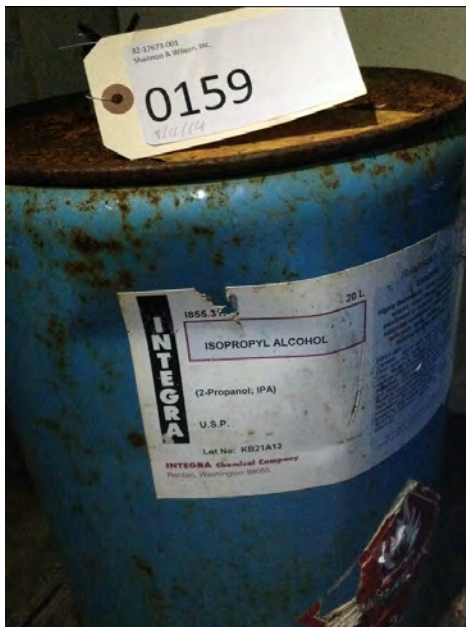
Container Condition: Intact with rust

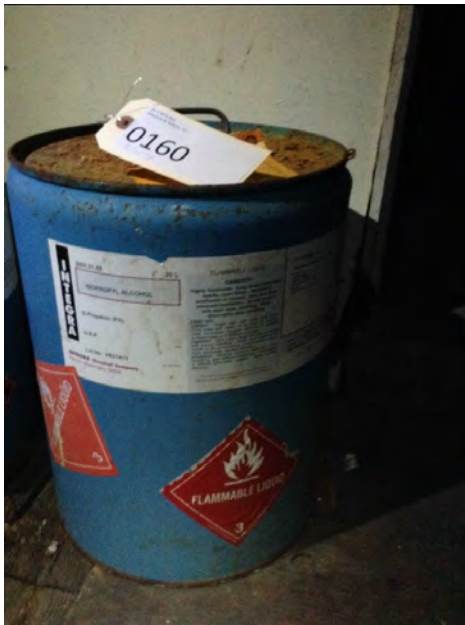
Container Condition: Intact with rust

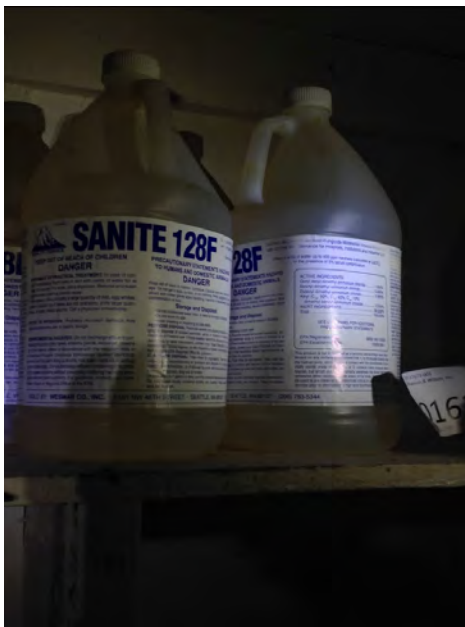
Container Condition: Good

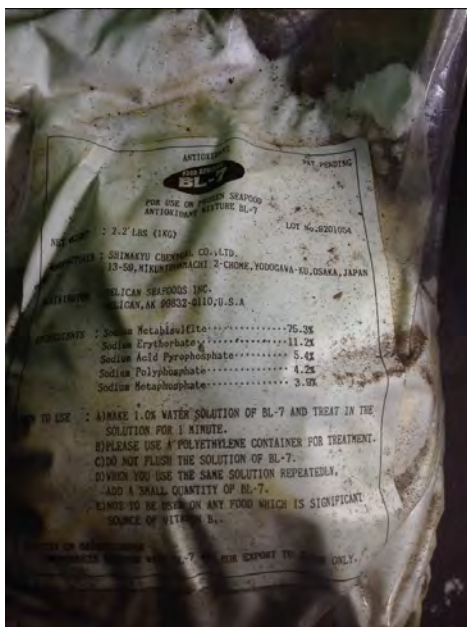
Container Condition: Open (no cover)

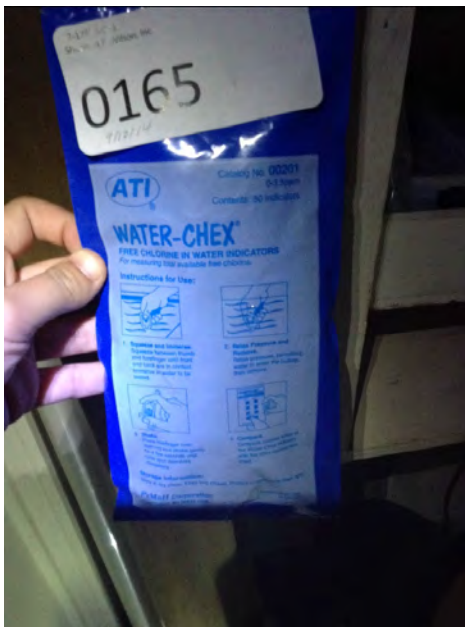
Container Condition: Good

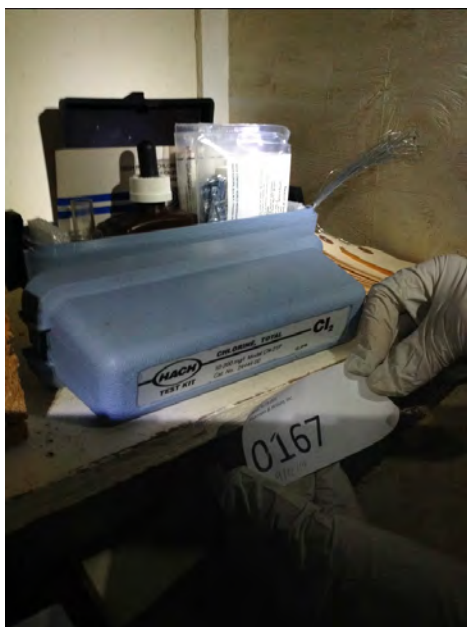
Container Condition: Good

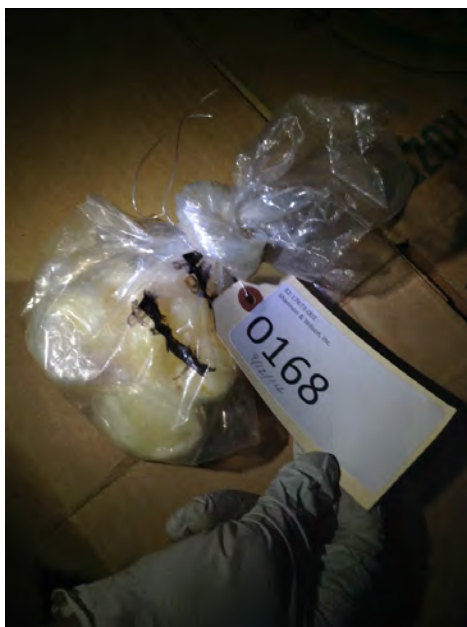
Container Condition: Good

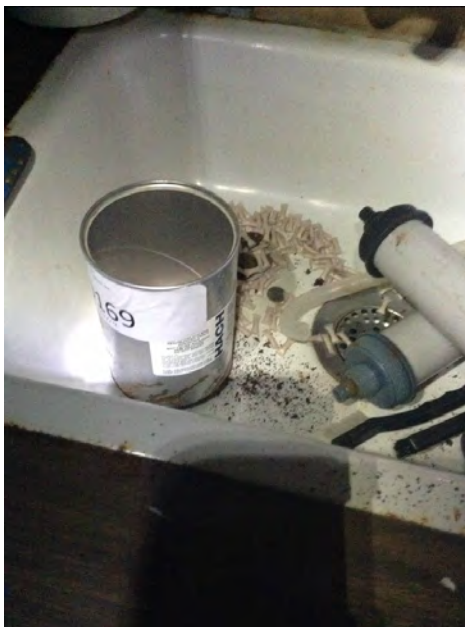
Label ID: Chlorine reagent powder pillows for 5 mL

Container Condition: Open (no cover)

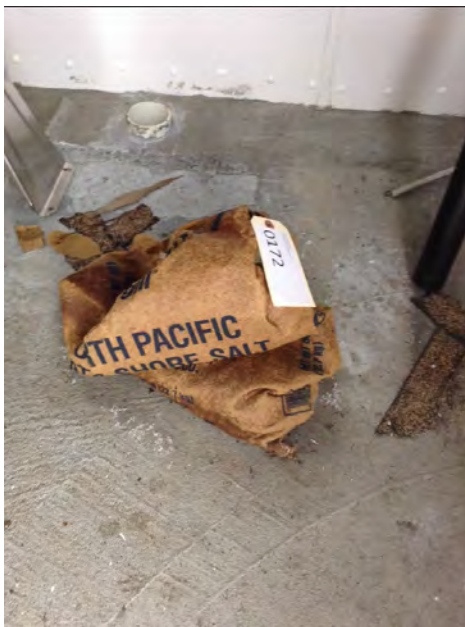
Label ID: North Pacific boat and shore salt

Container Condition: Poor

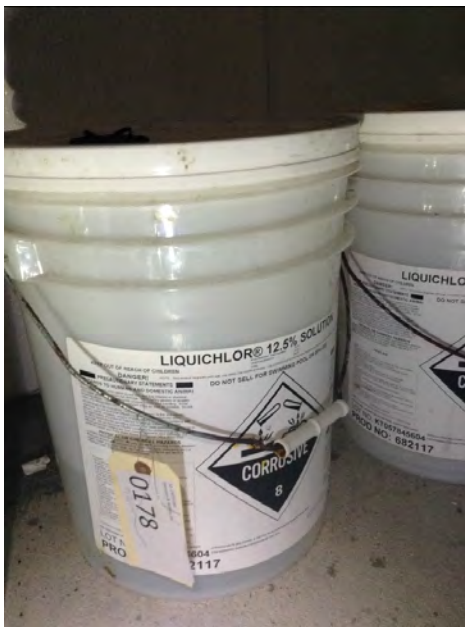
Label ID: Liquichlor 12.5% solution

Additional Details: Rusty cap
