**Site Assessment and Remediation Plan  
Pelican Seafood Processing Facility  
Pelican, Alaska**

May 2015

By:  
**Shannon & Wilson, Inc.**  
5430 Fairbanks Street, Suite 3  
Anchorage, Alaska 99518  
Phone: 907-561-2120  
FAX: 907-561-4483

32-1-17673

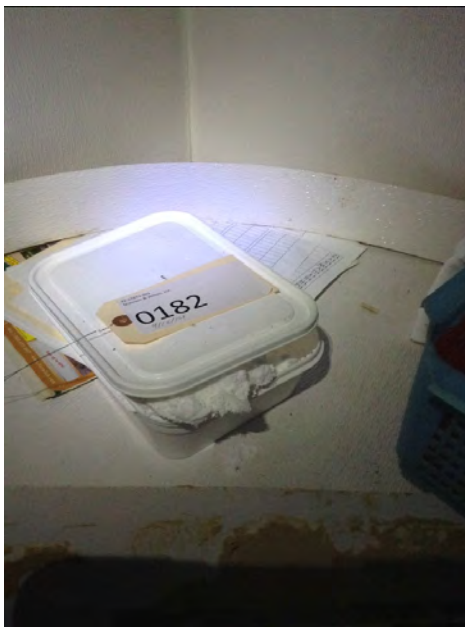
Label ID: CL

Container Condition: Leaking

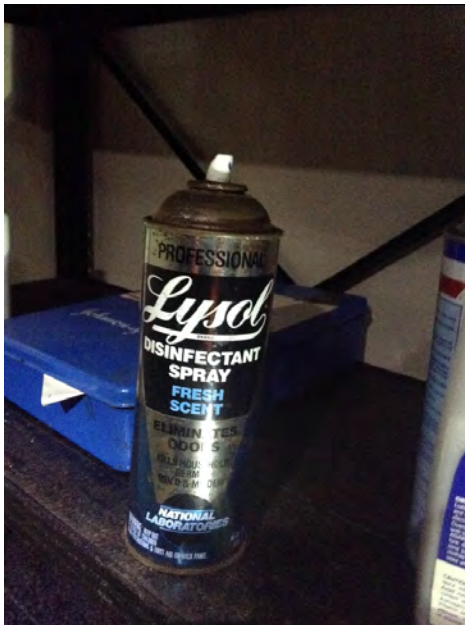
Label ID: Lysol disinfectant spray

Container Condition: Intact with rust

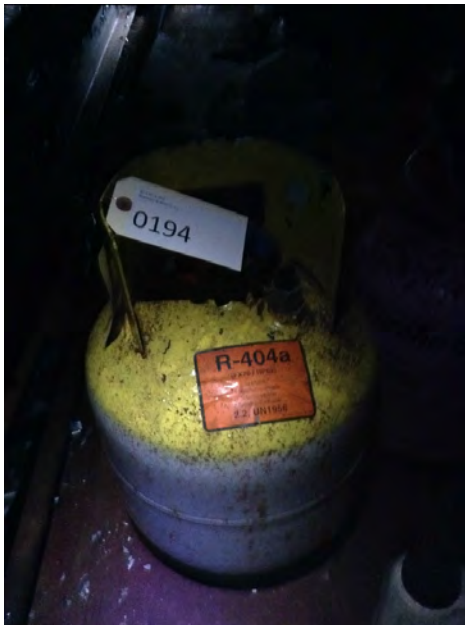
Label ID: R-405a

Container Condition: Intact with rust

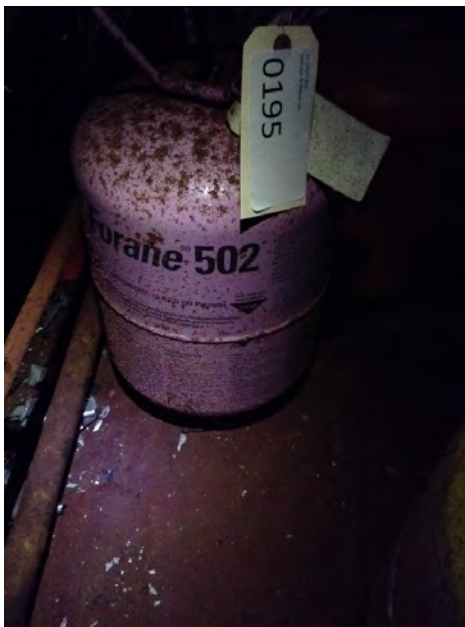
Label ID: Forane 502

Container Condition: Intact with rust

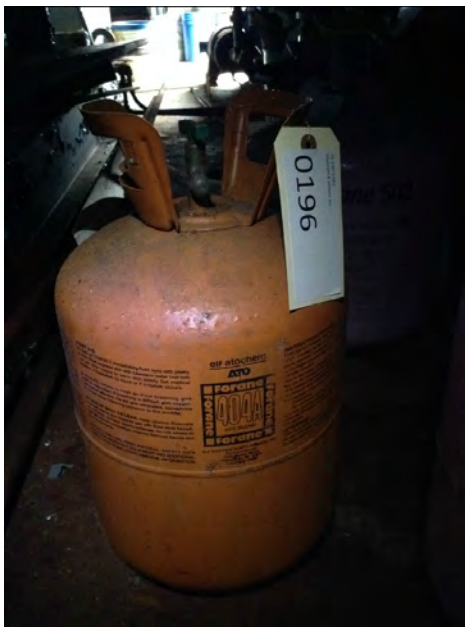
Label ID: Forane 404a

Container Condition: Intact with rust

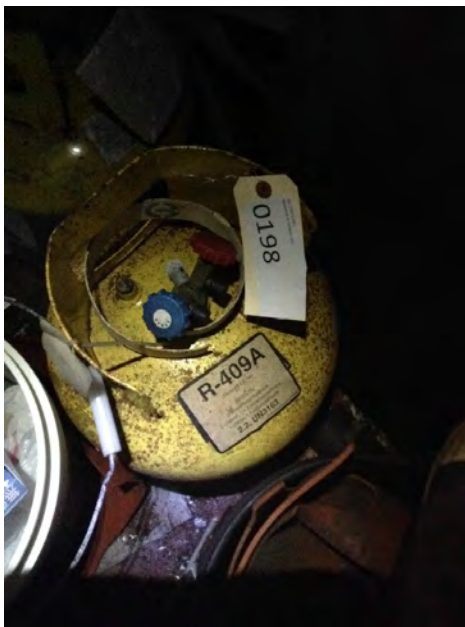
Label ID: R-409a

Container Condition: Intact with rust

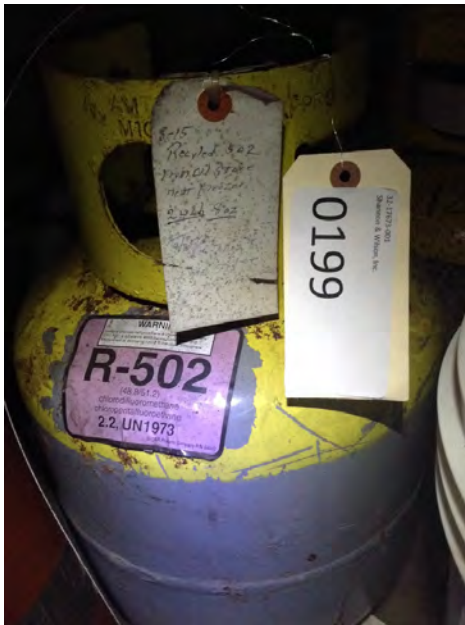
Label ID: R-502

Container Condition: Intact with rust

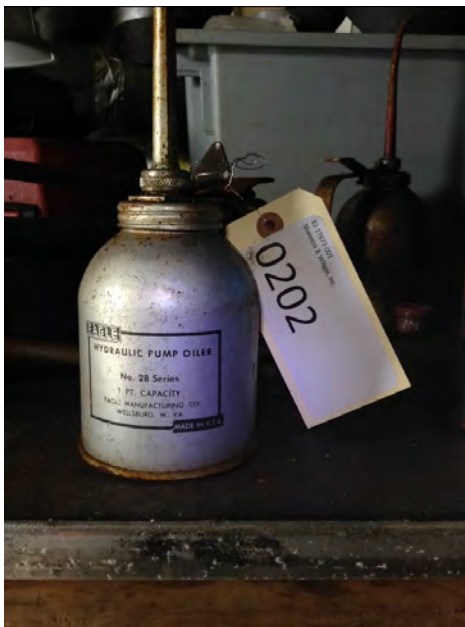
Label ID: Hydraulic pump oiler

Container Condition: Intact with rust

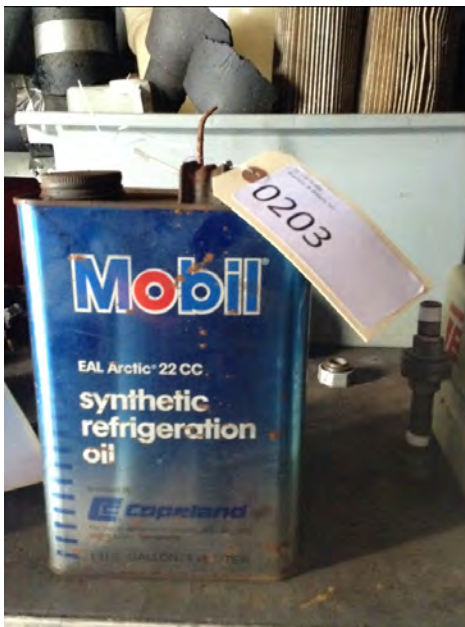
Label ID: Mobil eAL synthetic refrigeration oil

Container Condition: Intact with rust

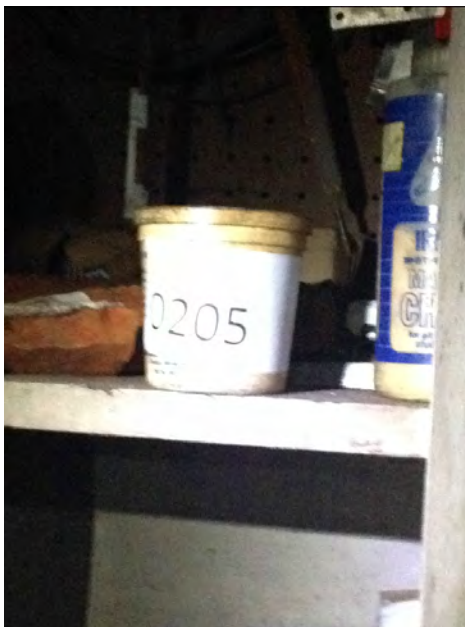
Label ID: Master plumber stainless fixture setting

Container Condition: Fair

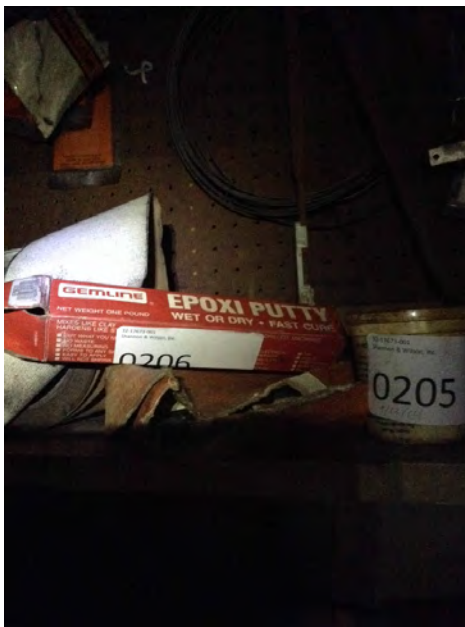
Label ID: Hemline epoxy putty

Container Condition: Fair

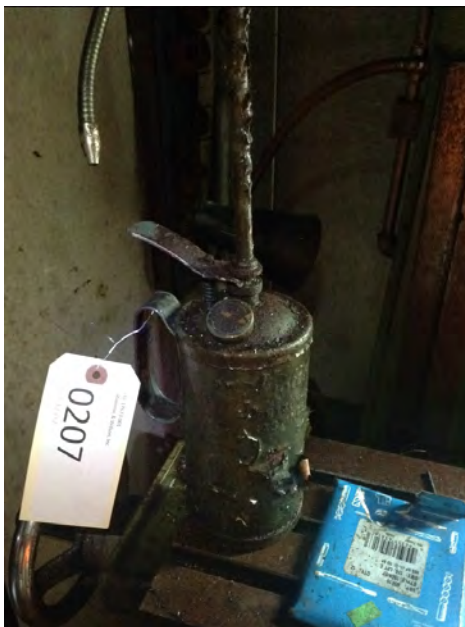
Label ID: No label

Container Condition: Intact with rust

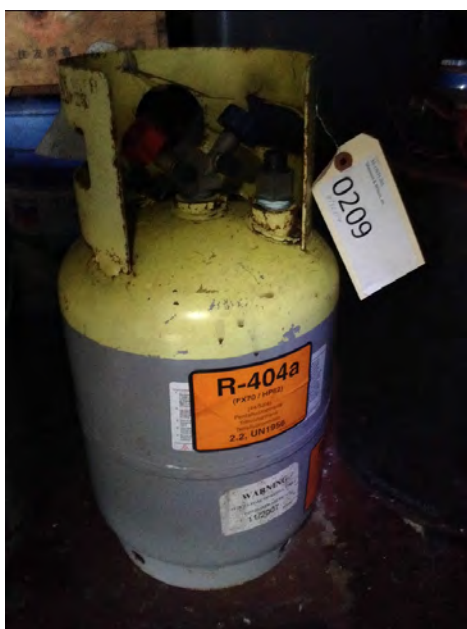
Label ID: R-404a

Container Condition: Good

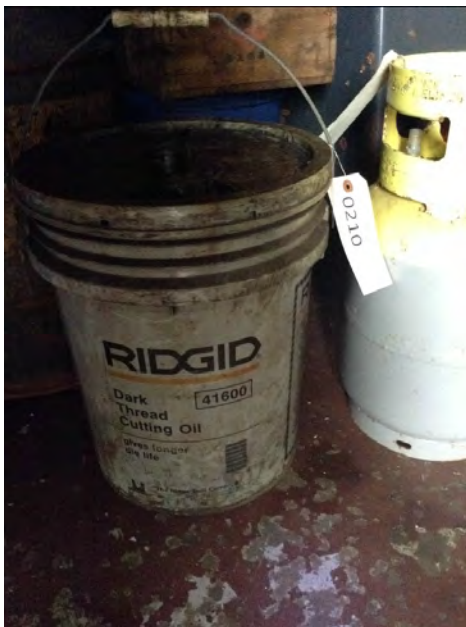
Label ID: Rigid dark thread cutting oil

Container Condition: Fair

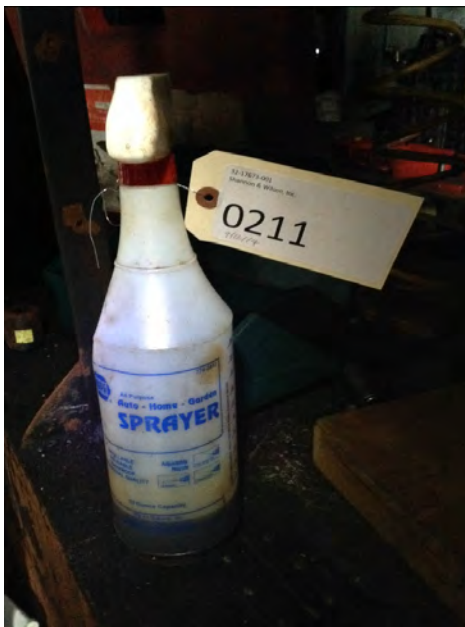
Label ID: No label

Container Condition: Fair

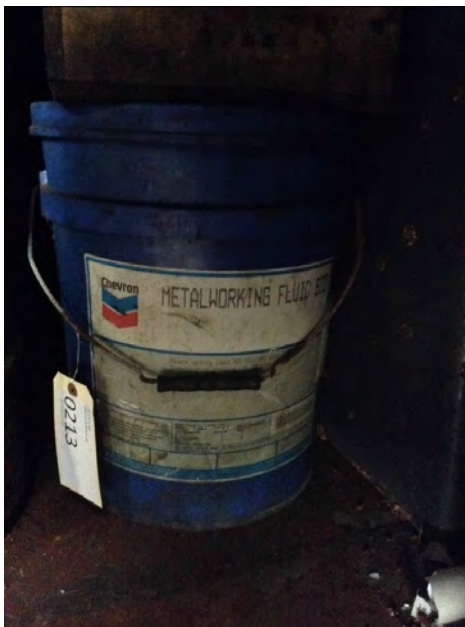
Label ID: Metalworking fluid 502

Container Condition: Good

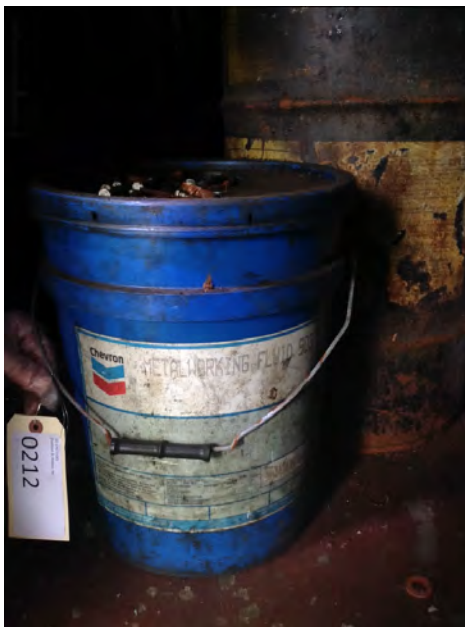
Label ID: Metalworking fluid 503

Container Condition: Fair

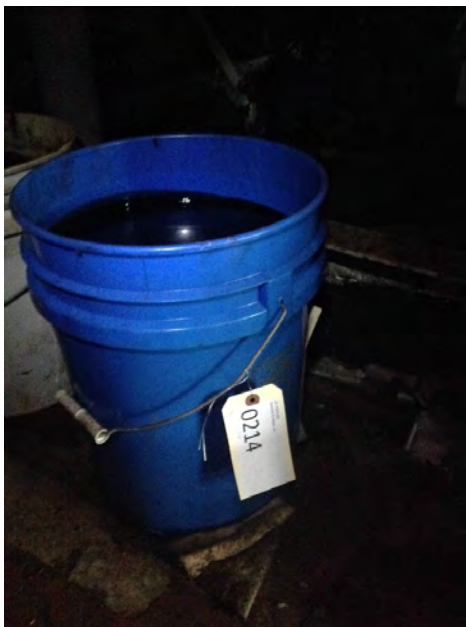
Label ID: Reused

Container Condition: Open (no cover)

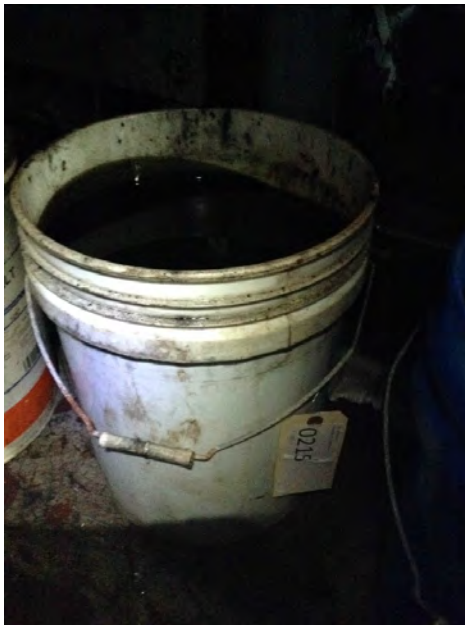
Label ID: Reused

Container Condition: Open (no cover)

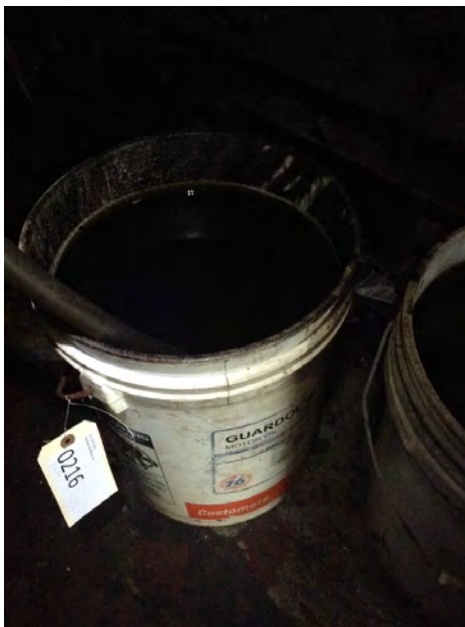
Label ID: Reused

Container Condition: Open (no cover)

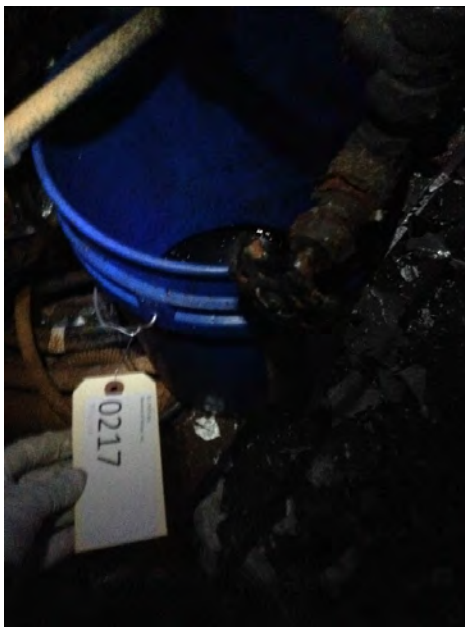
Label ID: Reused

Container Condition: Open (no cover)

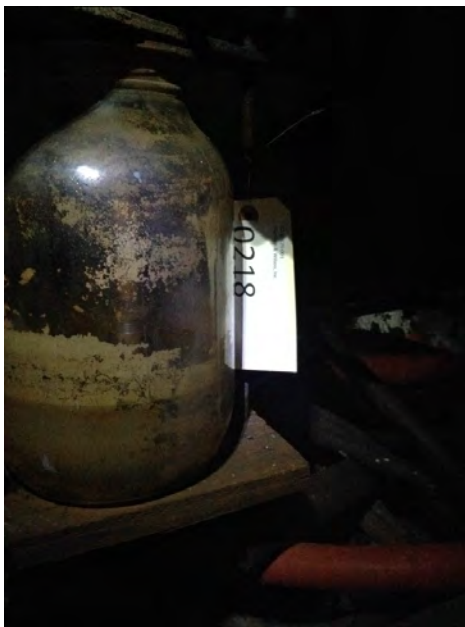
Label ID: No label

Container Condition: Fair

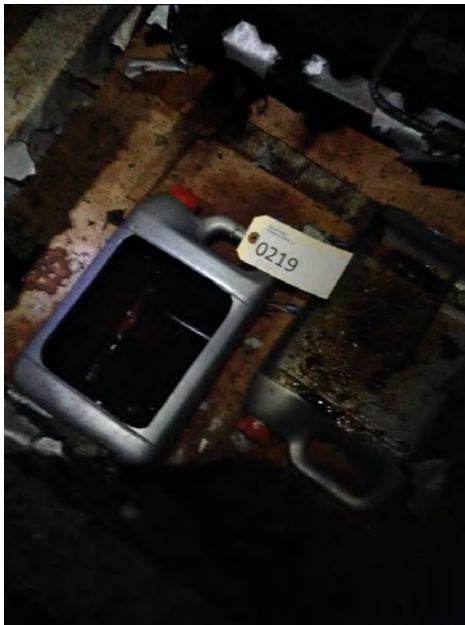
Label ID: No label

Container Condition: Poor

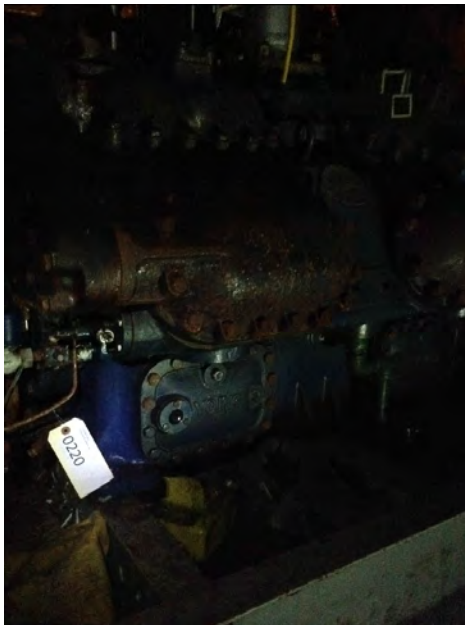
Label ID: No label

Container Condition: Intact with rust

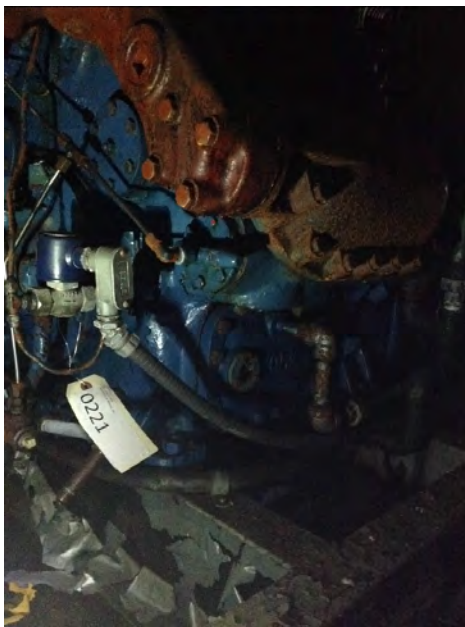
Label ID: No label

Container Condition: Intact with rust

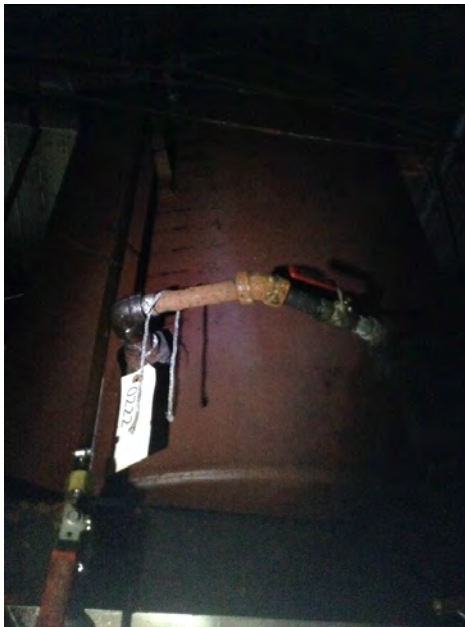
Label ID: No label

Container Condition: Intact with rust

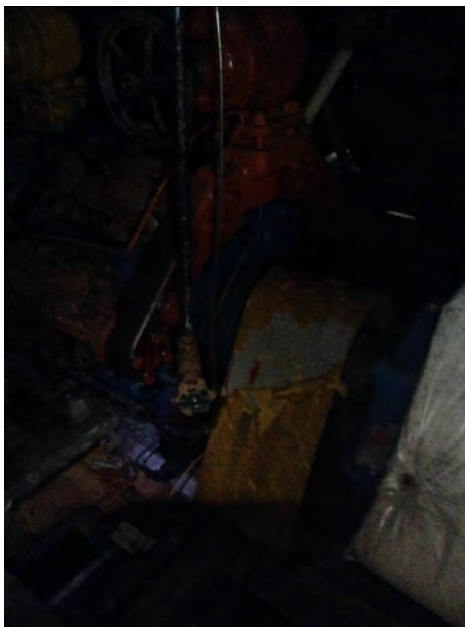
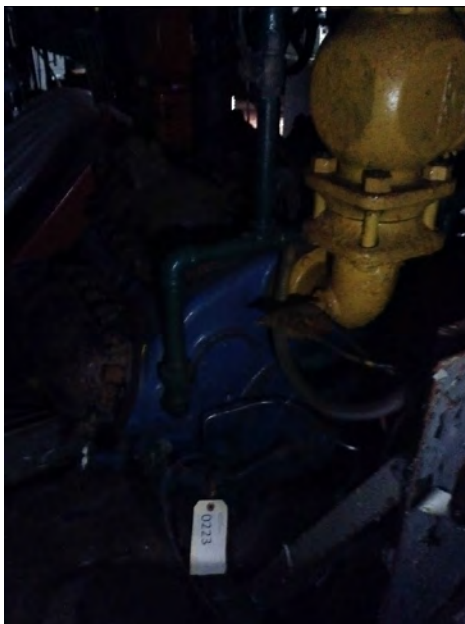
Label ID: No label

Container Condition: Intact with rust

Waste constituents: Compressor oil

Additional Details: Compressor #3

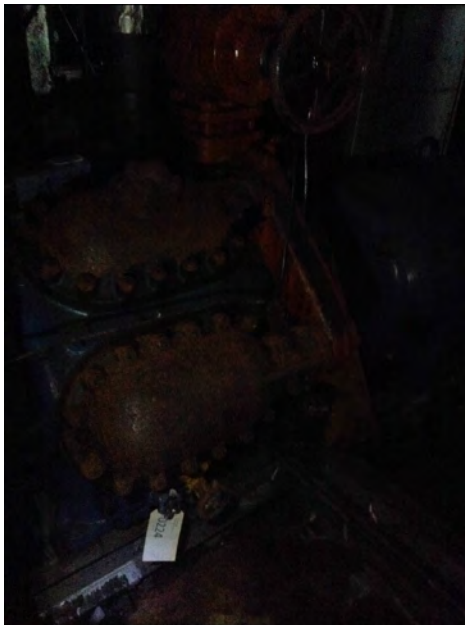
Label ID: No label

Container Condition: Intact with rust

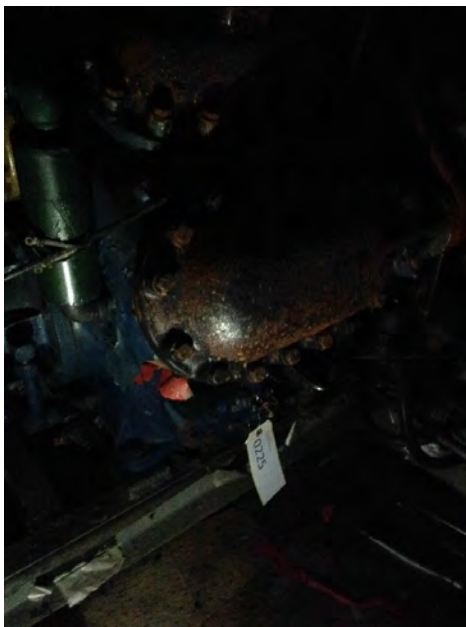
Label ID: No label

Container Condition: Intact with rust

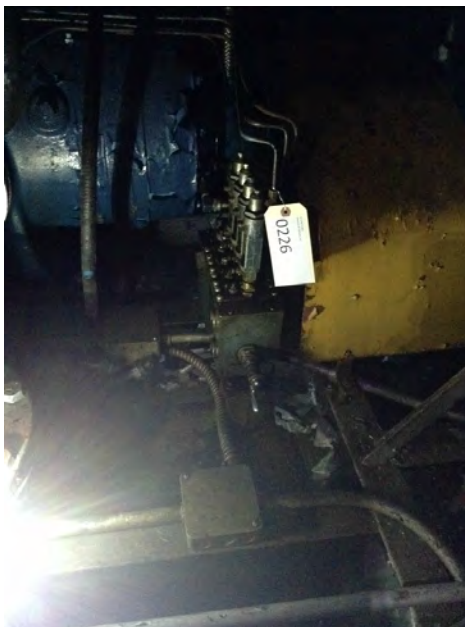
Label ID: No label

Container Condition: Intact with rust

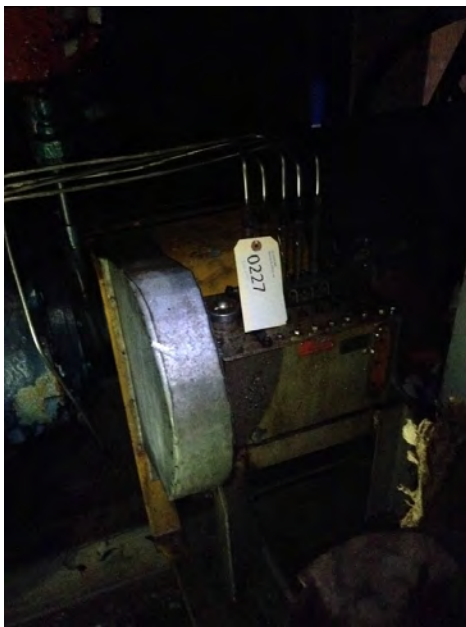
Label ID: No label

Container Condition: Intact with rust

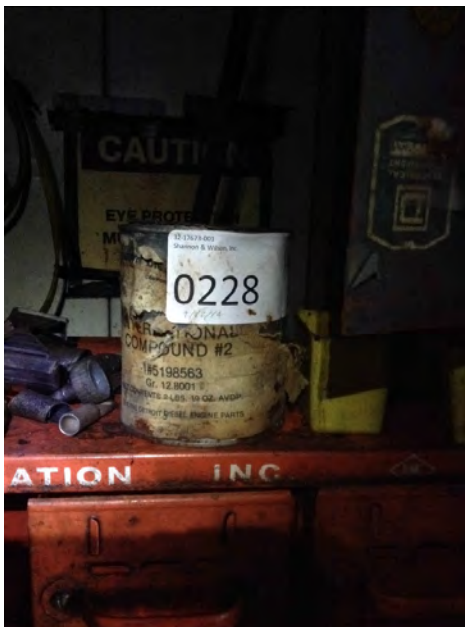
Label ID: International compound #2

Container Condition: Poor

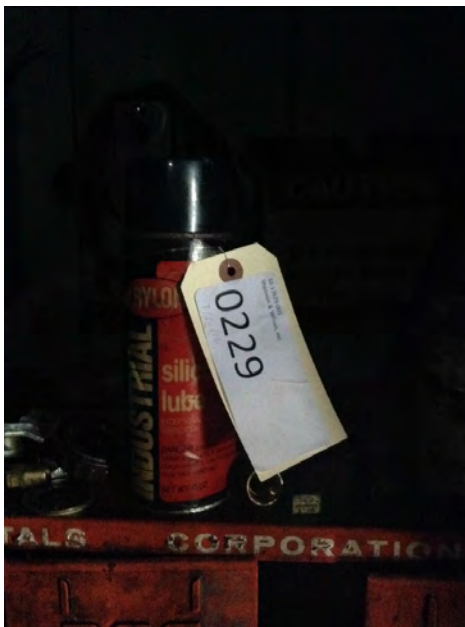
Label ID: Krytox silicone lube

Container Condition: Intact with rust

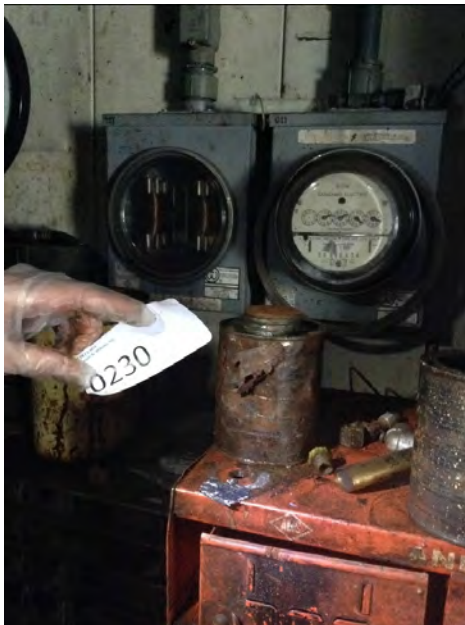
Label ID: Unreadable

Container Condition: Intact with rust

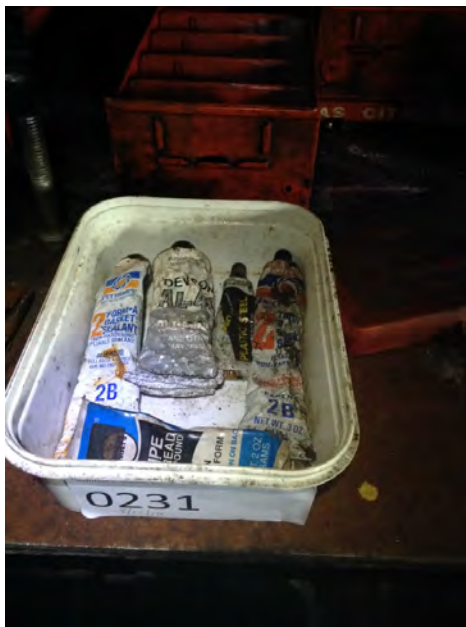
Label ID: Form a gasket, aluminum adhesive, plastic

Container Condition: Fair

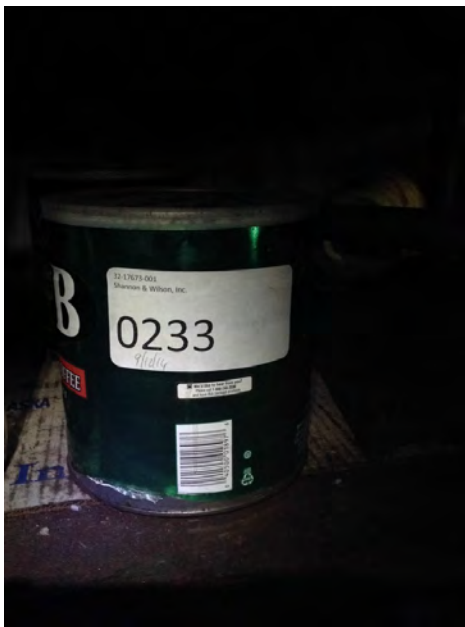
Label ID: Motor oil for heating bearings

Container Condition: Good

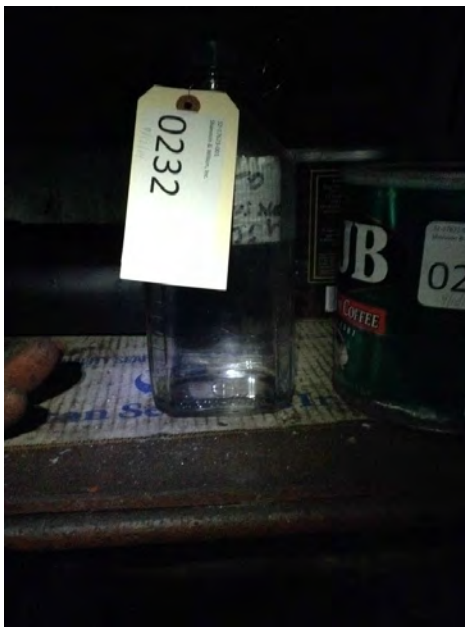
Label ID: 50/50 glycerine and water

Container Condition: Good

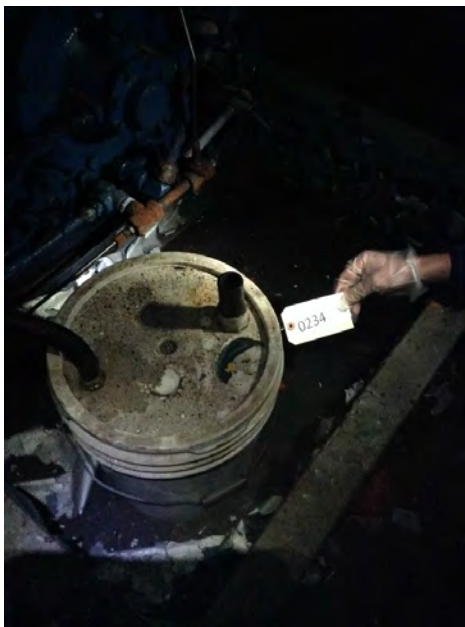
Label ID: No label

Container Condition: Good

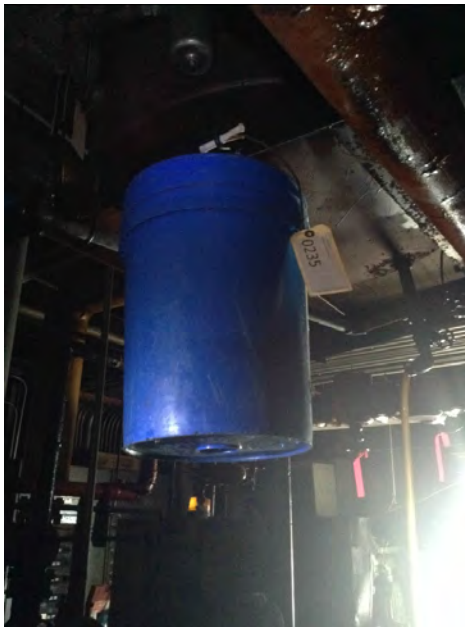
Label ID: No label

Container Condition: Open (no cover)

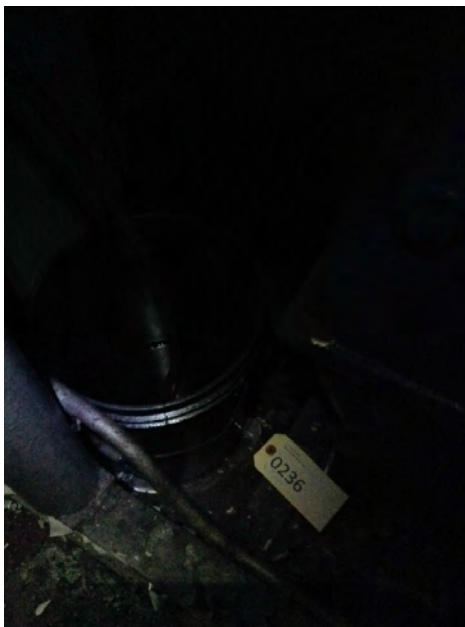
Label ID: No label

Container Condition: Open (no cover)

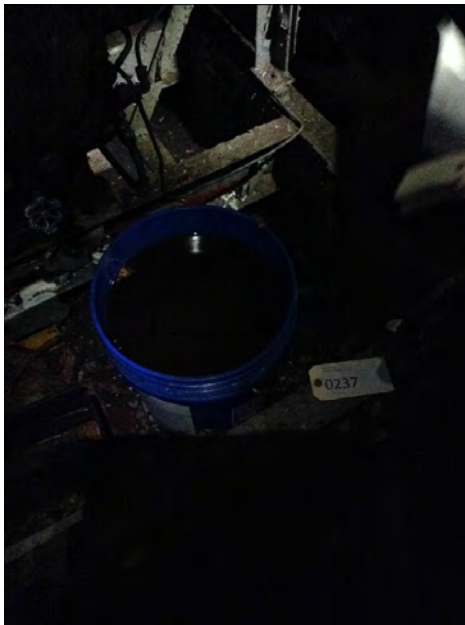
Label ID: No label

Container Condition: Open (no cover)

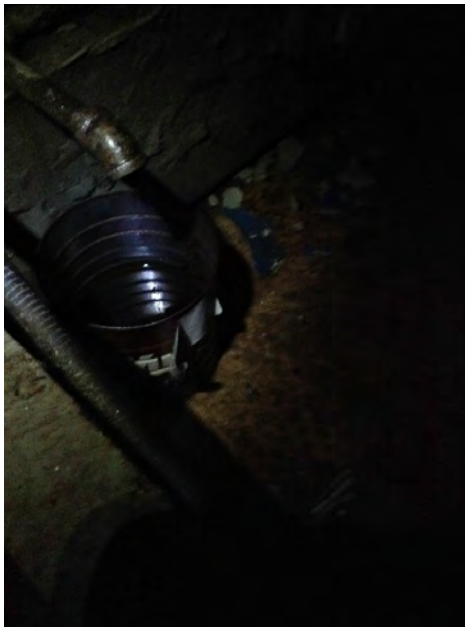
Label ID: No label

Container Condition: Open (no cover)

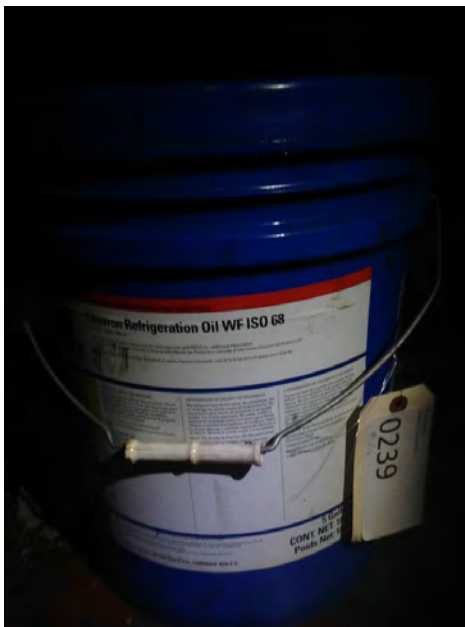
Label ID: Chevron refrigeration oil

Container Condition: Good

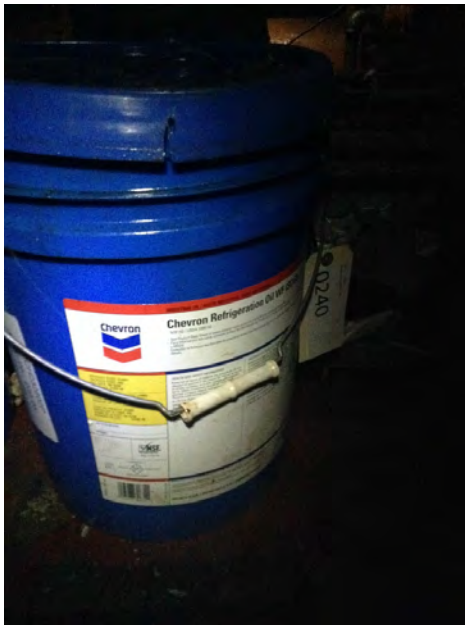
Label ID: Chevron refrigeration oil

Container Condition: Good

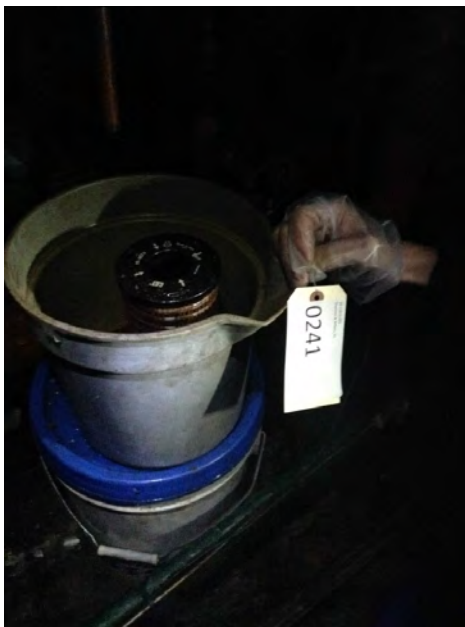
Label ID: No label

Container Condition: Open (no cover)

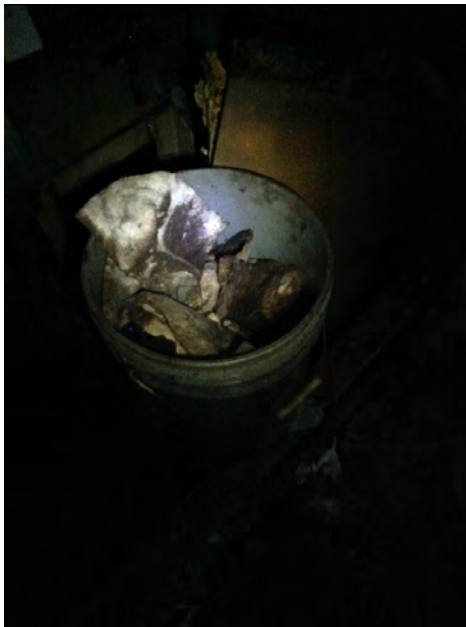
Label ID: None

Container Condition: Open (no cover)

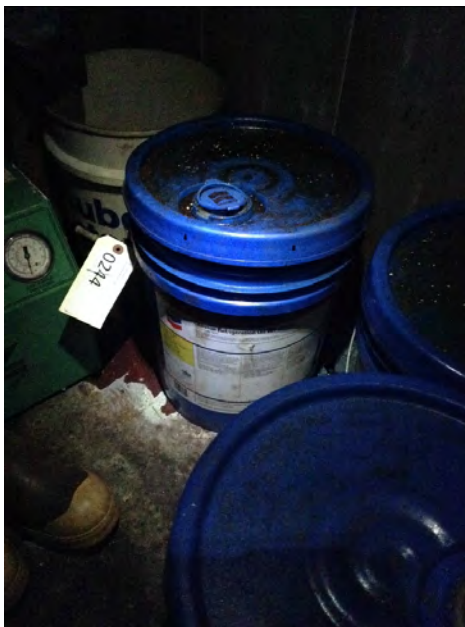
Label ID: Chevron refrigeration oil

Container Condition: Good

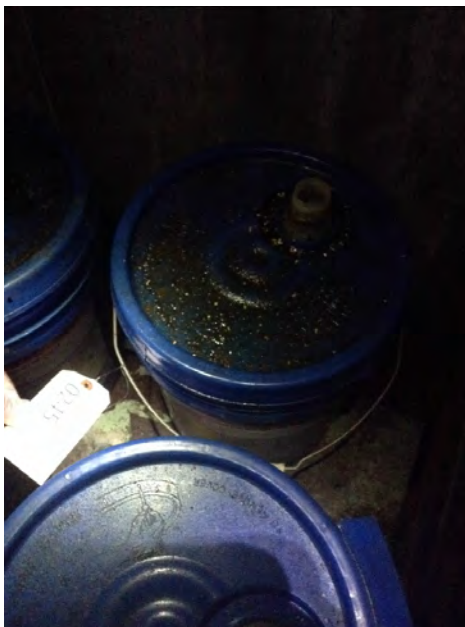
Label ID: Chevron refrigeration oil

Container Condition: Good

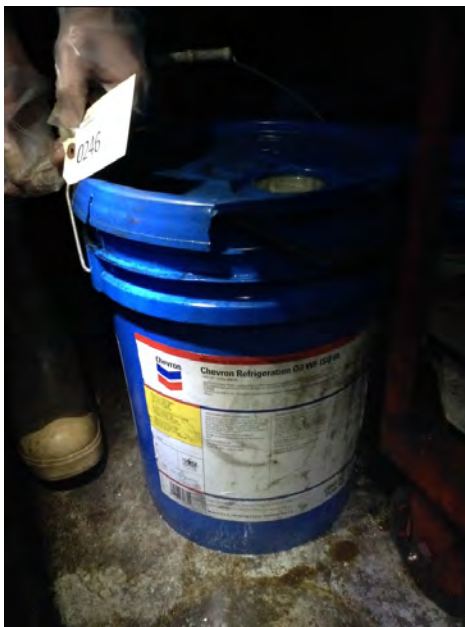
Label ID: Chevron refrigeration oil

Container Condition: Good

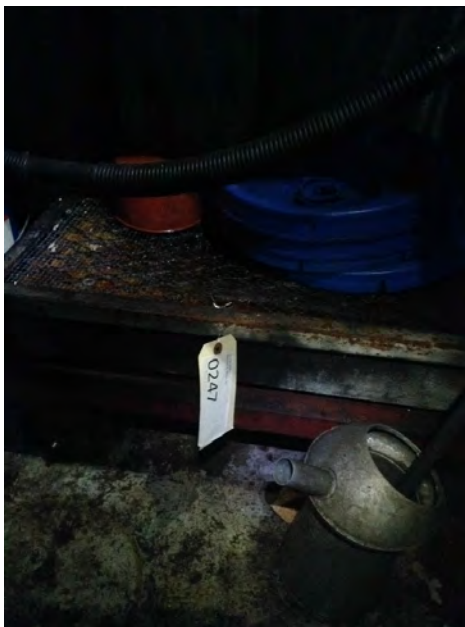
Label ID: No label

Container Condition: Intact with rust

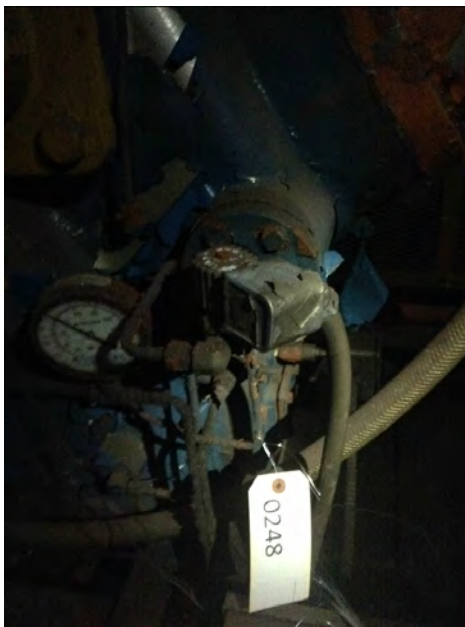
Container Condition: Intact with rust

Label ID: None

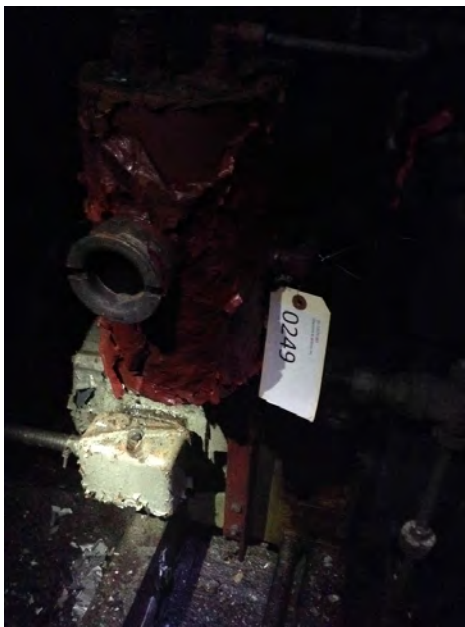
Container Condition: Intact with rust

Label ID: Pressure reciever

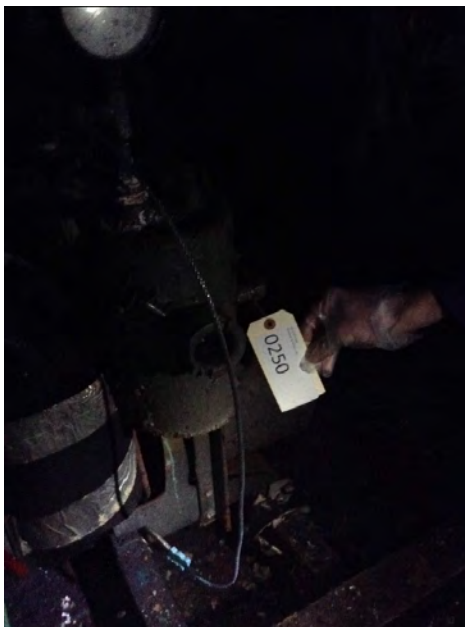
Container Condition: Intact with rust

Label ID: None

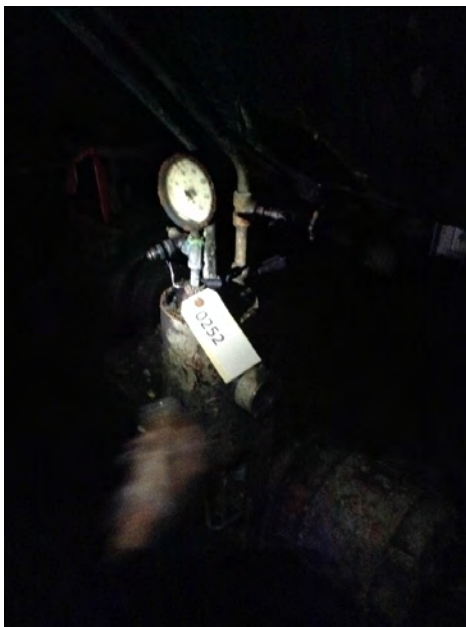
Container Condition: Intact with rust

Label ID: None

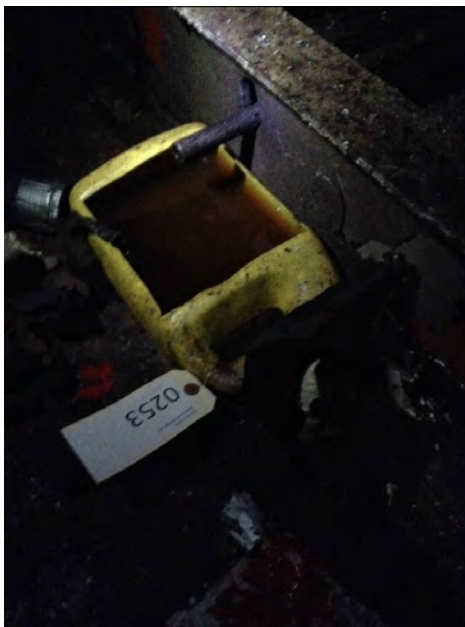
Container Condition: Poor

Label ID: None

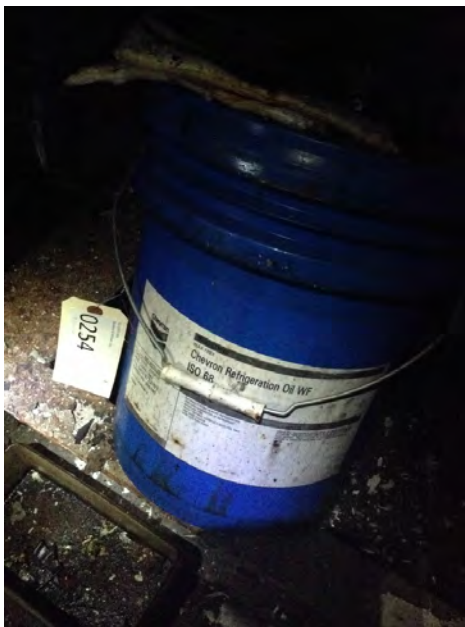
Container Condition: Good

Label ID: Chevron refrigeration oil

Additional Details: Missing cap

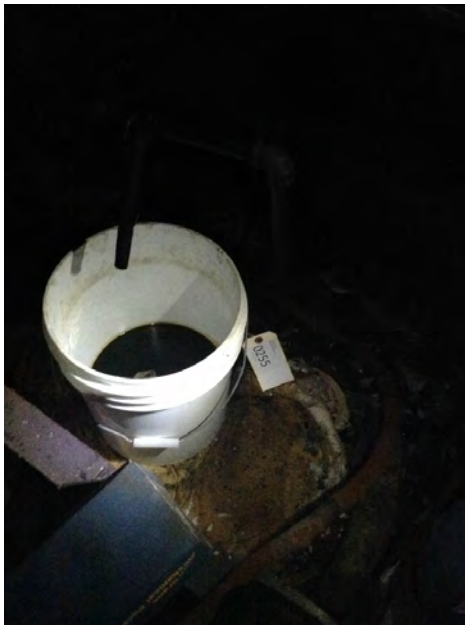
Container Condition: Open (no cover)

Label ID: No label

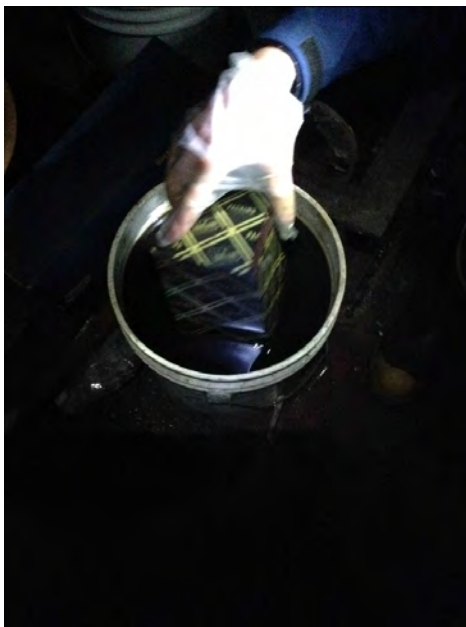
Container Condition: Open (no cover)

Label ID: No label

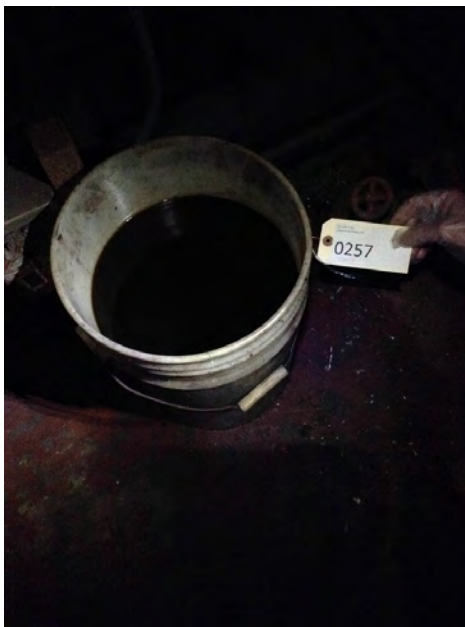
Container Condition: Open (no cover)

Label ID: None

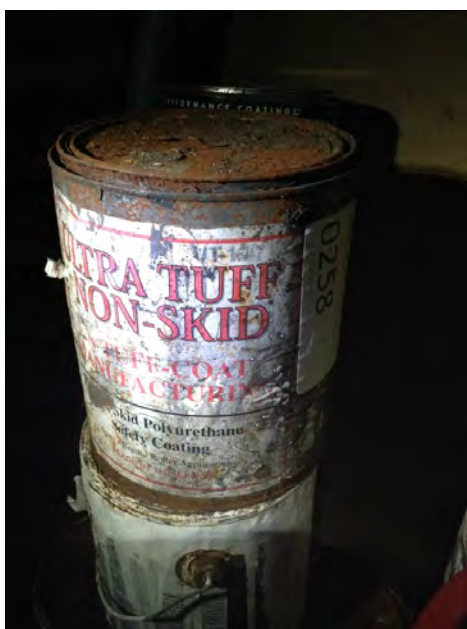
Container Condition: Poor

Label ID: Ultra tuff non skid poly urathane safety

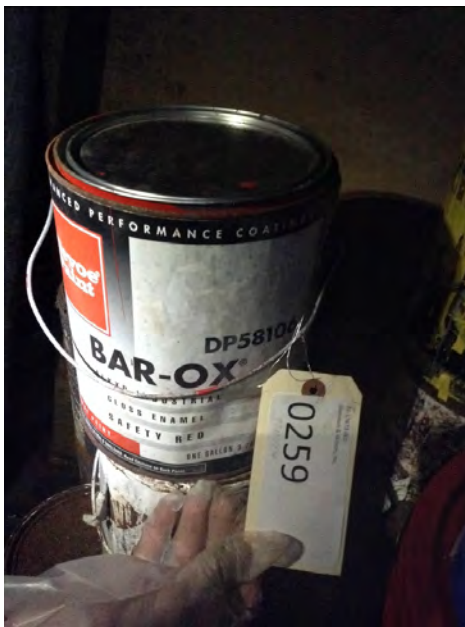
Container Condition: Good

Label ID: Bar-ox gloss enamel

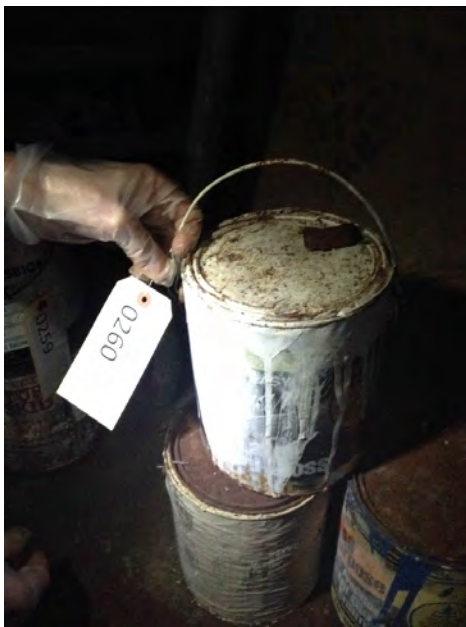
Container Condition: Intact with rust

Label ID: Latex semi gloss paint

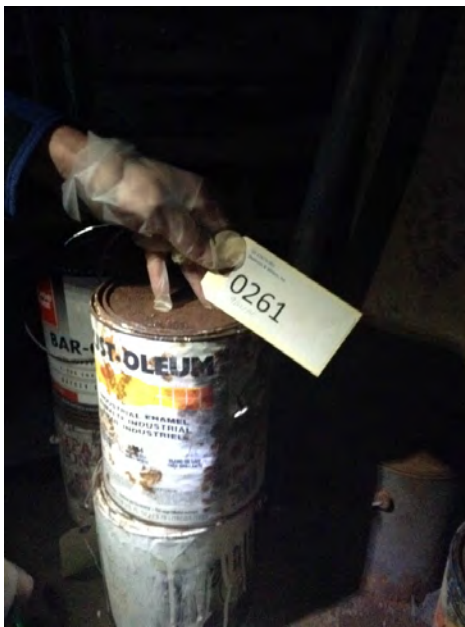
Container Condition: Intact with rust

Label ID: Industrial enamel

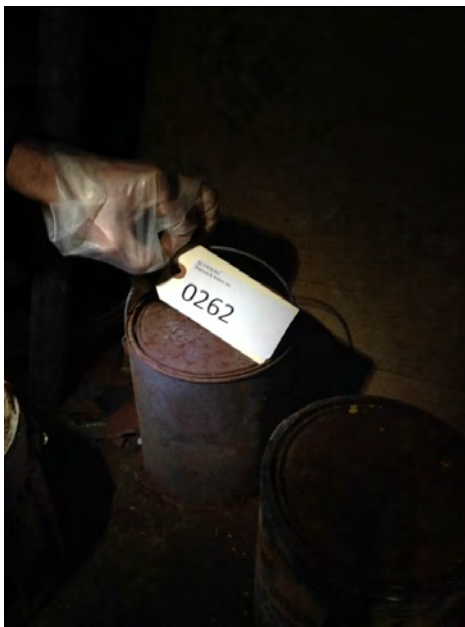
Container Condition: Intact with rust

Label ID: No label

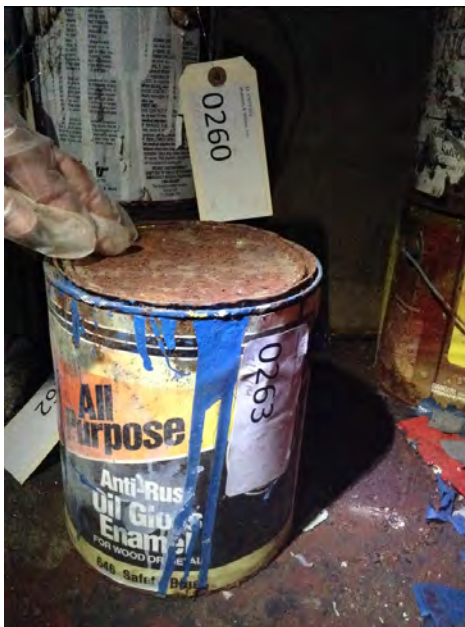
Container Condition: Intact with rust

Label ID: Anti rust enamel

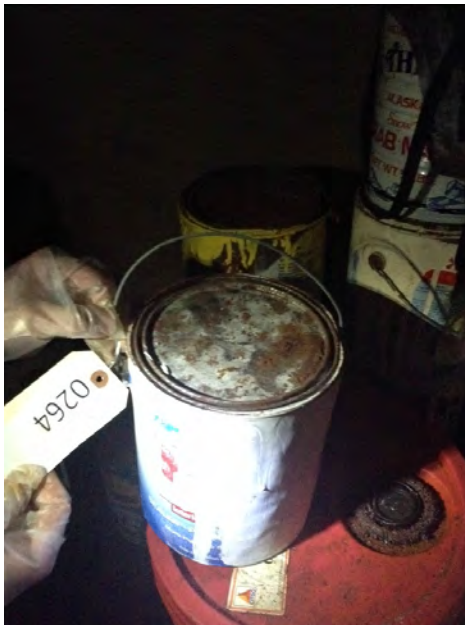
Container Condition: Intact with rust

Label ID: Kilz latex

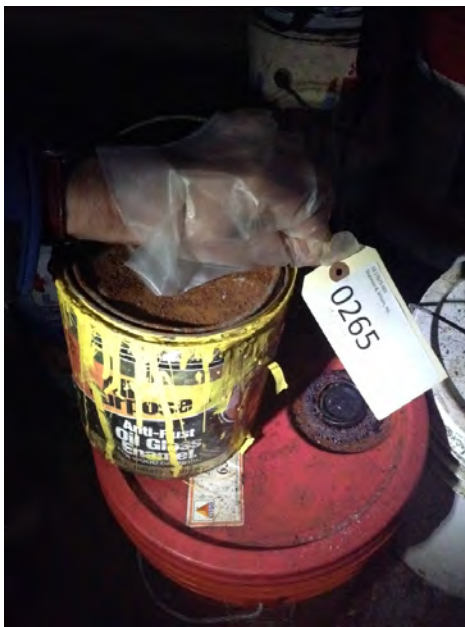
Container Condition: Intact with rust

Label ID: Gloss enamel

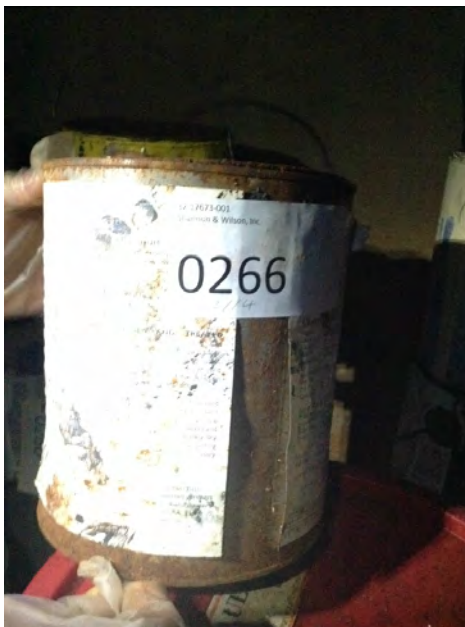
Container Condition: Intact with rust

Label ID: Non skid poly urathane

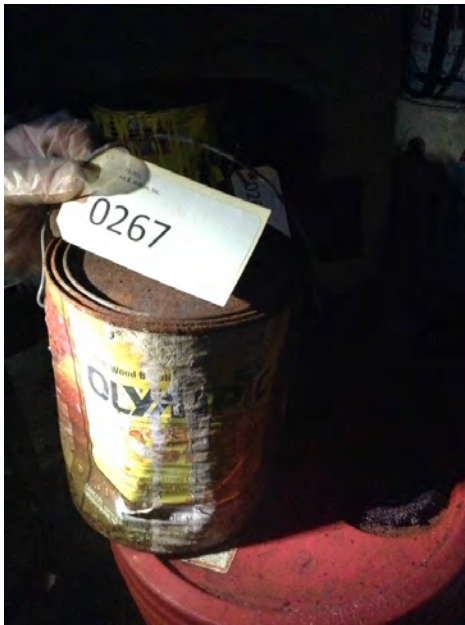
Container Condition: Intact with rust

Label ID: Water repellant oil stain

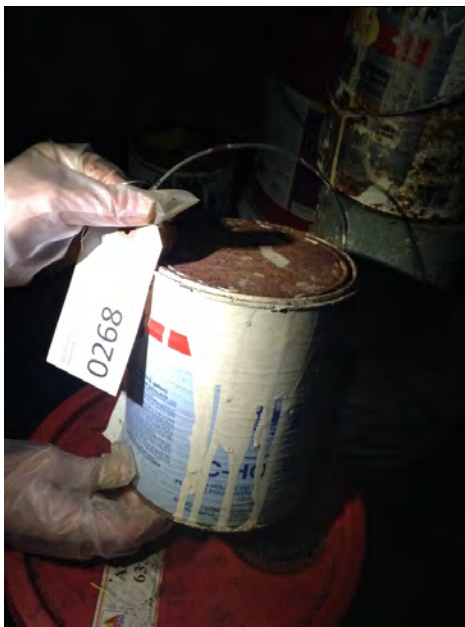
Container Condition: Intact with rust

Label ID: C hold fish hold paint coating

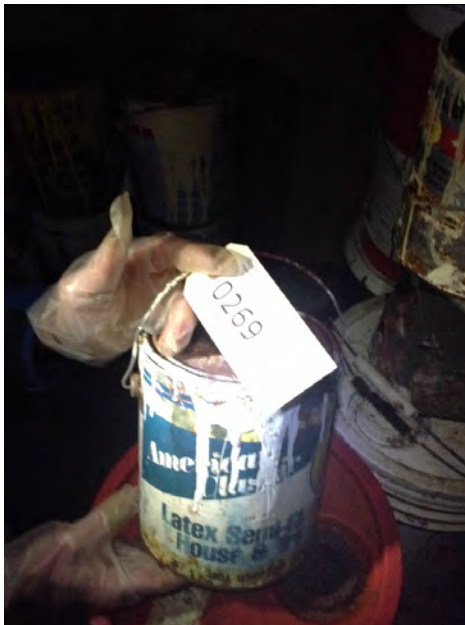
Container Condition: Intact with rust

Label ID: Latex semi gloss

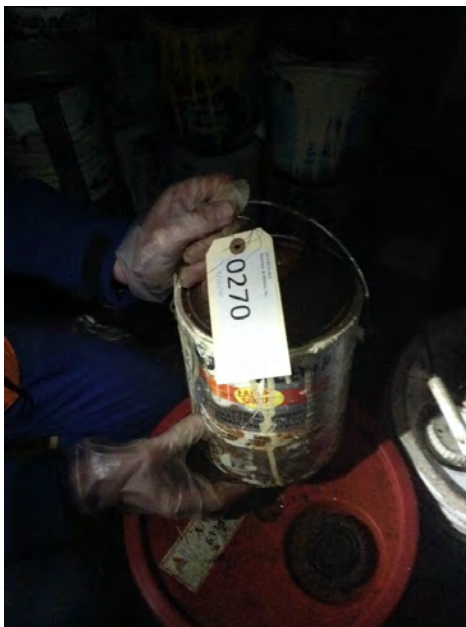
Container Condition: Intact with rust

Label ID: Industrial enamel

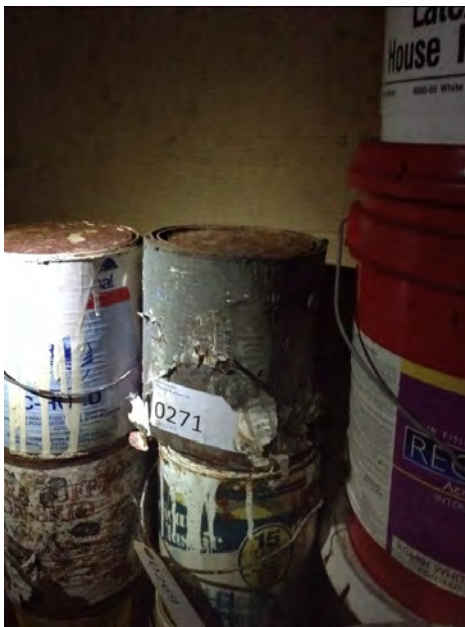
Container Condition: Poor

Label ID: Unreadable

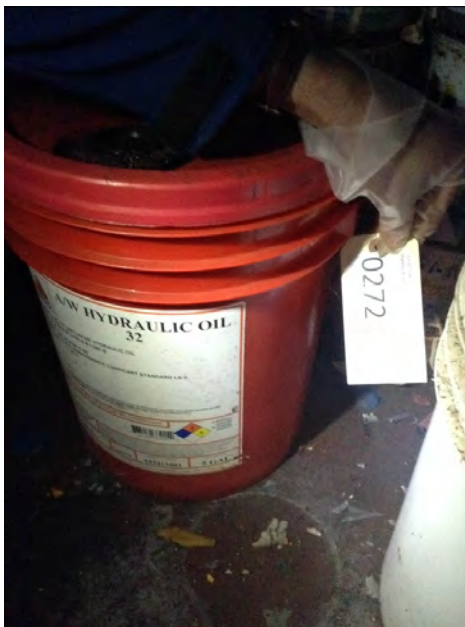
Container Condition: Good

Label ID: AW hydraulic oil

Additional Details: Rusty cap
