**Site Assessment and Remediation Plan  
Pelican Seafood Processing Facility  
Pelican, Alaska**

May 2015

By:  
**Shannon & Wilson, Inc.**  
5430 Fairbanks Street, Suite 3  
Anchorage, Alaska 99518  
Phone: 907-561-2120  
FAX: 907-561-4483

32-1-17673

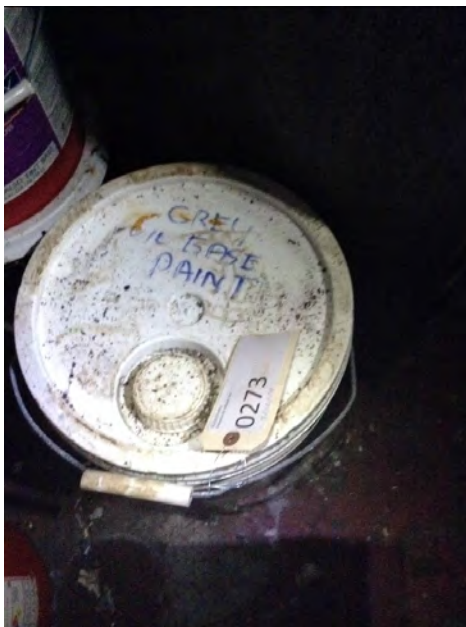
Container Condition: Good

Label ID: Grey oil based paint

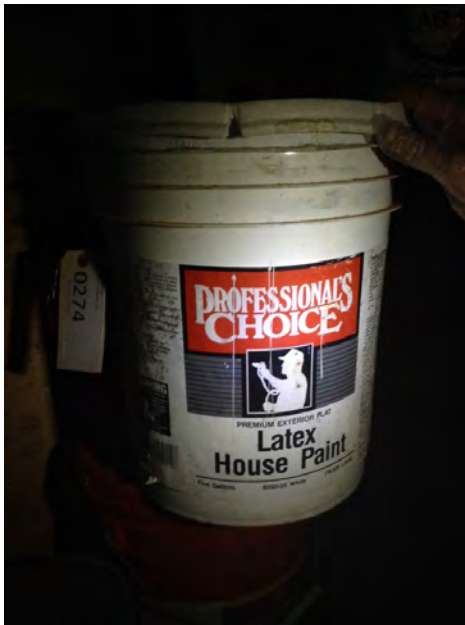
Container Condition: Good

Label ID: Latex house paint

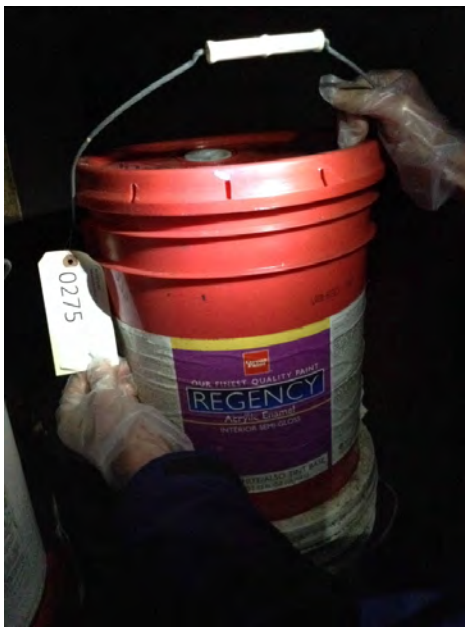
Container Condition: Good

Label ID: Acrylic enamel

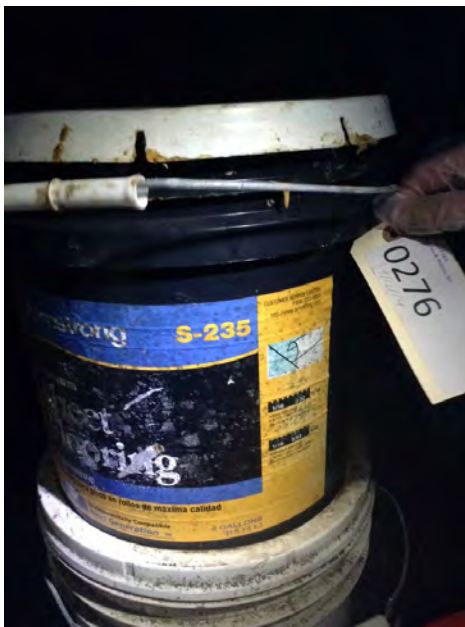
Container Condition: Good

Label ID: Sheet flooring adhesive

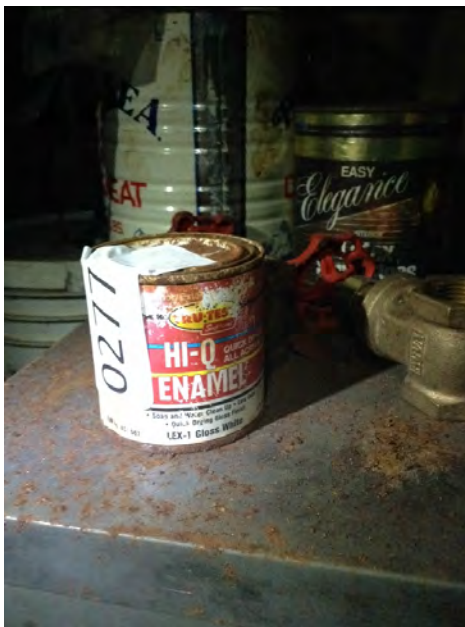
Container Condition: Intact with rust

Label ID: Hi Q enamel

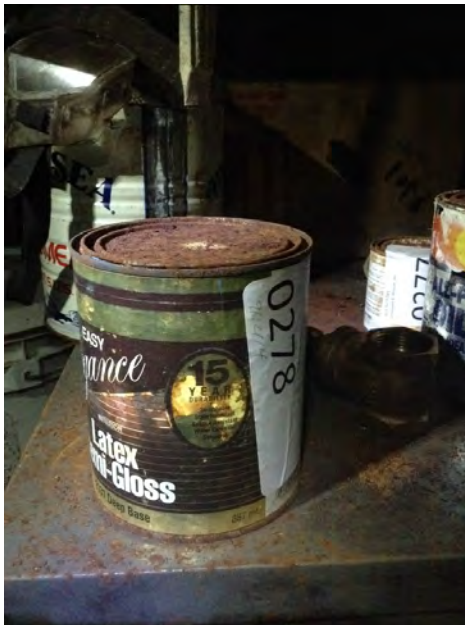
Container Condition: Intact with rust

Label ID: Latex semi gloss

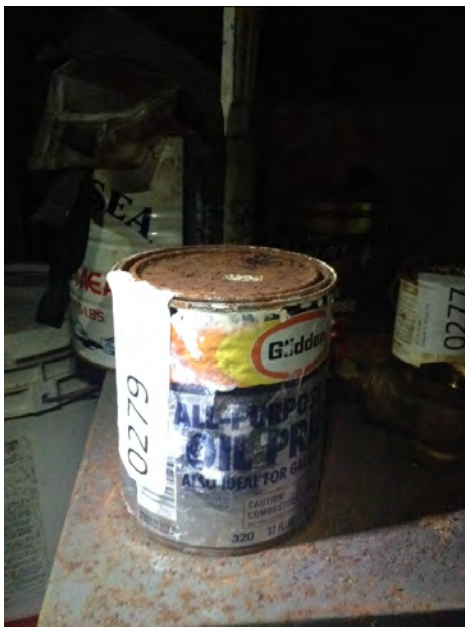
Container Condition: Intact with rust

Label ID: All purpose metal oil primer

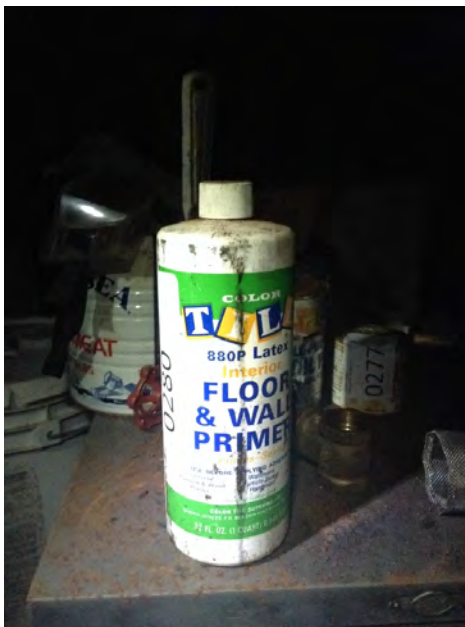
Container Condition: Good

Label ID: Latex floor and wall primer

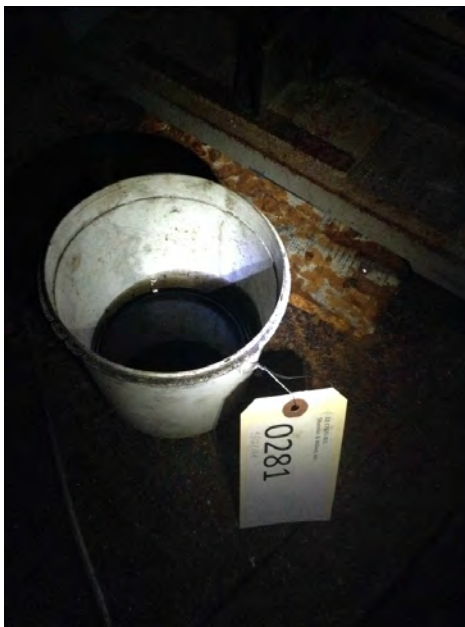
Container Condition: Open (no cover)

Label ID: No label

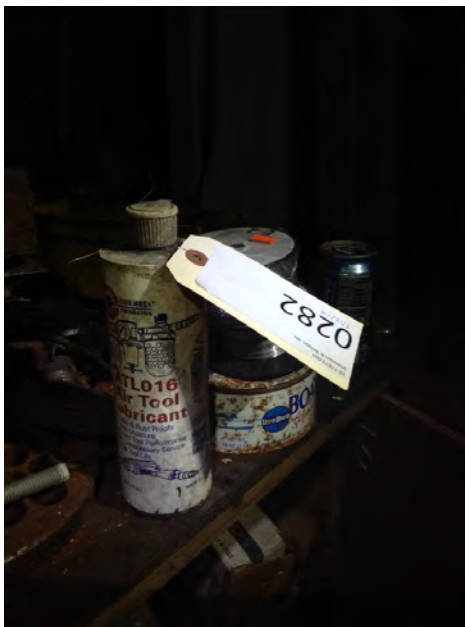
Container Condition: Fair

Label ID: Alto 16 air tool lubricant

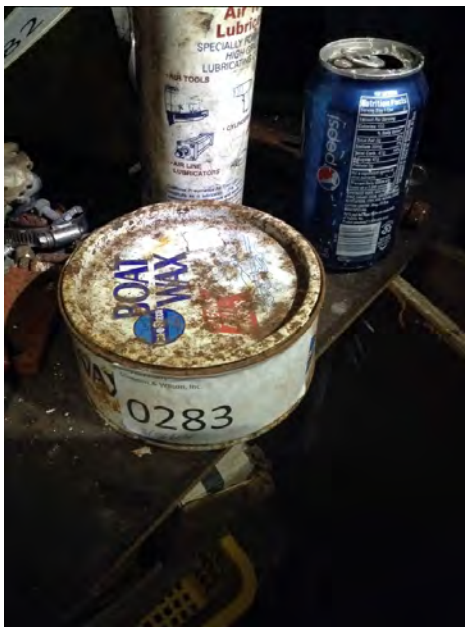
Container Condition: Intact with rust

Label ID: Boat wax

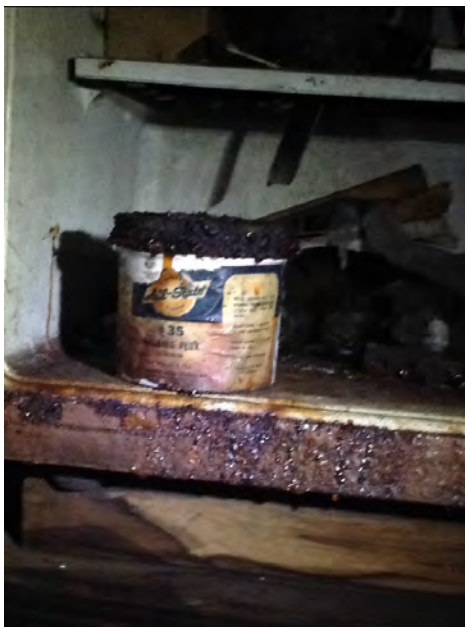
Container Condition: Poor

Label ID: Aluminum welding flux

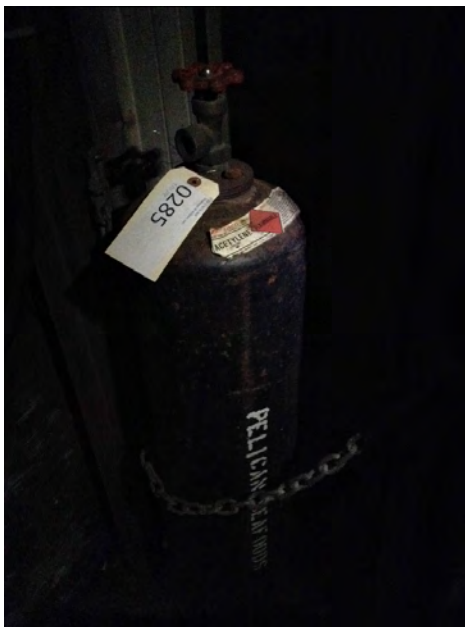
Container Condition: Intact with rust

Label ID: Acetylene

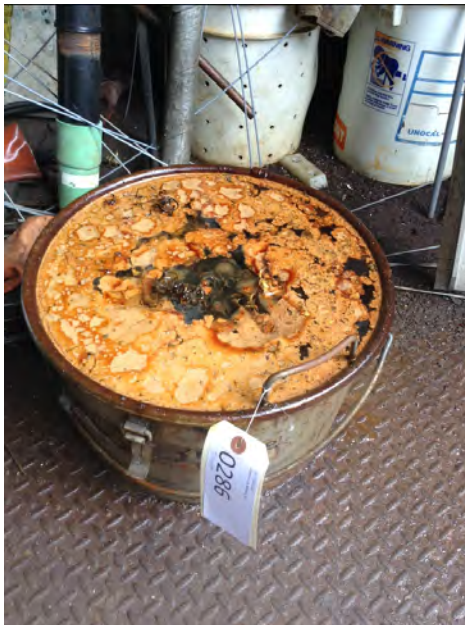
Container Condition: Intact with rust

Label ID: No. 818 oiler

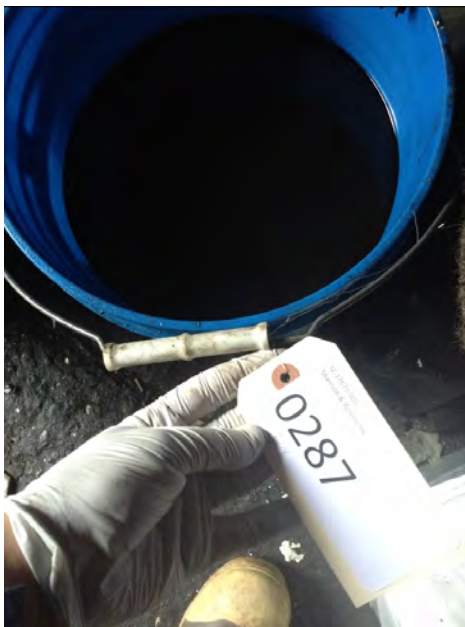
Container Condition: Open (no cover)

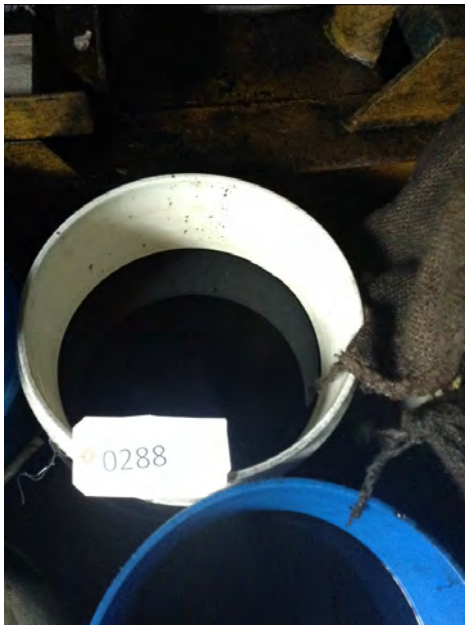
Container Condition: Open (no cover)

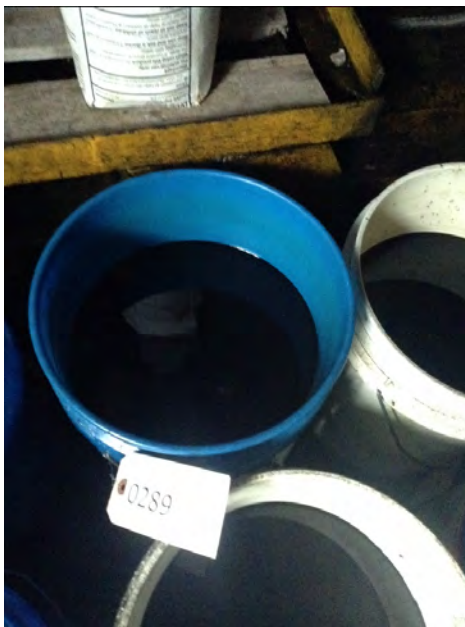
Container Condition: Open (no cover)

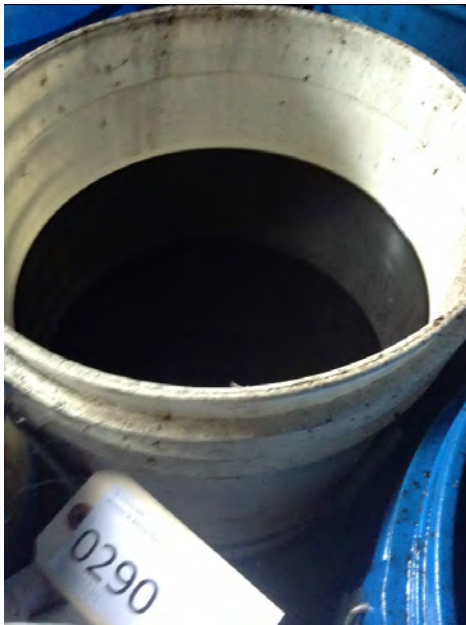
Container Condition: Open (no cover)

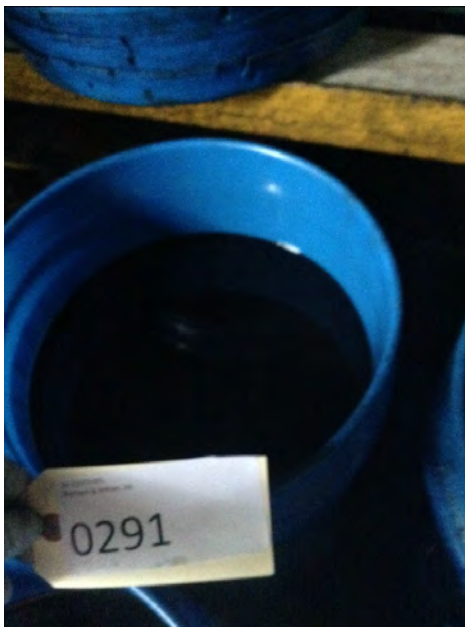
Container Condition: Open (no cover)

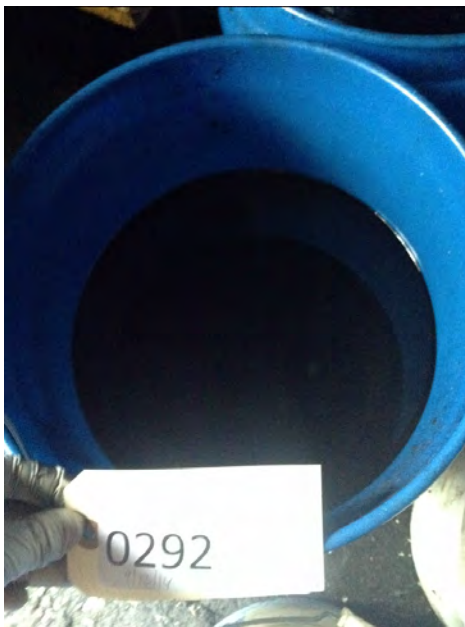
Container Condition: Open (no cover)

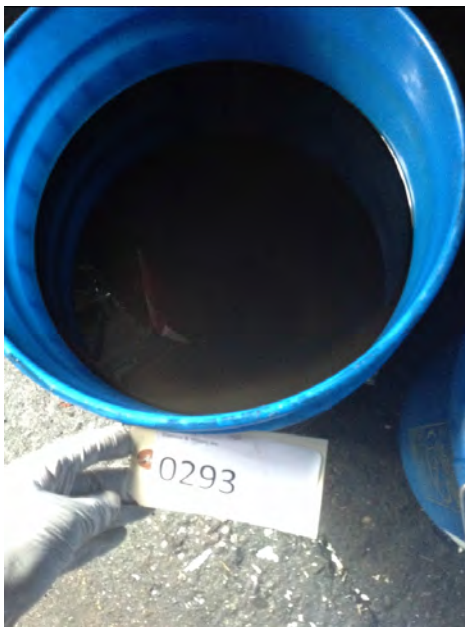
Container Condition: Open (no cover)

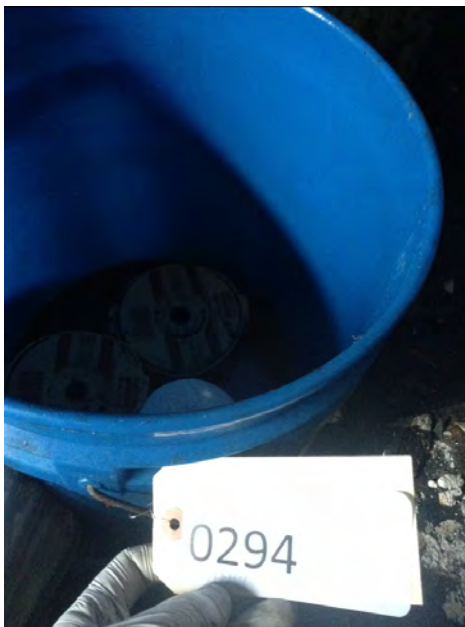
Container Condition: Open (no cover)

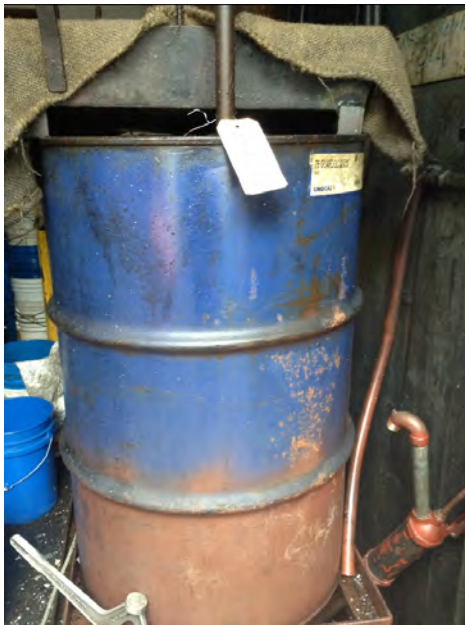
Container Condition: Intact with rust

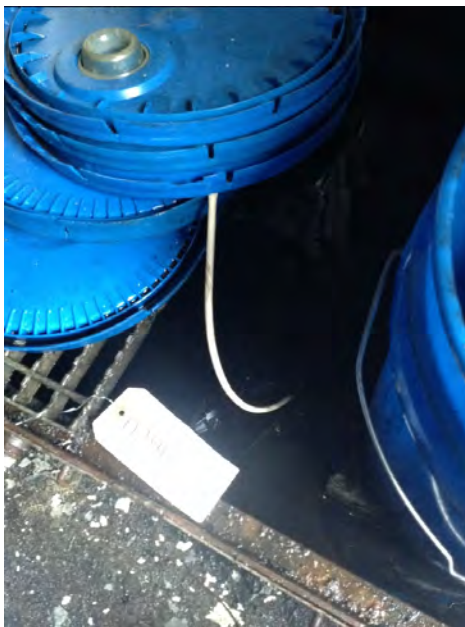
Additional Details: Oil catch under drum

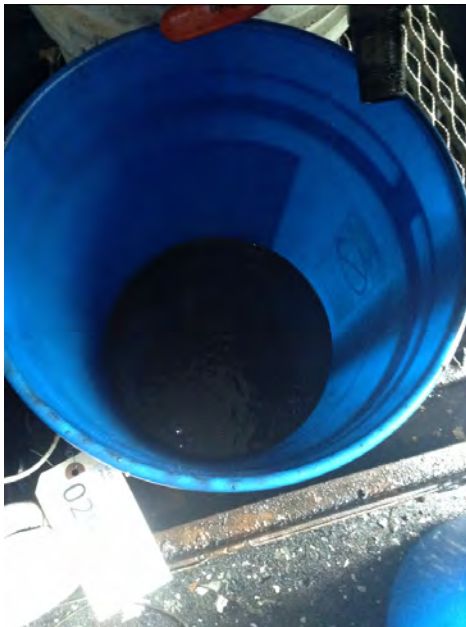
Container Condition: Open (no cover)

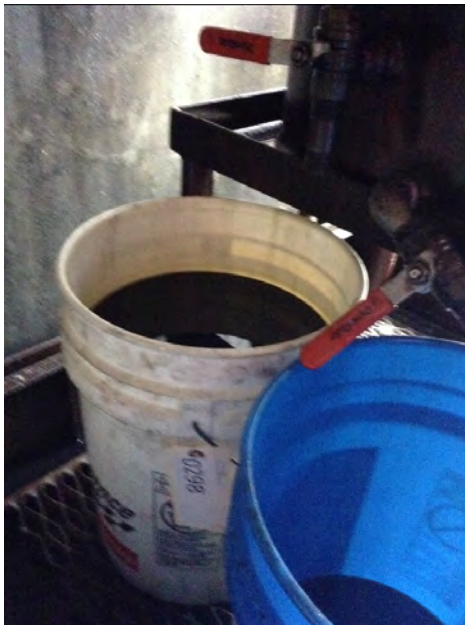
Container Condition: Open (no cover)

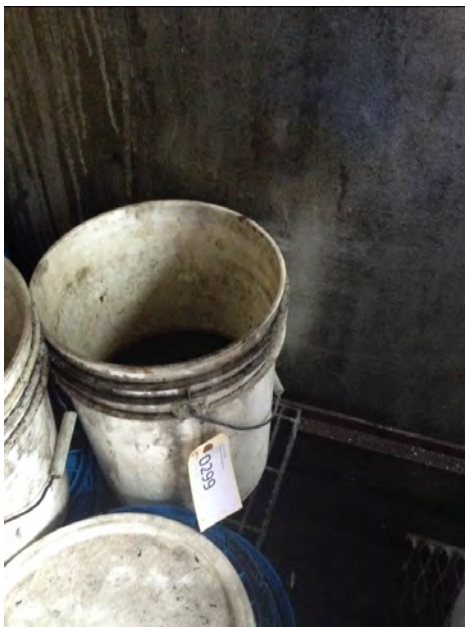
Container Condition: Open (no cover)

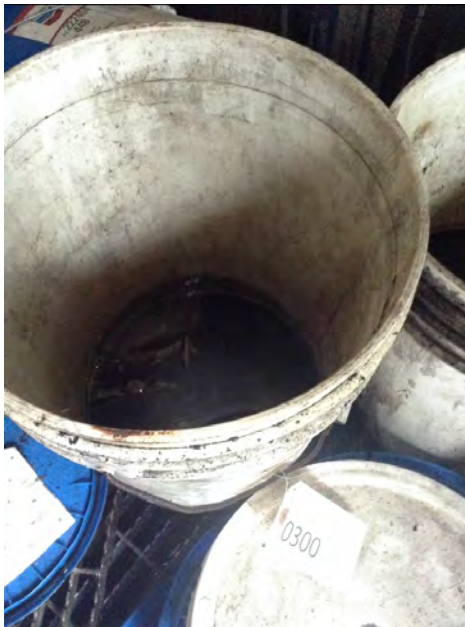
Container Condition: Open (no cover)

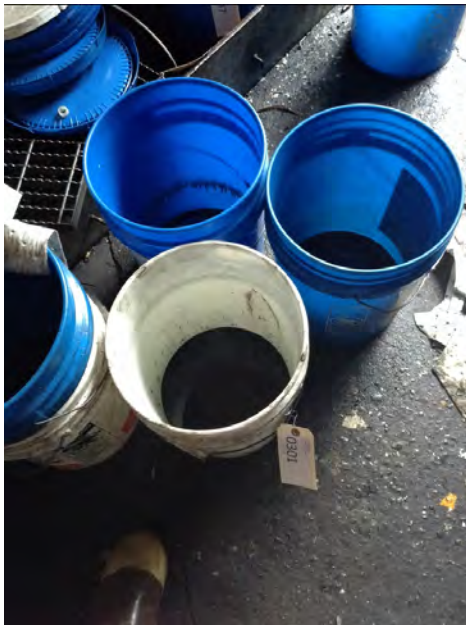
Container Condition: Open (no cover)

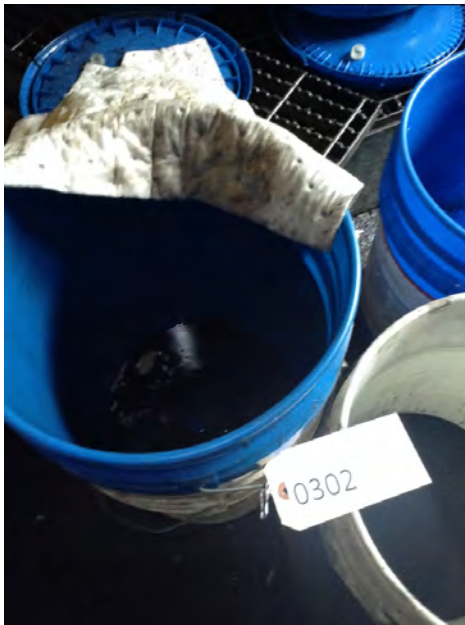
Container Condition: Open (no cover)

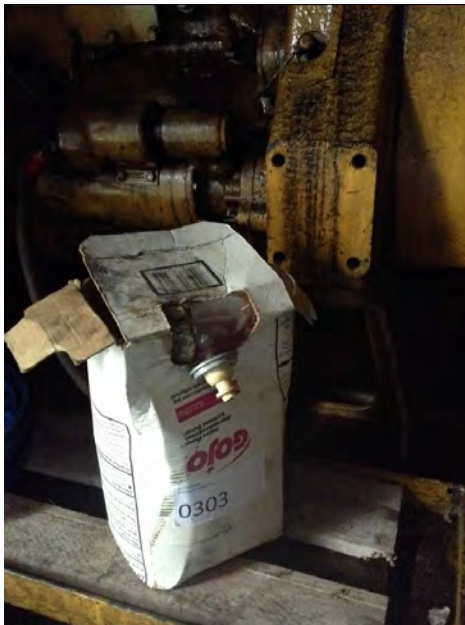
Container Condition: Fair

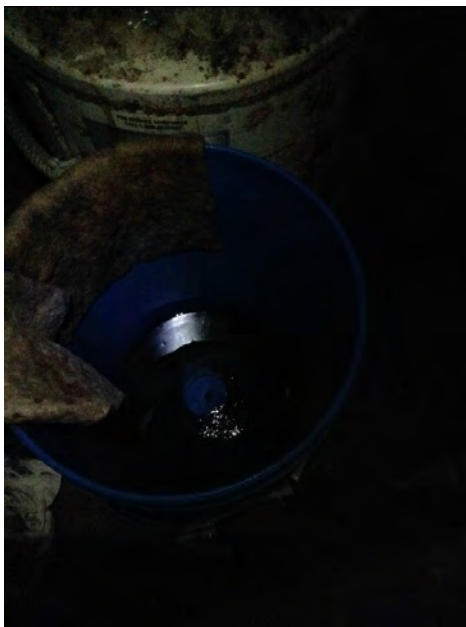
Container Condition: Open (no cover)

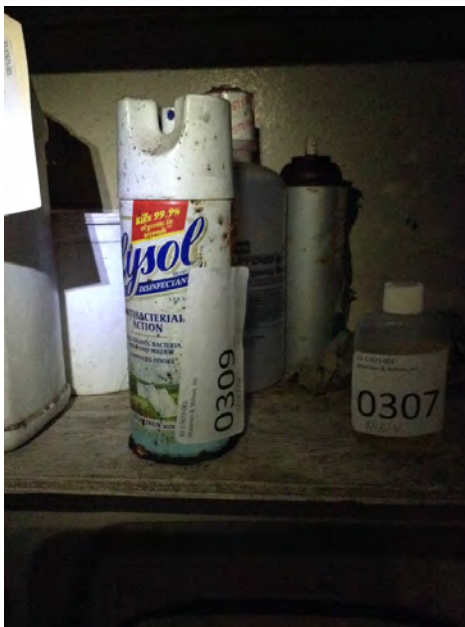
Container Condition: Intact with rust

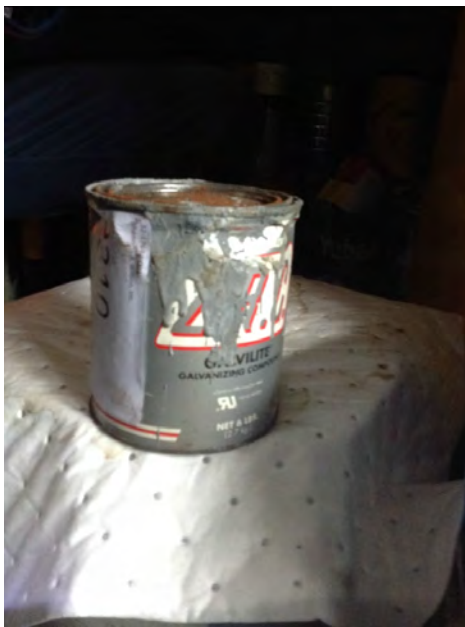
Container Condition: Intact with rust

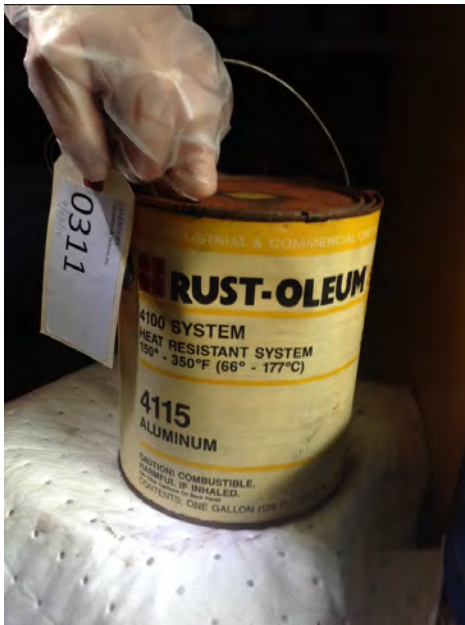
Container Condition: Intact with rust

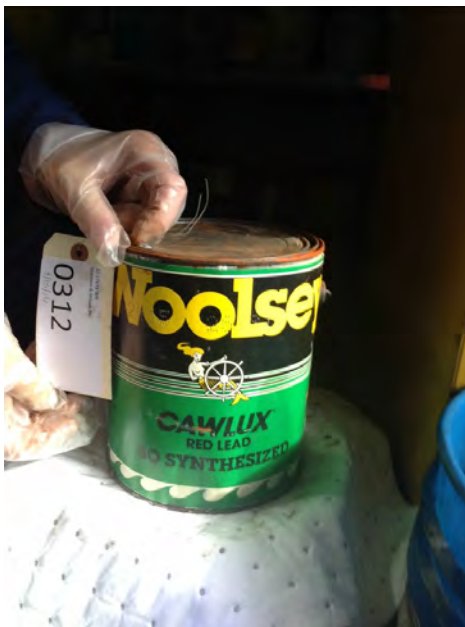
Container Condition: Intact with rust

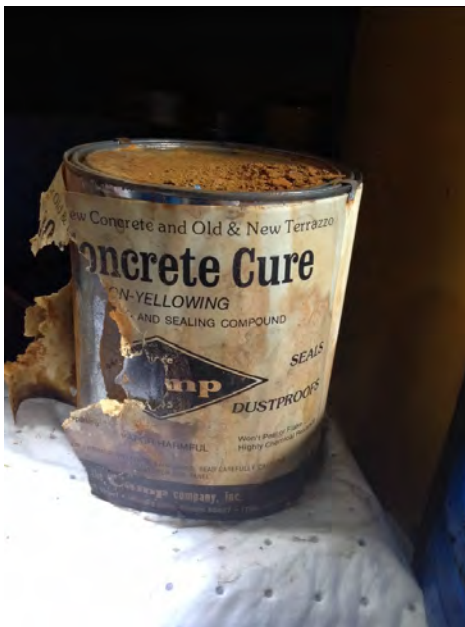
Container Condition: Leaking

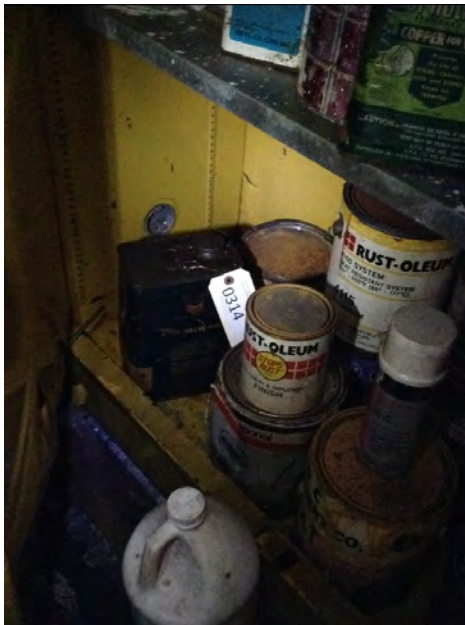
Container Condition: Leaking

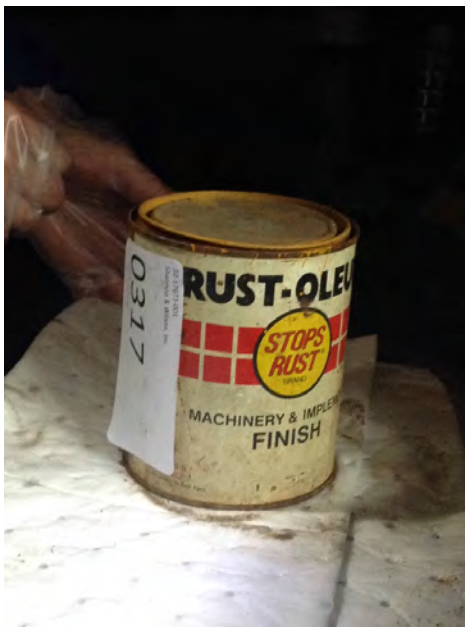
Container Condition: Intact with rust

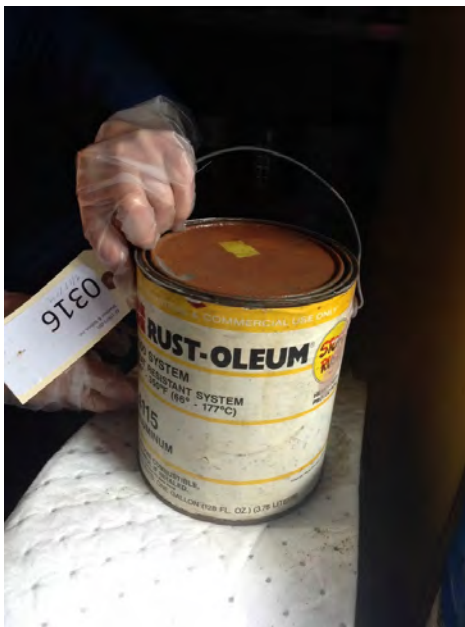
Container Condition: Intact with rust

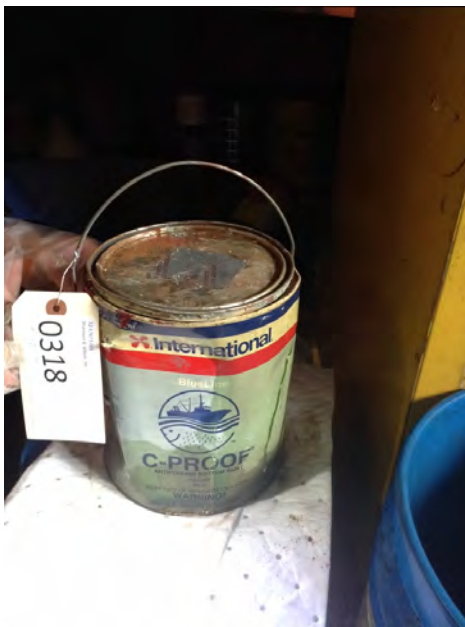
Container Condition: Poor

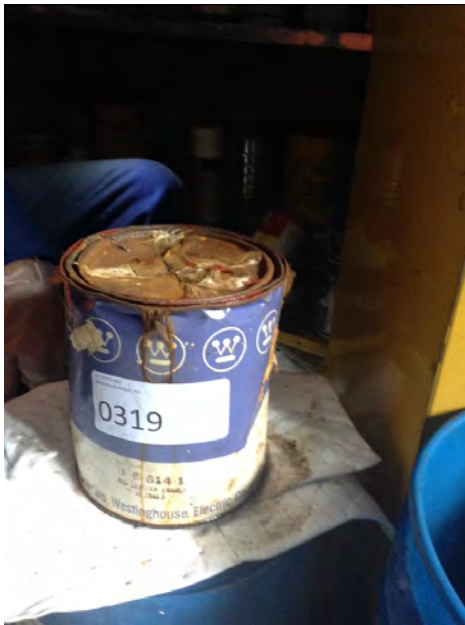
Container Condition: Poor

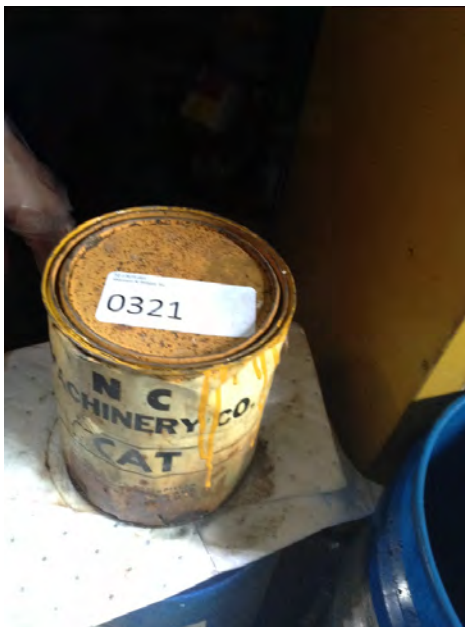
Container Condition: Intact with rust

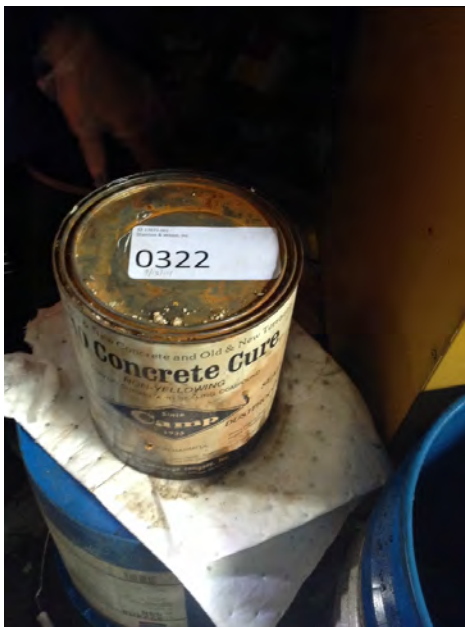
Container Condition: Intact with rust

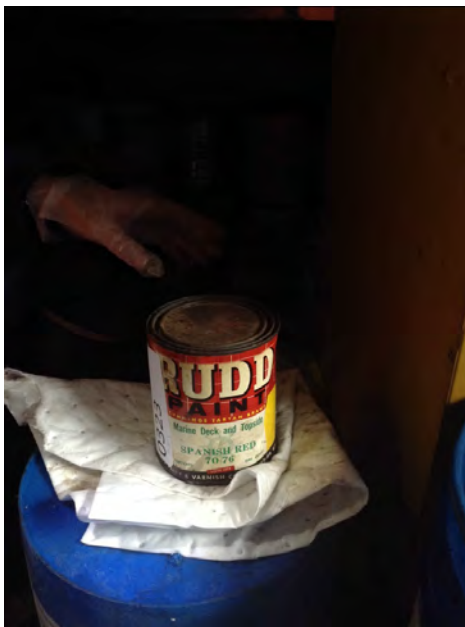
Container Condition: Intact with rust

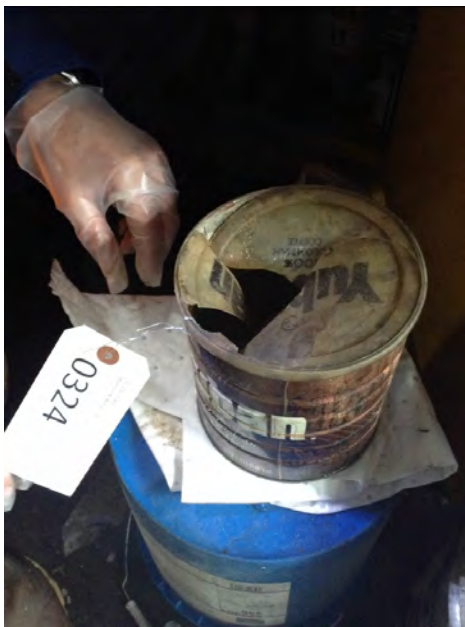
Container Condition: Open (no cover)

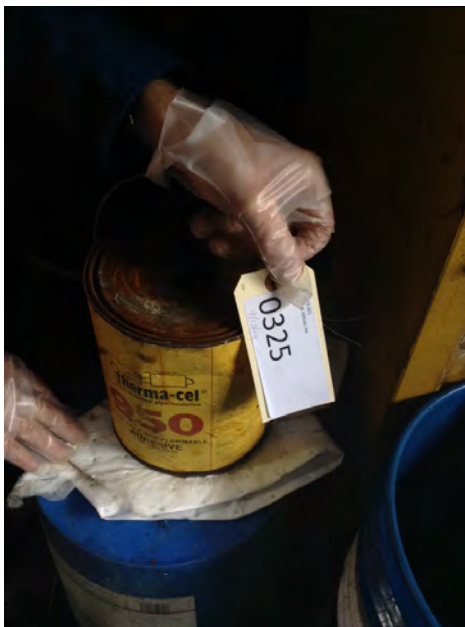
Container Condition: Poor

Label ID: Fast taco non flammable adhesive

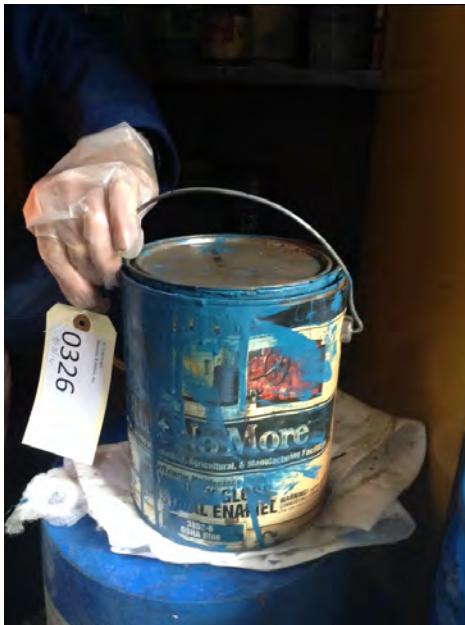
Container Condition: Intact with rust

Label ID: Industrial enamel

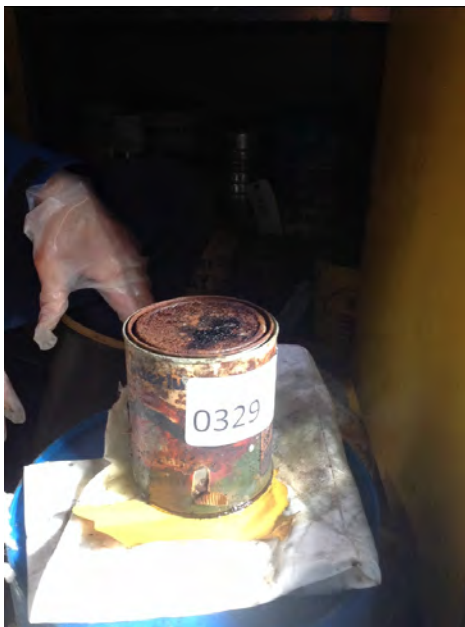
Container Condition: Intact with rust

Label ID: Premium enamel

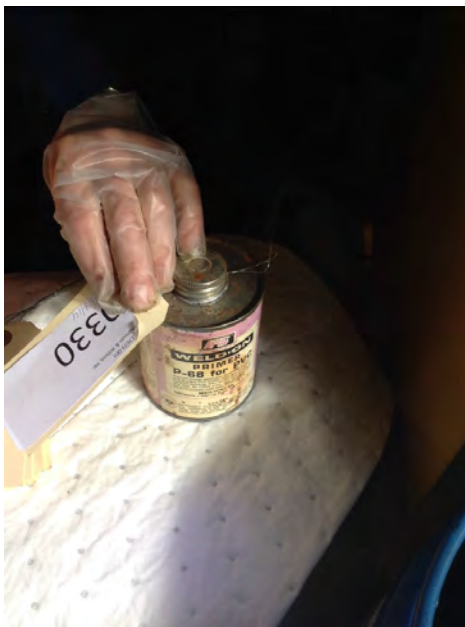
Container Condition: Intact with rust

Label ID: Primer for PVC

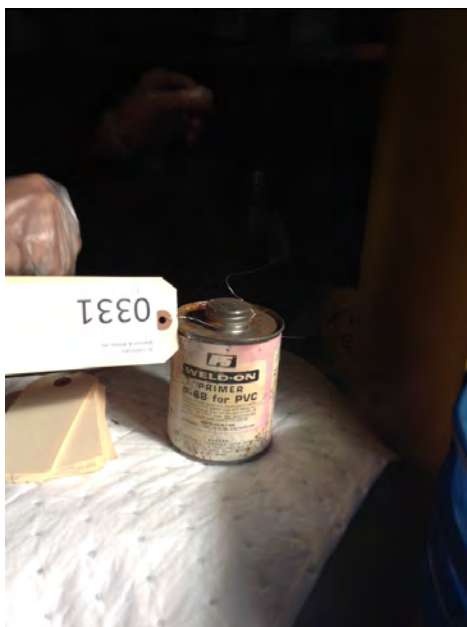
Container Condition: Intact with rust

Label ID: PVC primer

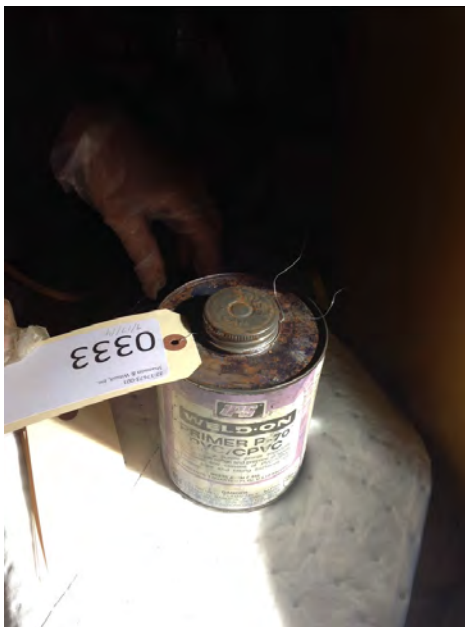
Container Condition: Intact with rust

Label ID: PVC primer

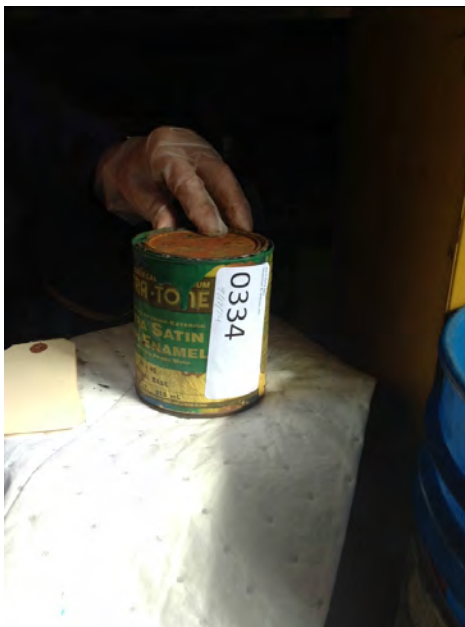
Container Condition: Intact with rust

Label ID: Satin finish enamel

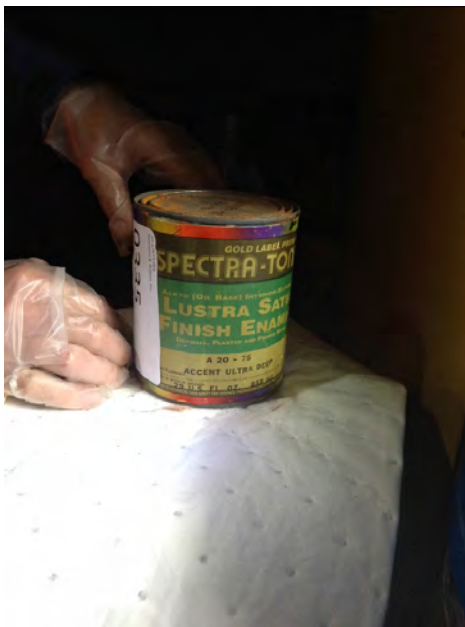
Container Condition: Intact with rust

Label ID: Satin finish enamel

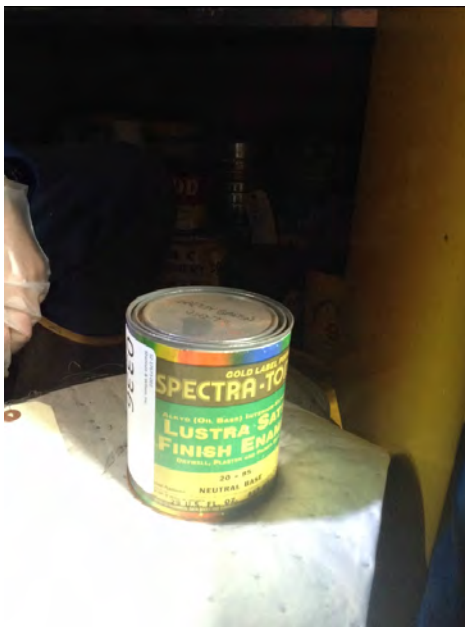
Container Condition: Intact with rust

Label ID: Satin finish enamel

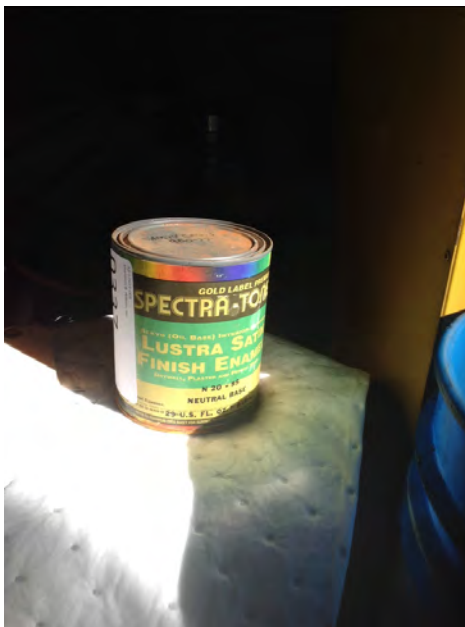
Container Condition: Intact with rust

Label ID: Satin finish enamel

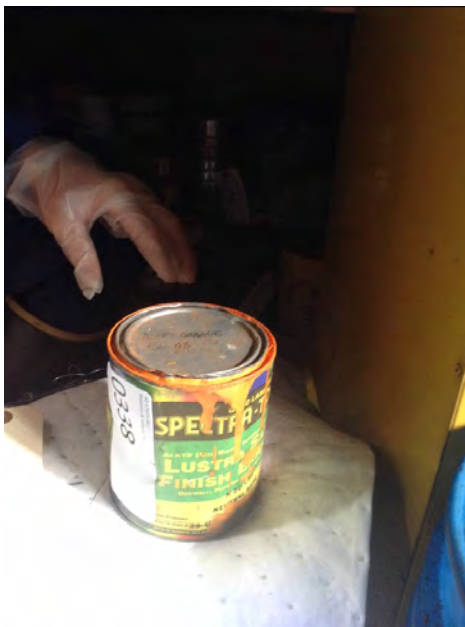
Container Condition: Intact with rust

Label ID: Satin finish enamel

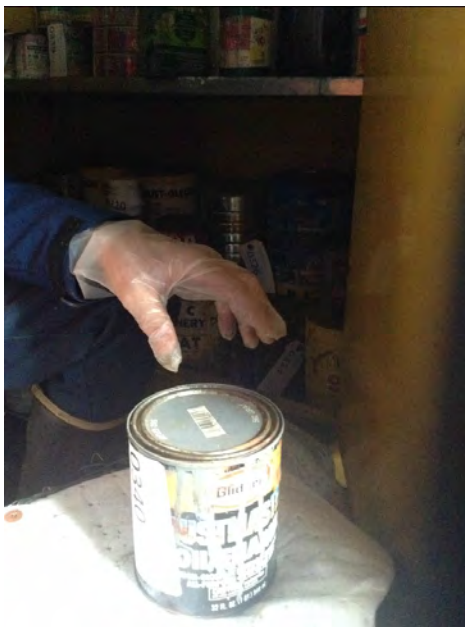
Container Condition: Intact with rust

Label ID: Oil enamel

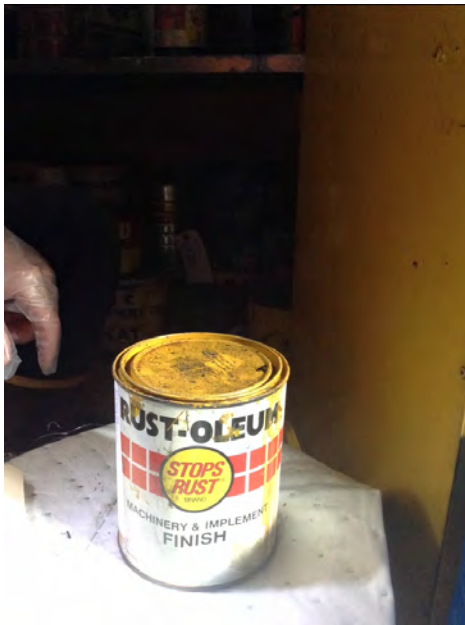
Container Condition: Intact with rust

Label ID: Machinery and implement finish

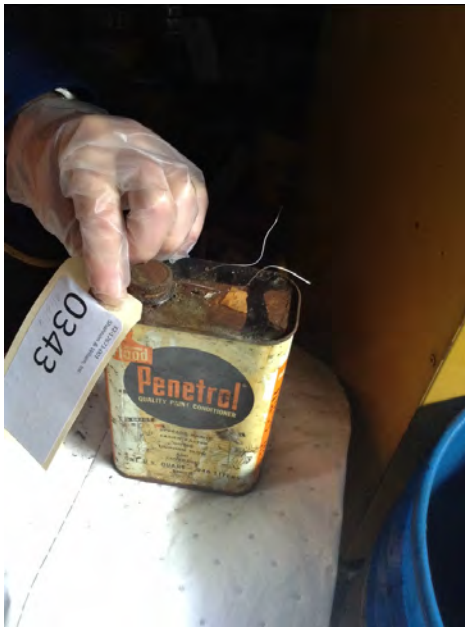
Container Condition: Intact with rust

Label ID: Penetrol paint conditioner

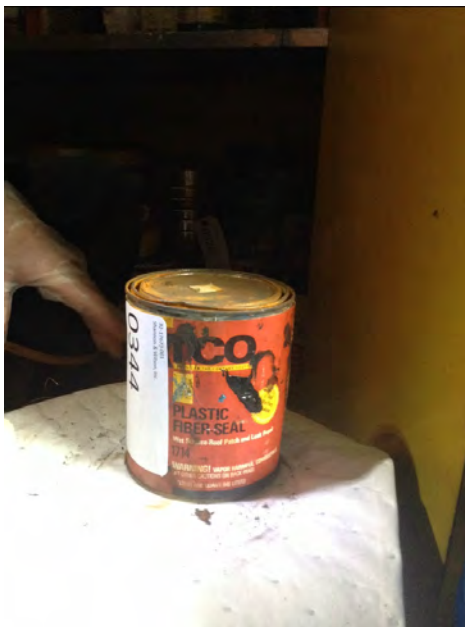
Container Condition: Intact with rust

Label ID: Plastic fiber seal roof patch

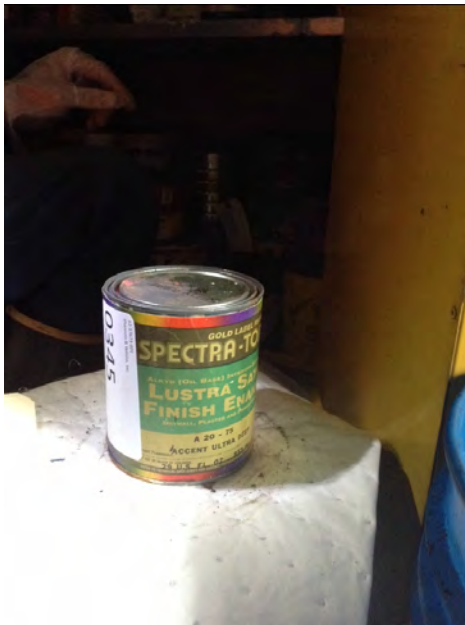
Container Condition: Intact with rust

Label ID: Satin finish enamel

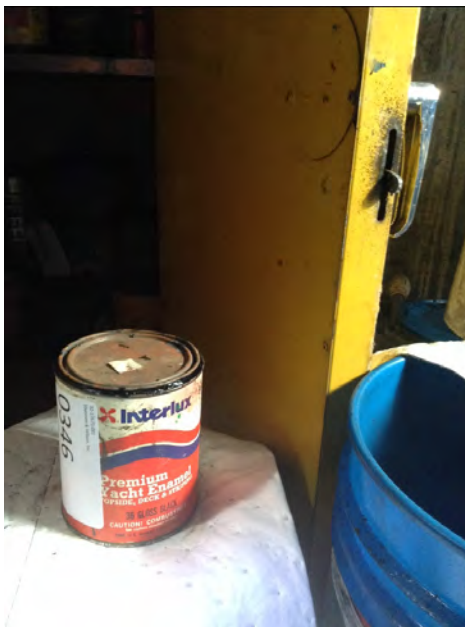
Container Condition: Intact with rust

Label ID: Yacht enamel

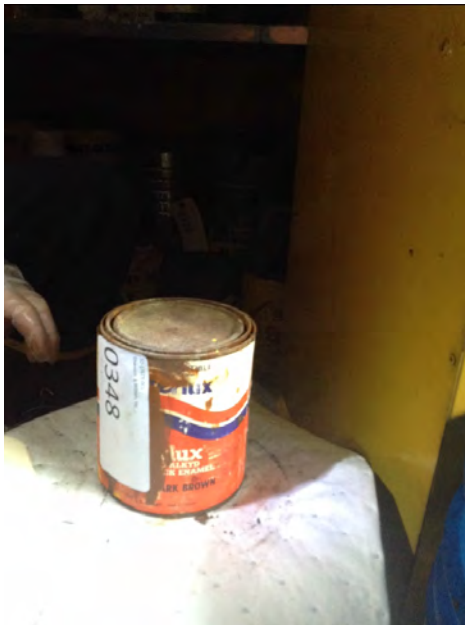
Container Condition: Intact with rust

Label ID: Deck enamel

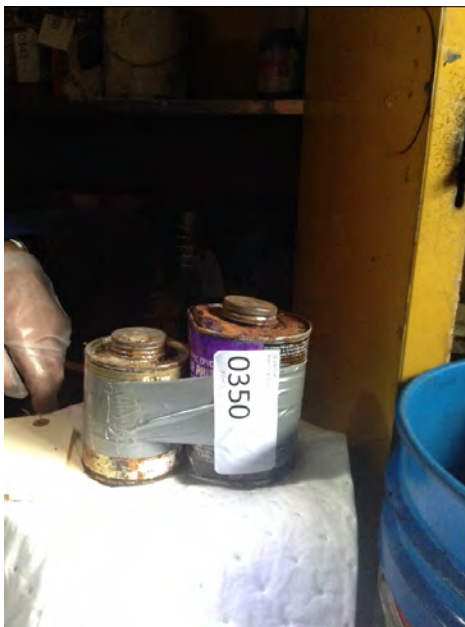
Container Condition: Intact with rust

Label ID: PVC primer

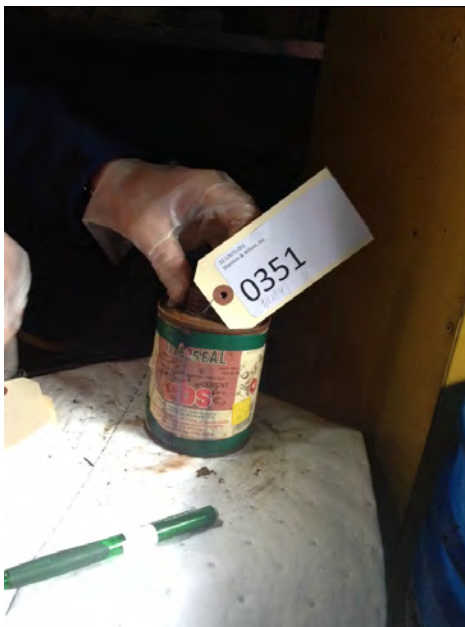
Container Condition: Intact with rust

Label ID: ABS solvent cement

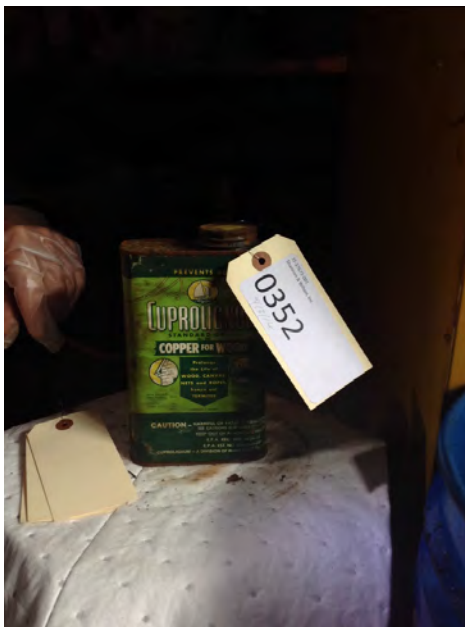
Container Condition: Intact with rust

Label ID: Cupro lignum copper for woof

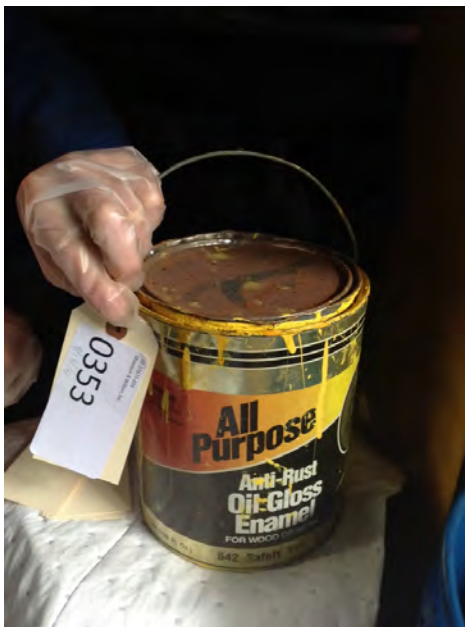
Container Condition: Intact with rust

Label ID: Oil gloss enamel

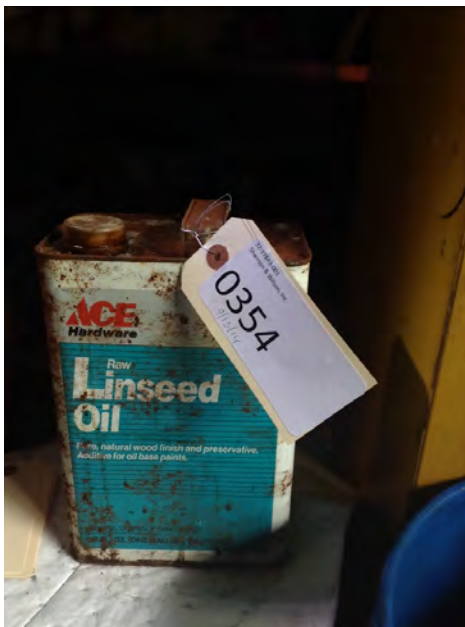
Container Condition: Intact with rust

Label ID: Raw linseed oil

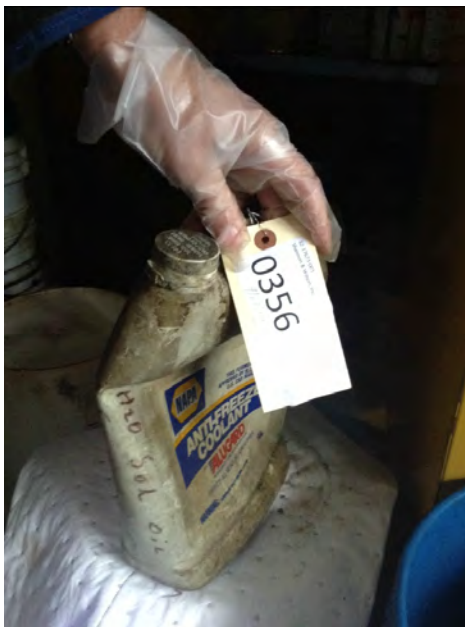
Container Condition: Fair

Label ID: Water sol. Oil for valve grinding

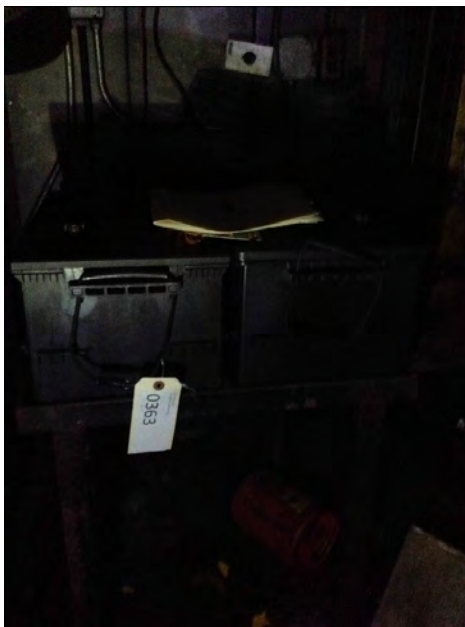
Container Condition: Fair

Label ID: Exide commercial starting battery

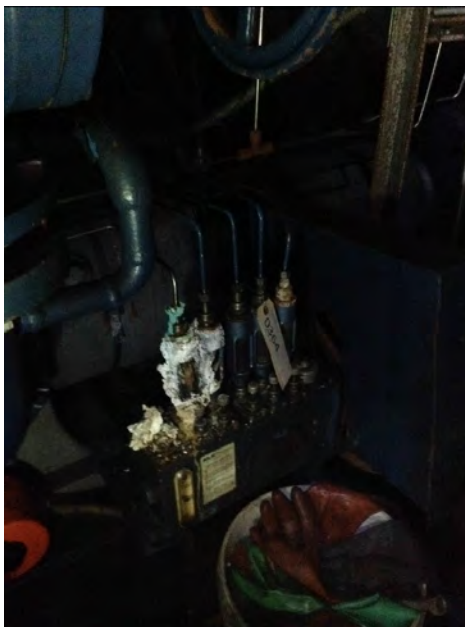
Container Condition: Other (see addt'l details)

Label ID: Force feed lubricator

Additional Details: Booster compressor #11,  
corroded

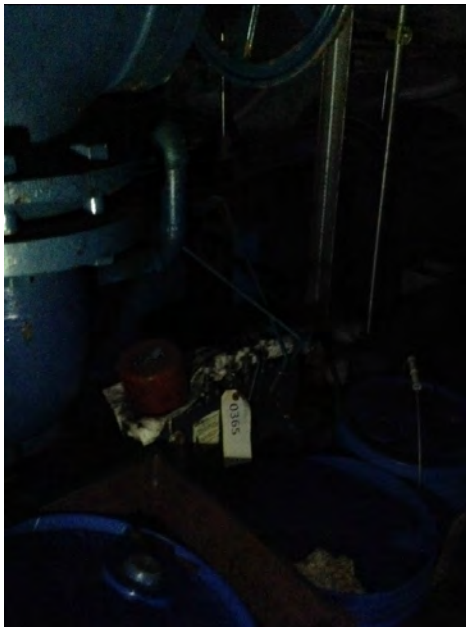
Label ID: Force feed lubricator

Container Condition: Other (see addtl details)

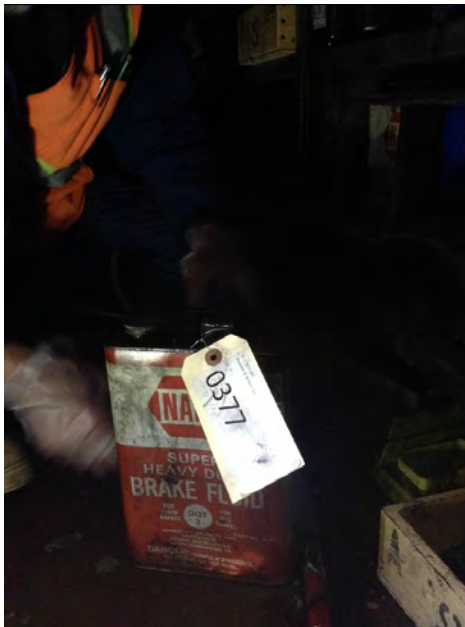
Label ID: Brake fluid

Container Condition: Fair

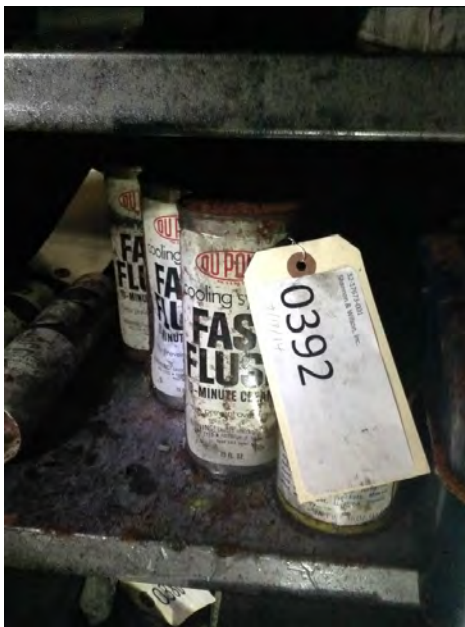
Label ID: Cooling system fast flush

Container Condition: Intact with rust
