**Site Assessment and Remediation Plan  
Pelican Seafood Processing Facility  
Pelican, Alaska**

May 2015

By:  
**Shannon & Wilson, Inc.**  
5430 Fairbanks Street, Suite 3  
Anchorage, Alaska 99518  
Phone: 907-561-2120  
FAX: 907-561-4483

32-1-17673

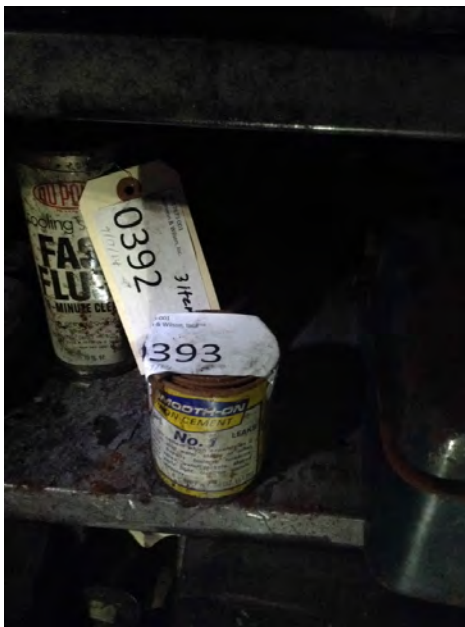
Label ID: Smooth on iron cement

Container Condition: Intact with rust

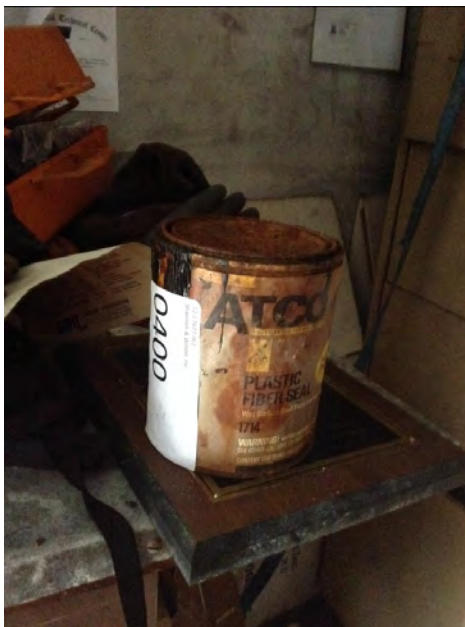
Label ID: Plastic fiber seal roof patch

Container Condition: Intact with rust

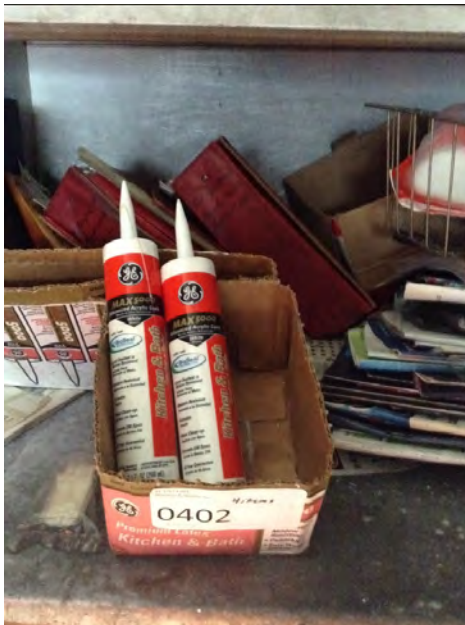
Label ID: Premium latex kitchen and bath

Container Condition: Fair

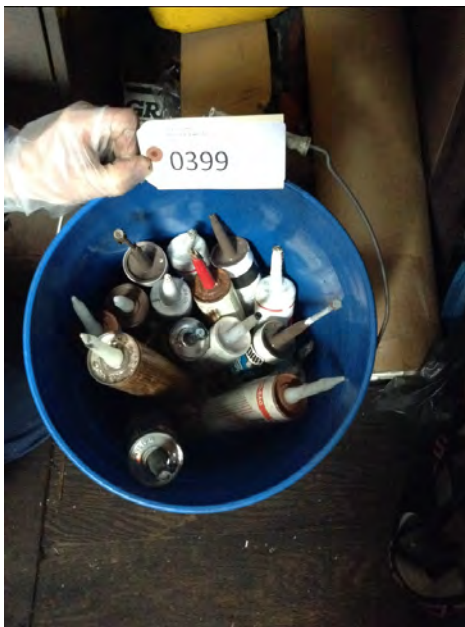
Label ID: Various

Container Condition: Fair

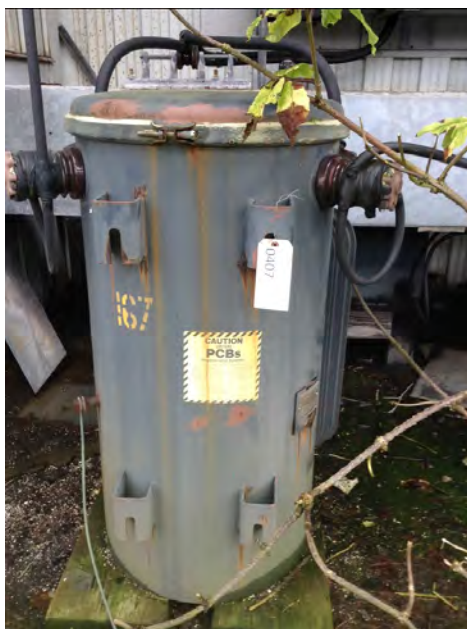
Container Condition: Intact with rust

Label ID: 1330 lb 2400V distribution transformer

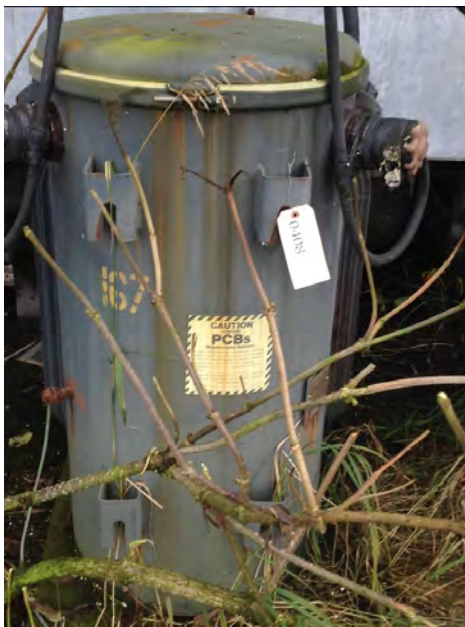
Container Condition: Intact with rust

Label ID: 1330 lb 2400V distribution transformer

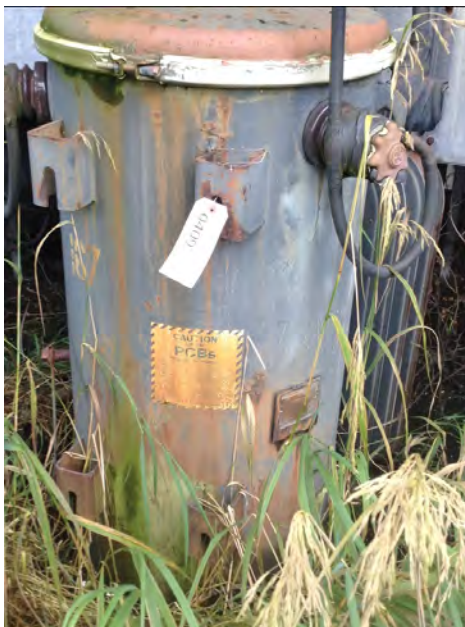
Container Condition: Intact with rust

Label ID: 1330 lb 2400V distribution transformer

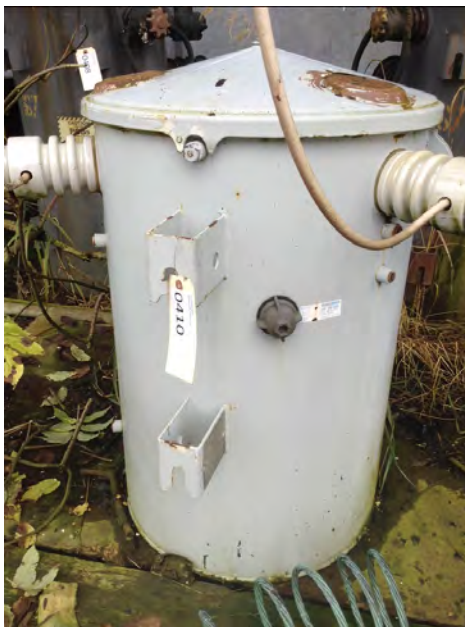
Container Condition: Intact with rust

Label ID: 2400V distribution transformer

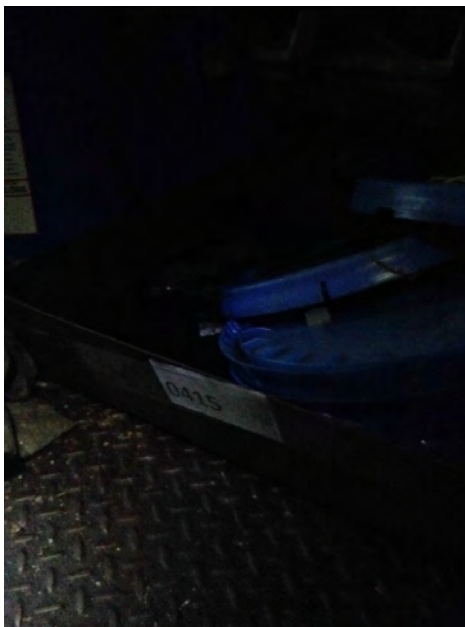
Container Condition: Open (no cover)

Label ID: No label

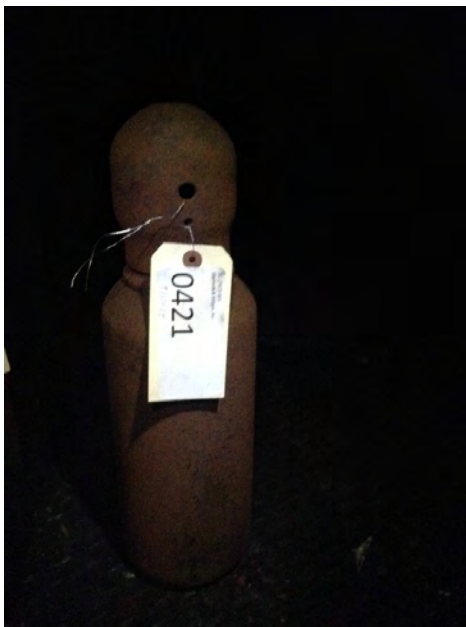
Container Condition: Intact with rust

Corroded, 5 lb cyclinder,  
potentially empty

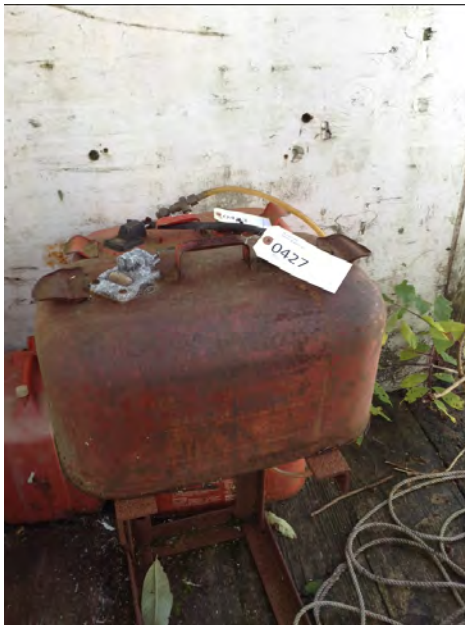
Container Condition: Poor

Label ID: Yamaha flammable liquid

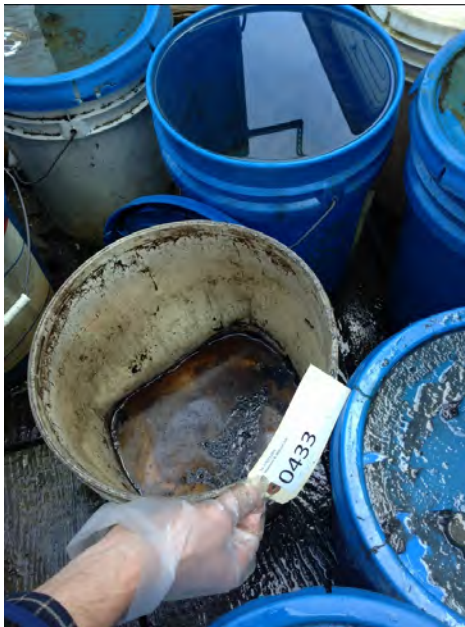
Container Condition: Poor

Label ID: Cement grout

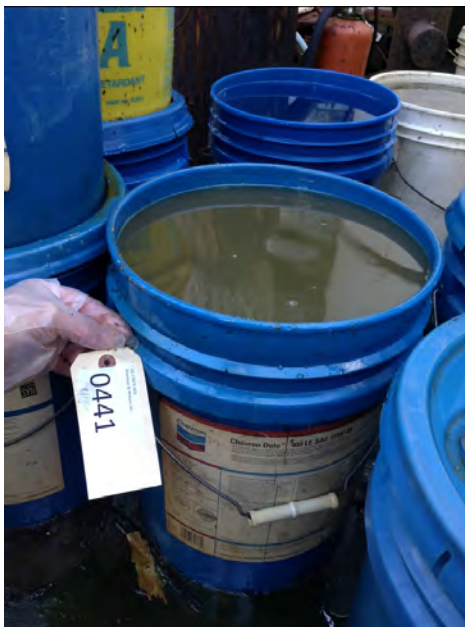
Container Condition: Open (no cover)

Label ID: Delo 400 motor oil

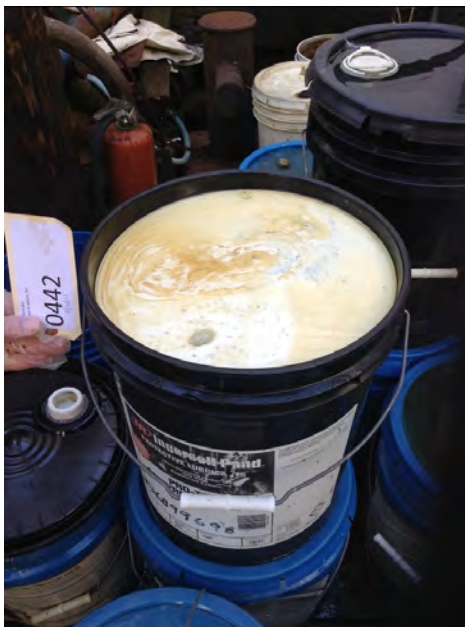
Label ID: Pro-tec compressor fluid

Container Condition: Good

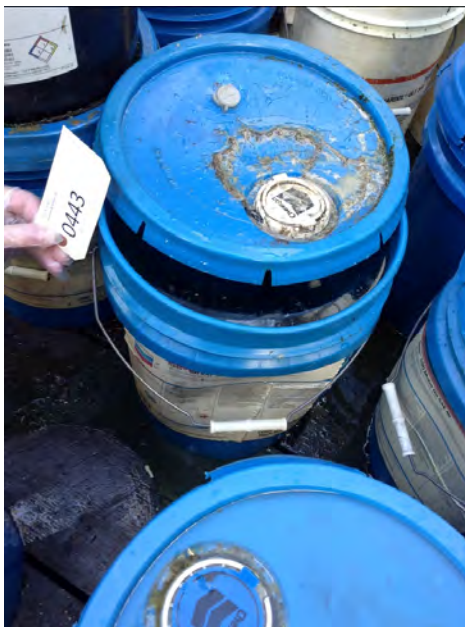
Label ID: Delo 400 motor oil

Container Condition: Other (see addt'l details)

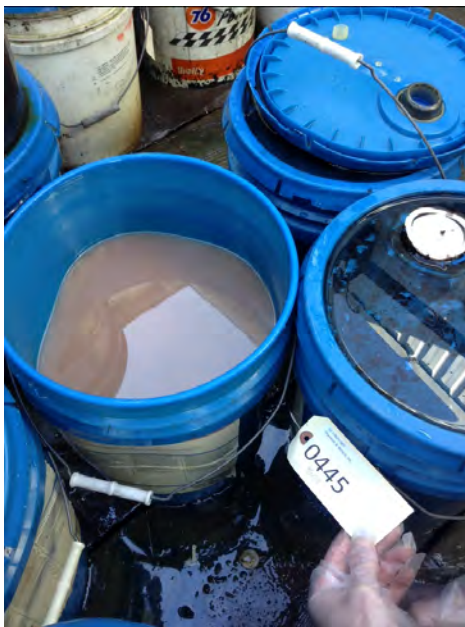
Label ID: Delo 100 motor oil

Container Condition: Other (see add'l details)

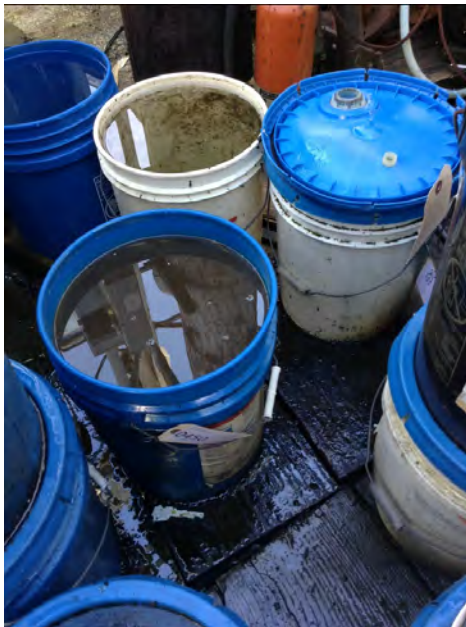
Label ID: Delo 100 motor oil

Container Condition: Other (see addt'l details)

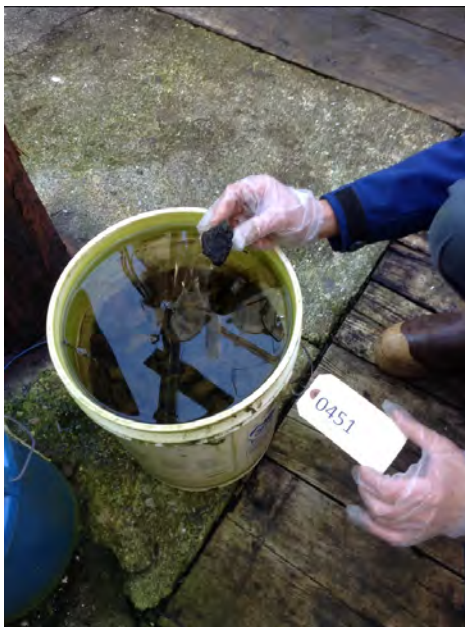
Label ID: 76 guardol QLT 15W-40

Container Condition: Open (no cover)

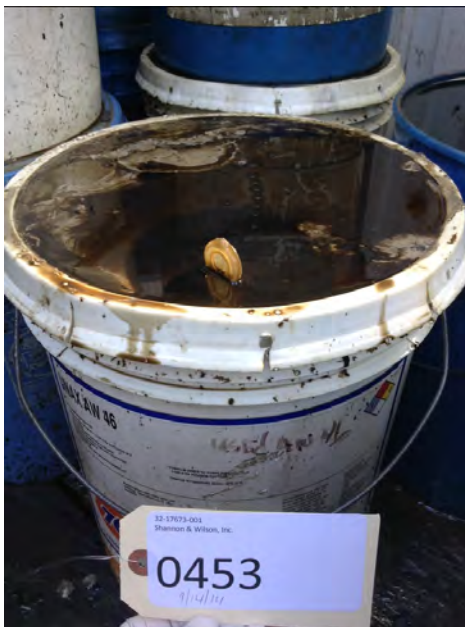
Label ID: Used Aw 46

Container Condition: Other (see addtl details)

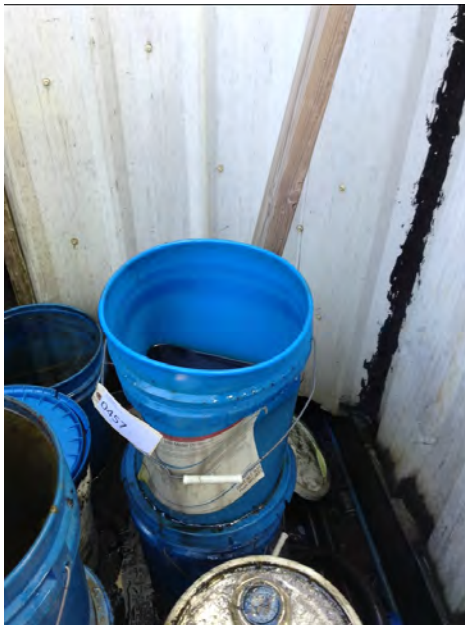
Label ID: Delo 100 motor oil

Container Condition: Other (see addt'l details)

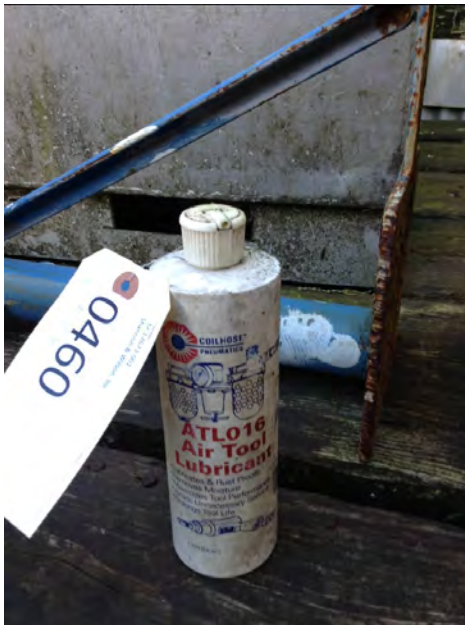
Label ID: Alto 16 air tool lubricant

Container Condition: Fair

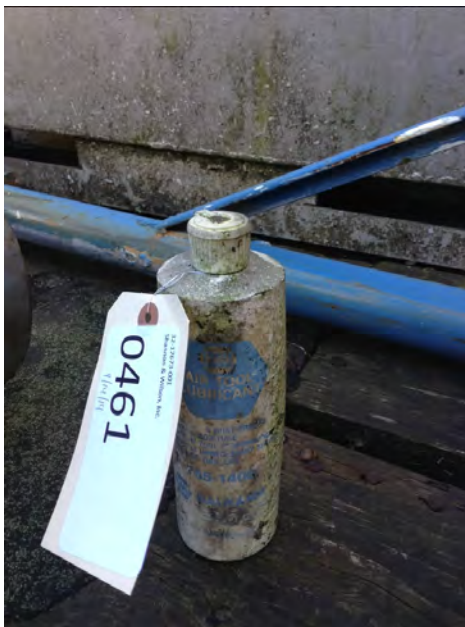
Label ID: Air tool lubricant

Container Condition: Fair

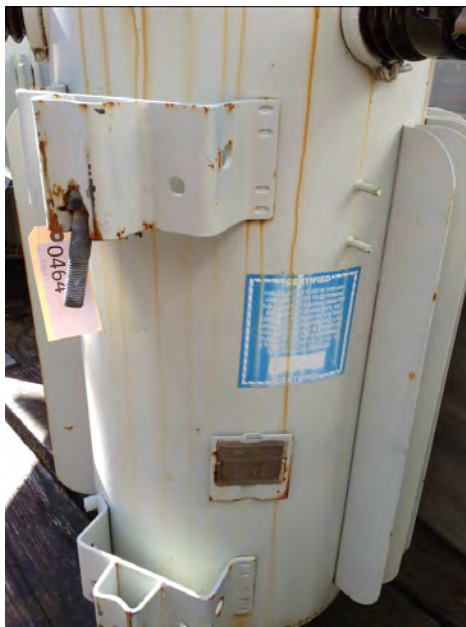
Label ID: GE transformer

Container Condition: Intact with rust

Waste constituents: Label states less than 50 ppm PCBs

Additional Details: 765lb distribution transformer

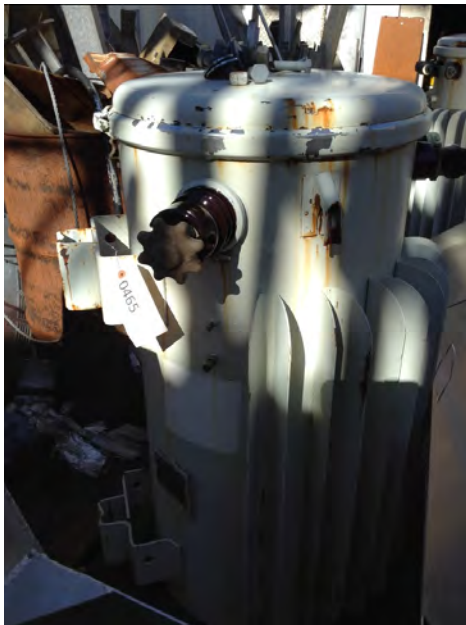
Label ID: GE transformer

Container Condition: Intact with rust

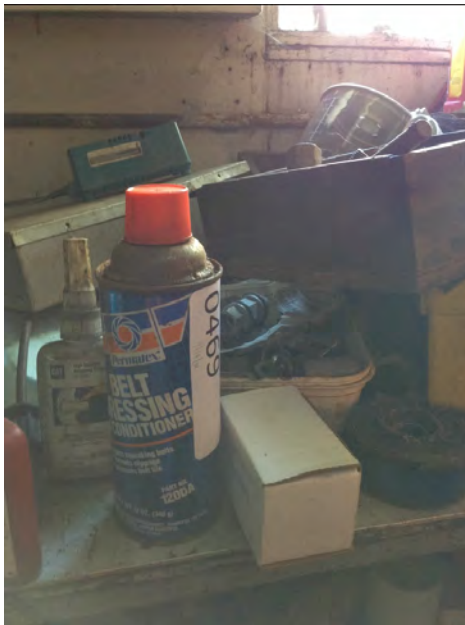
Label ID: Belts dressing and conditioner

Container Condition: Intact with rust

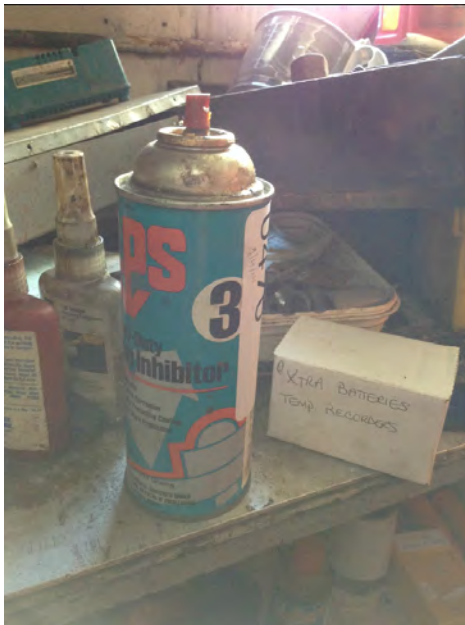
Label ID: Lips rust inhibitor

Container Condition: Intact with rust

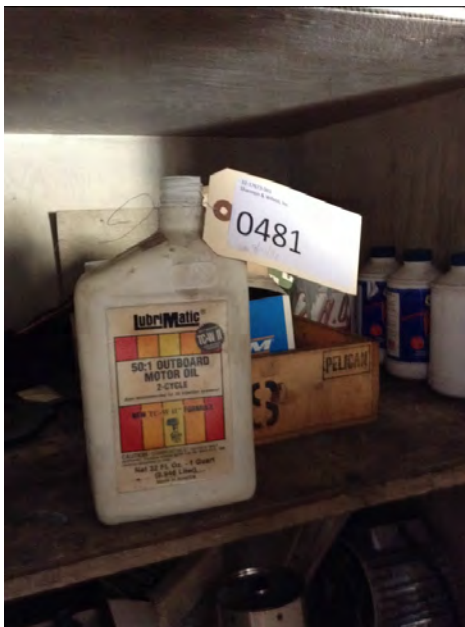
Label ID: Outboard motor oil

Container Condition: Open (no cover)

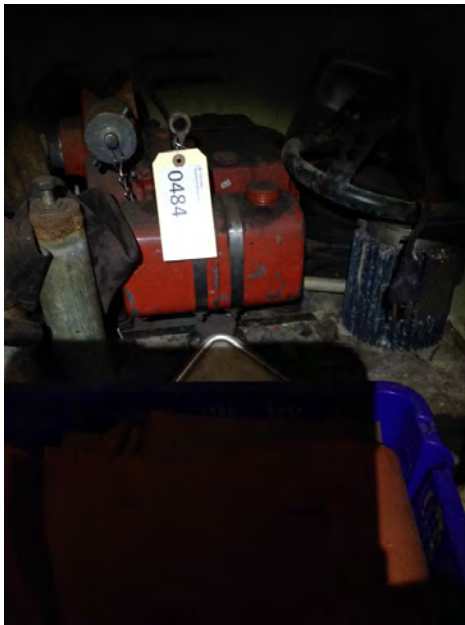
Label ID: None

Container Condition: Intact with rust

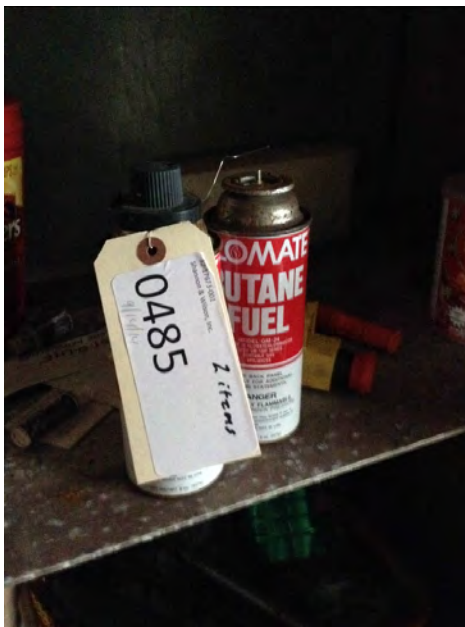
Label ID: Butane fuel

Container Condition: Intact with rust

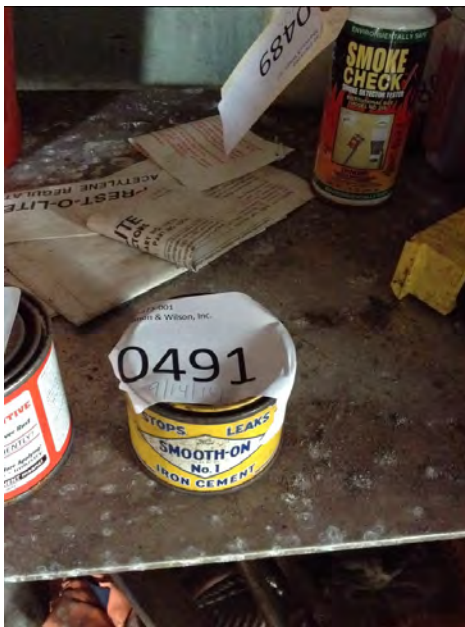
Label ID: #1 iron cement

Container Condition: Intact with rust

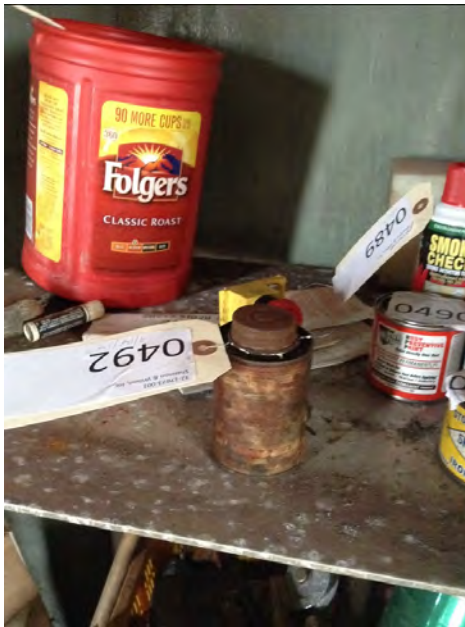
Label ID: Multi purpose thread sealant

Container Condition: Intact with rust

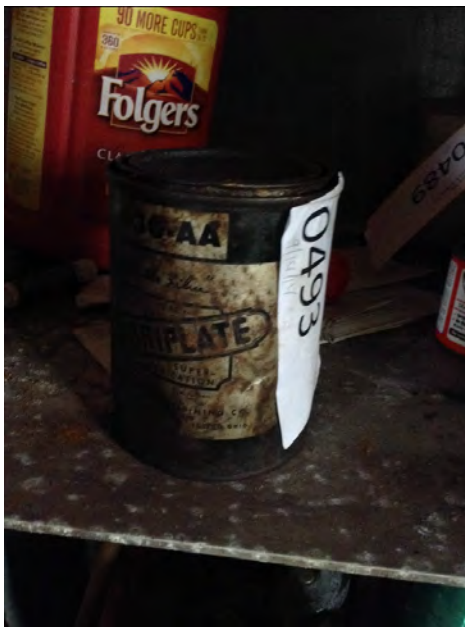
Label ID: Lubraplate super lubrication

Container Condition: Poor

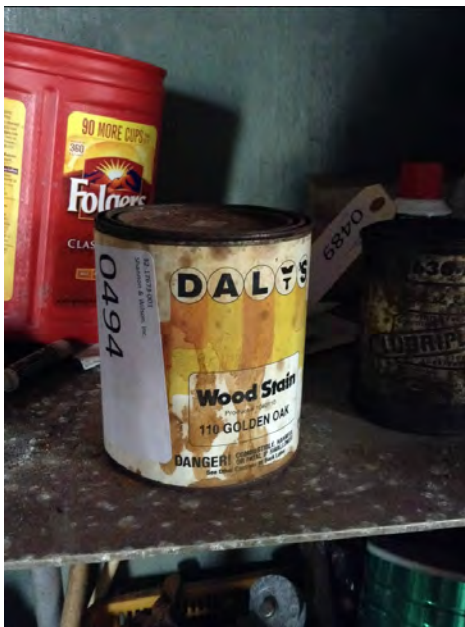
Label ID: Wood stain

Container Condition: Intact with rust

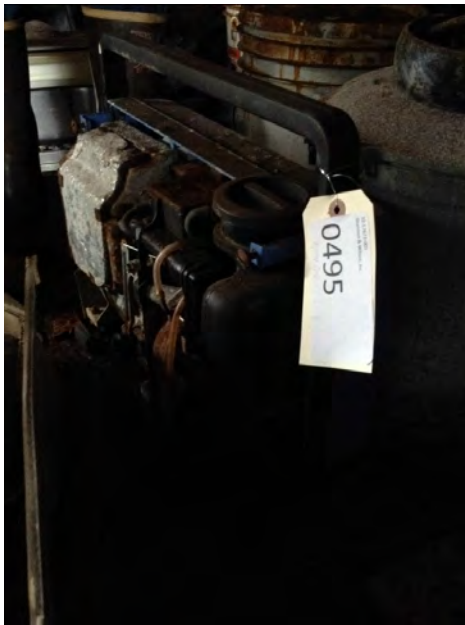
Label ID: Yamaha ef 600 gasoline generator

Container Condition: Poor

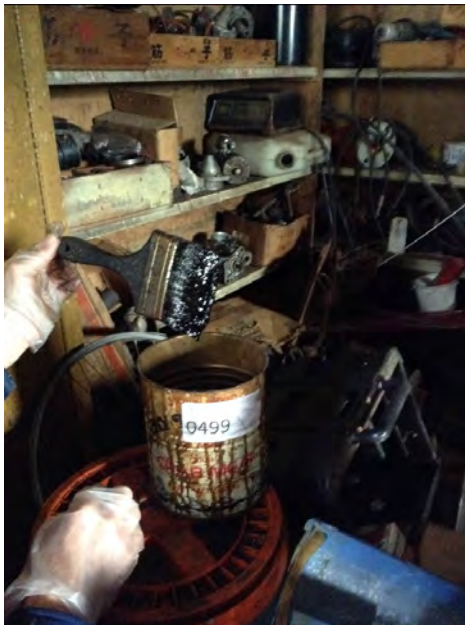
Label ID: No label

Container Condition: Open (no cover)

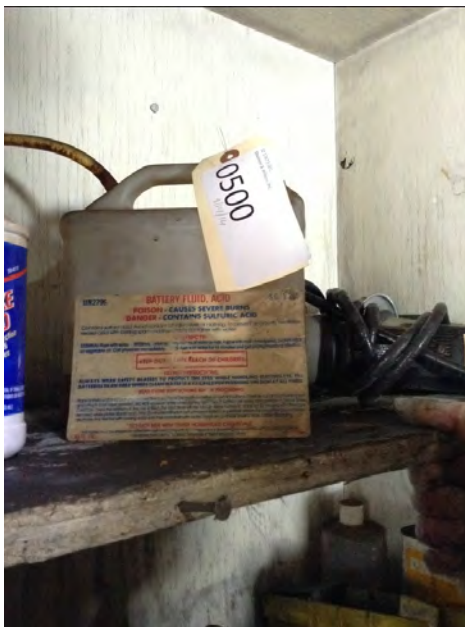
Label ID: Battery fluid, acid

Container Condition: Open (no cover)

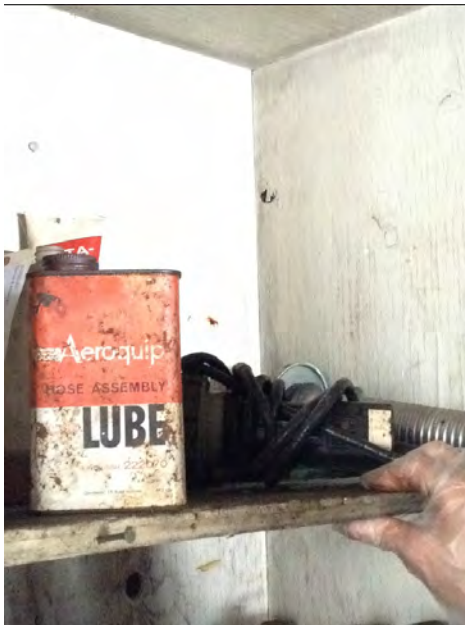
Label ID: Hose assembly lube

Container Condition: Intact with rust

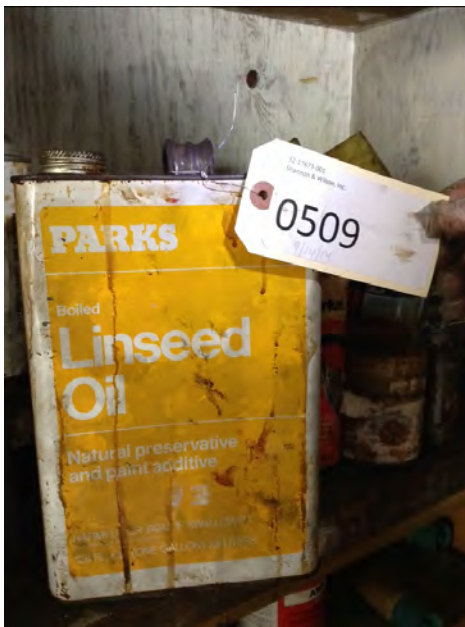
Label ID: Linseed oil

Container Condition: Intact with rust

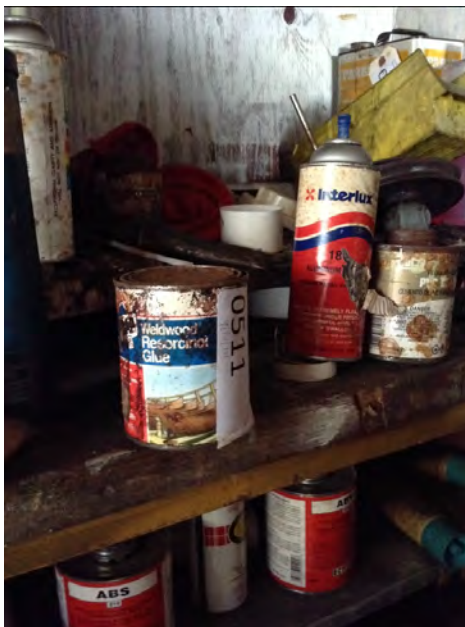
Label ID: Weldwood resorcinol glue

Container Condition: Intact with rust

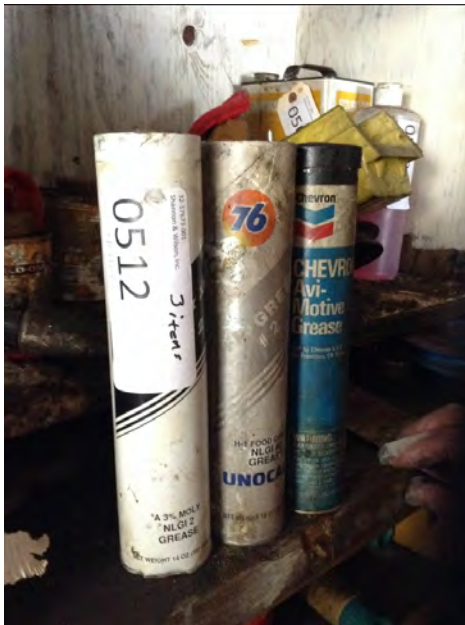
Label ID: Grease

Container Condition: Open (no cover)

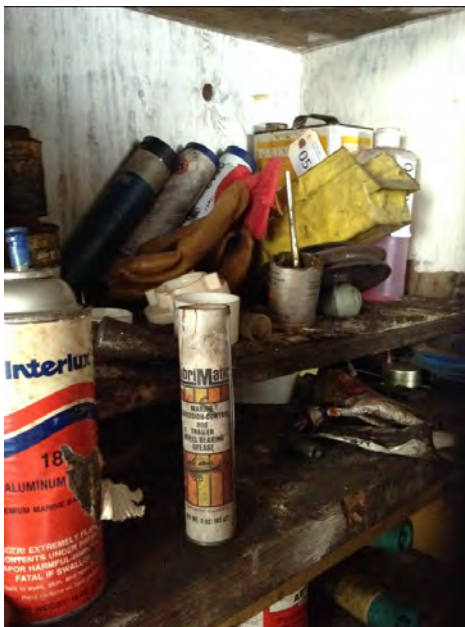
Label ID: Marine corrosion control wheel bearing

Container Condition: Open (no cover)

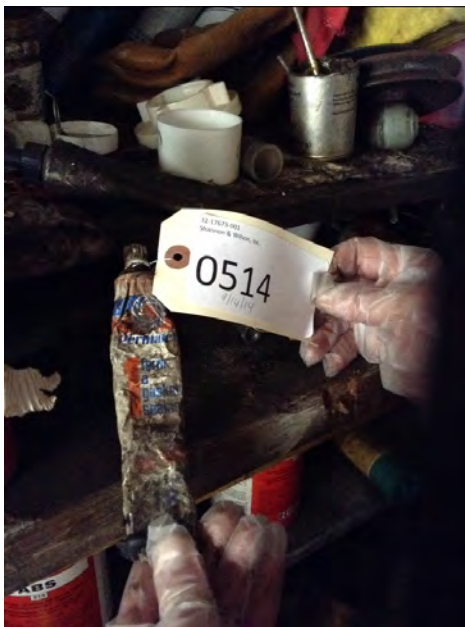
Label ID: Permatex formagasget

Container Condition: Fair

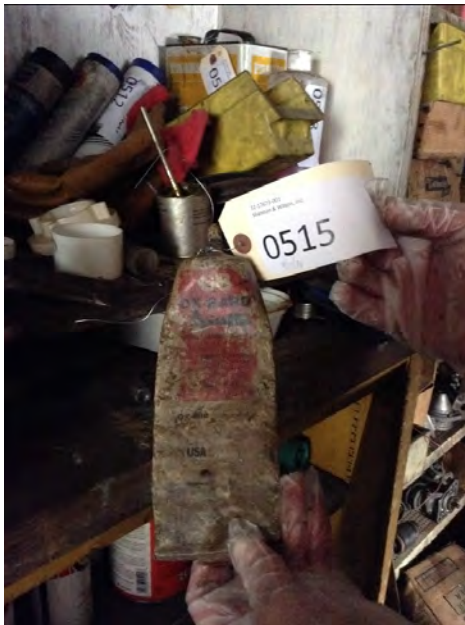
Label ID: Ox guard

Container Condition: Fair

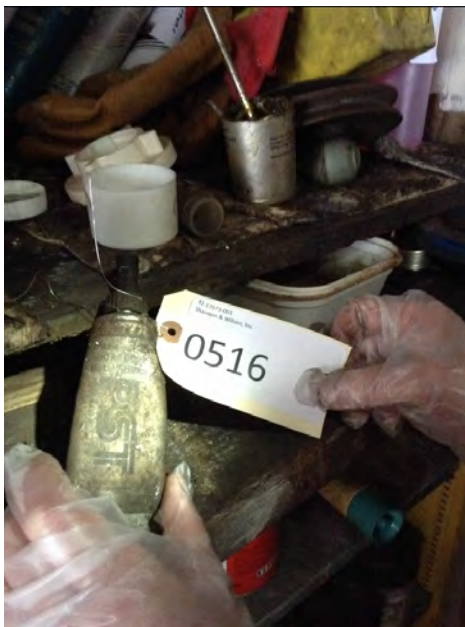
Label ID: PST stainless steel pipe sealant

Container Condition: Fair

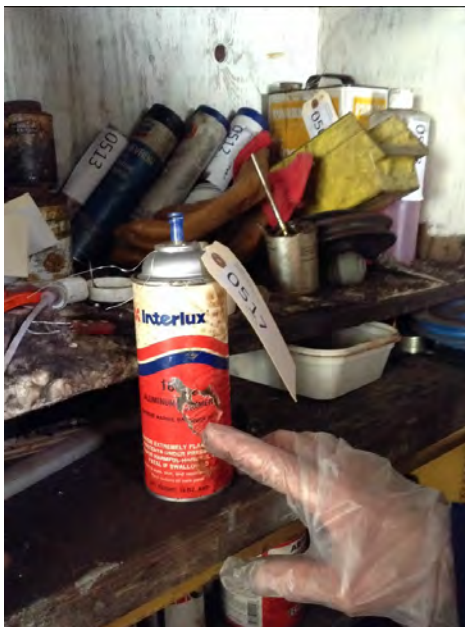
Label ID: Aluminum primer

Container Condition: Intact with rust

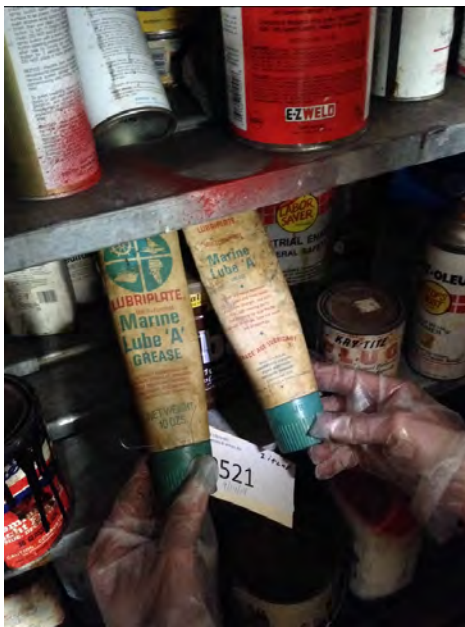
Container Condition: Good

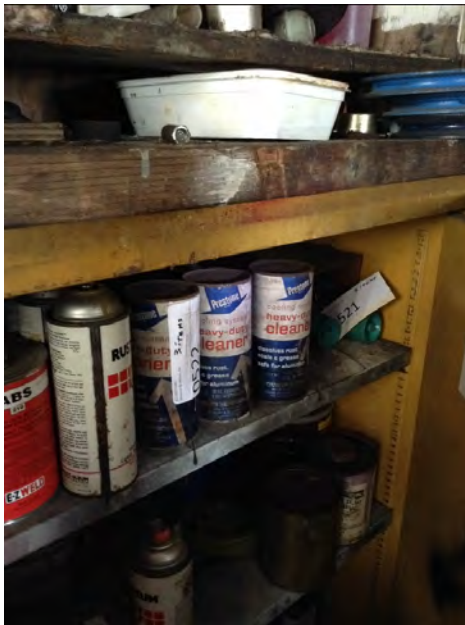
Container Condition: Intact with rust

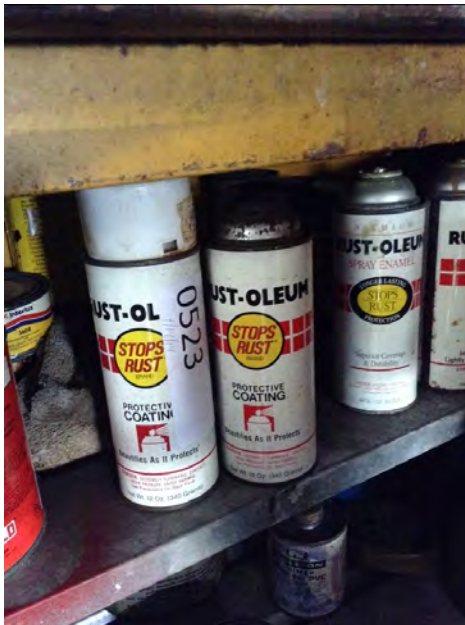
Container Condition: Intact with rust

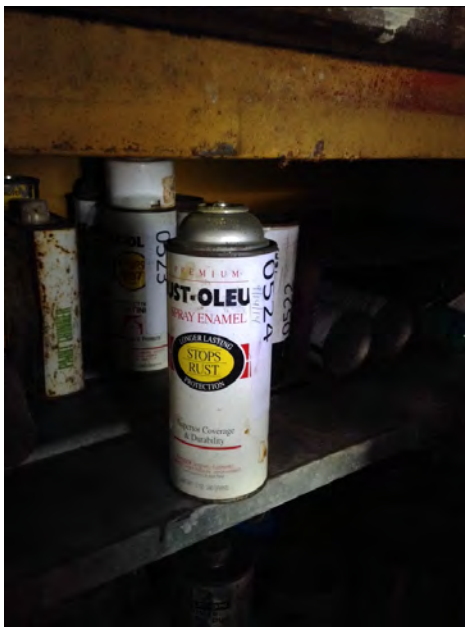
Container Condition: Intact with rust

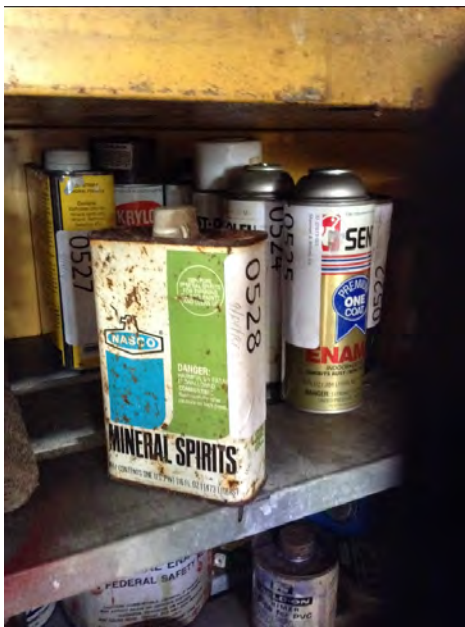
Container Condition: Intact with rust

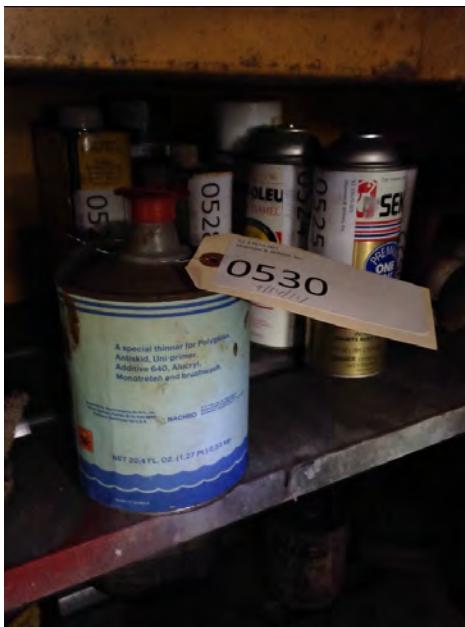
Container Condition: Intact with rust

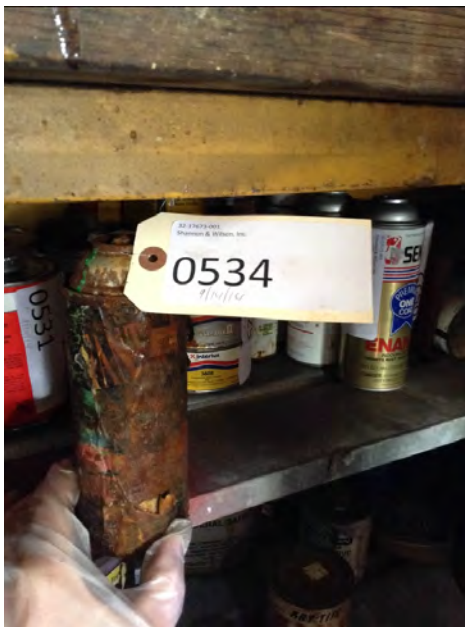
Container Condition: Intact with rust

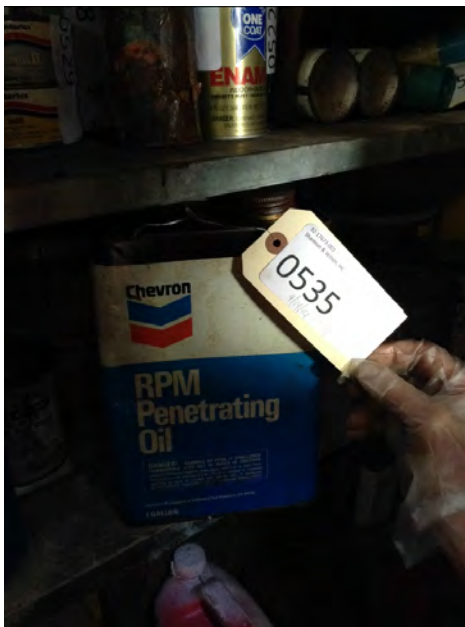
Container Condition: Intact with rust

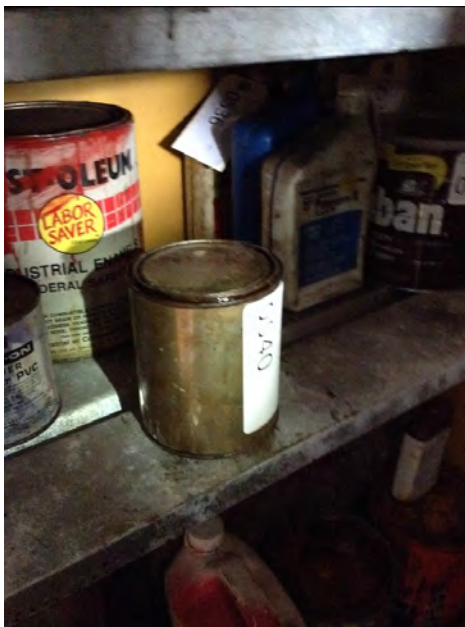
Container Condition: Intact with rust

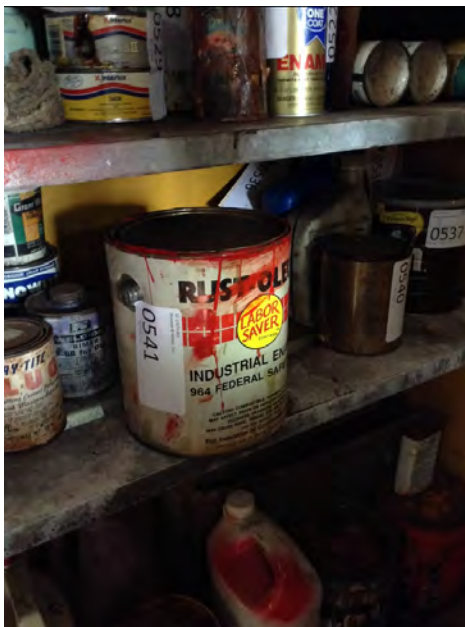
Container Condition: Fair

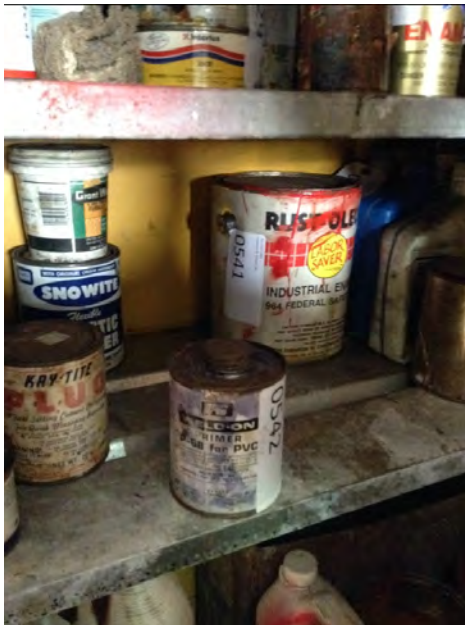
Container Condition: Intact with rust

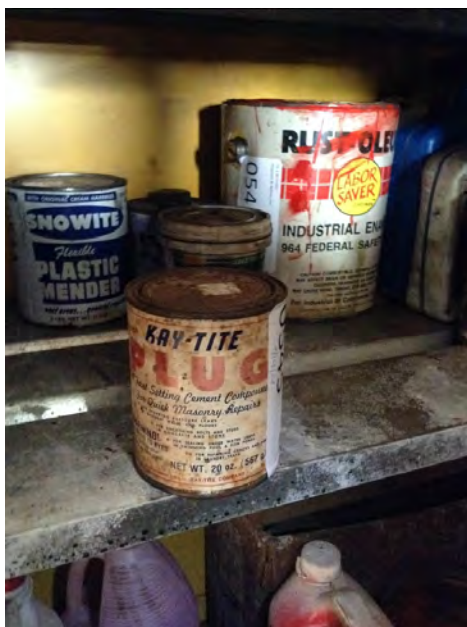
Container Condition: Intact with rust

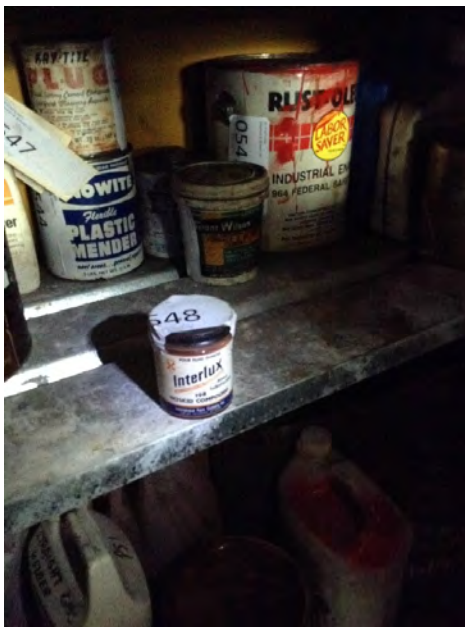
Container Condition: Intact with rust

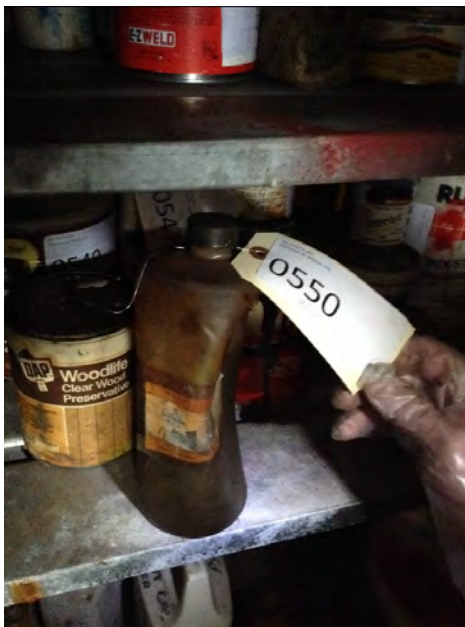
Container Condition: Fair

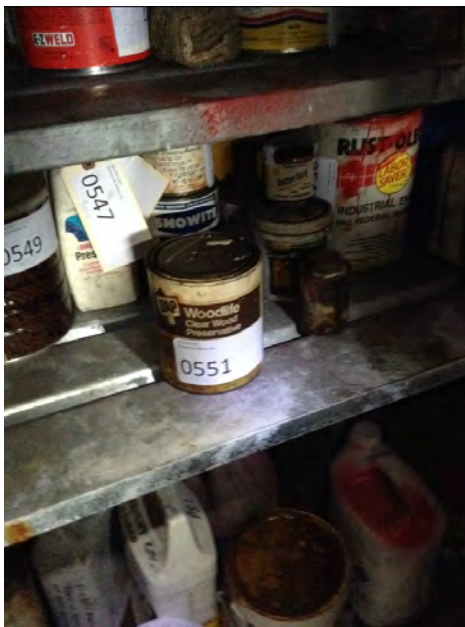
Container Condition: Intact with rust

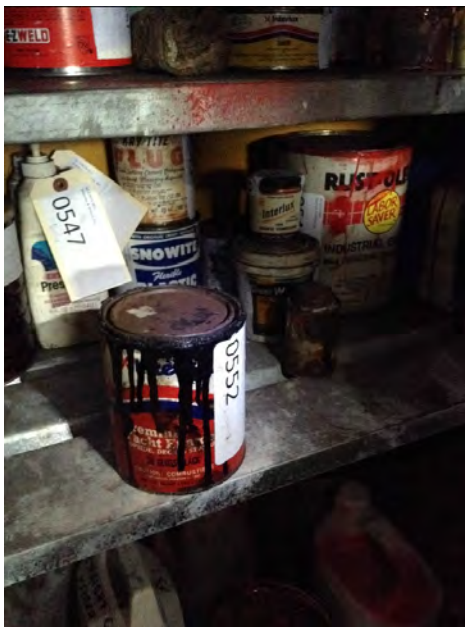
Container Condition: Intact with rust

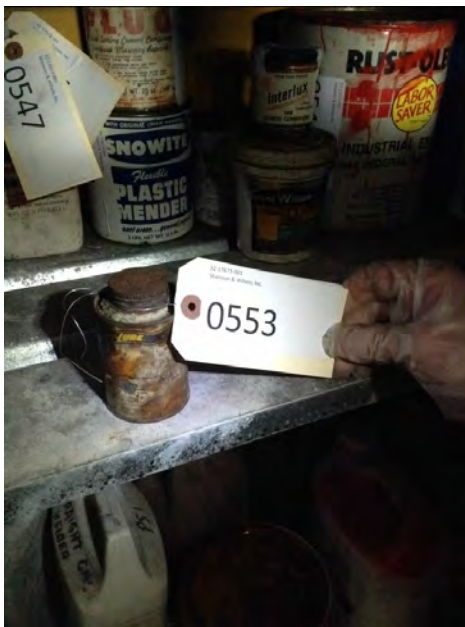
Container Condition: Intact with rust

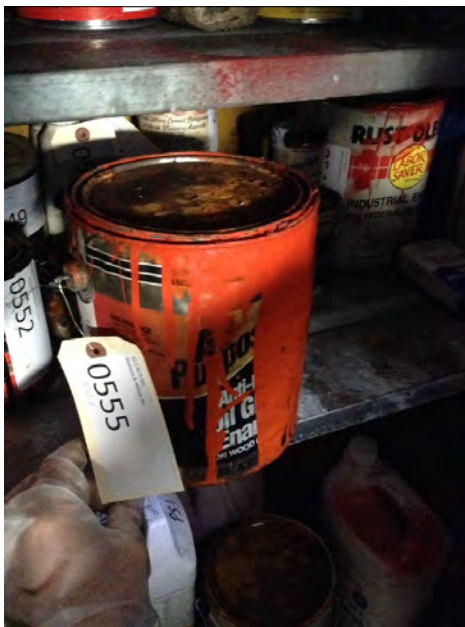
Container Condition: Intact with rust

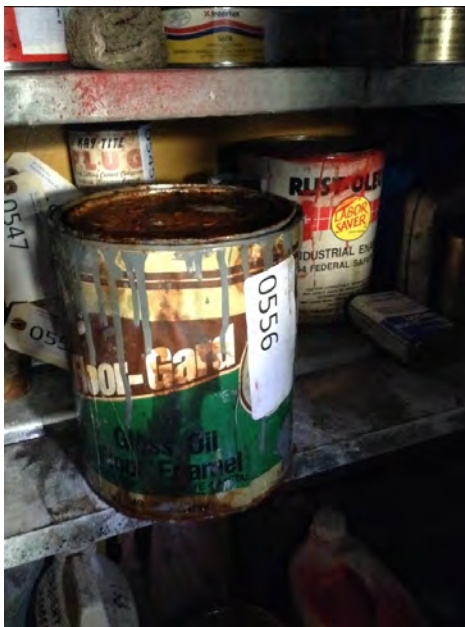
Container Condition: Intact with rust

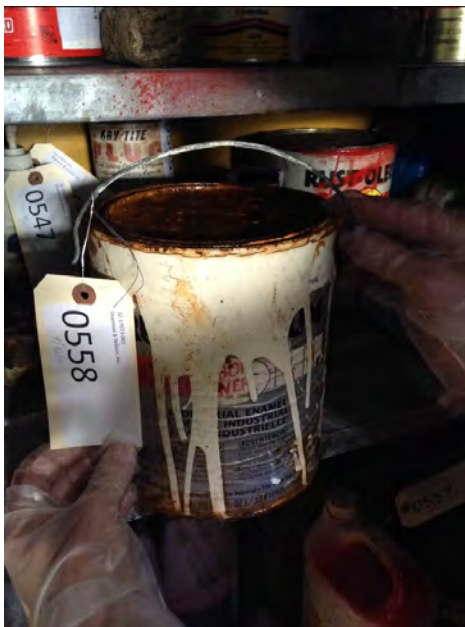
Container Condition: Intact with rust

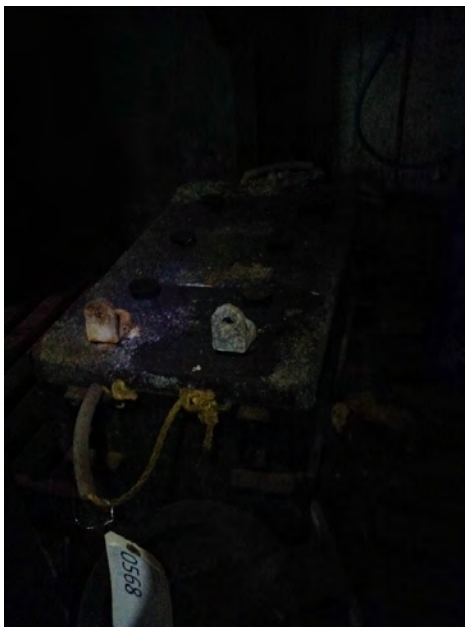
Label ID: 6V lead acid battery

Container Condition: Poor

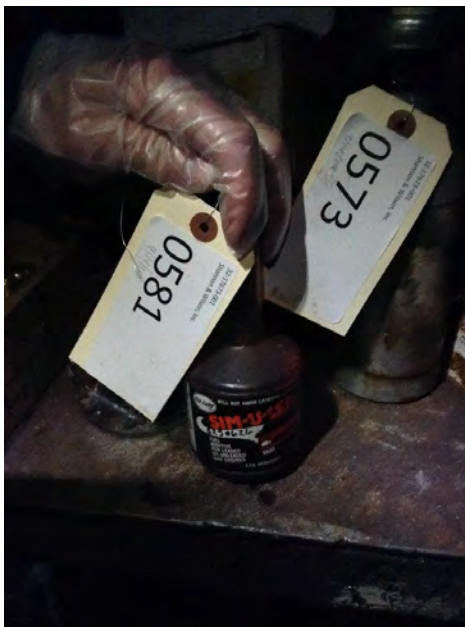
Label ID: Sim u lead fuel additive

Container Condition: Leaking

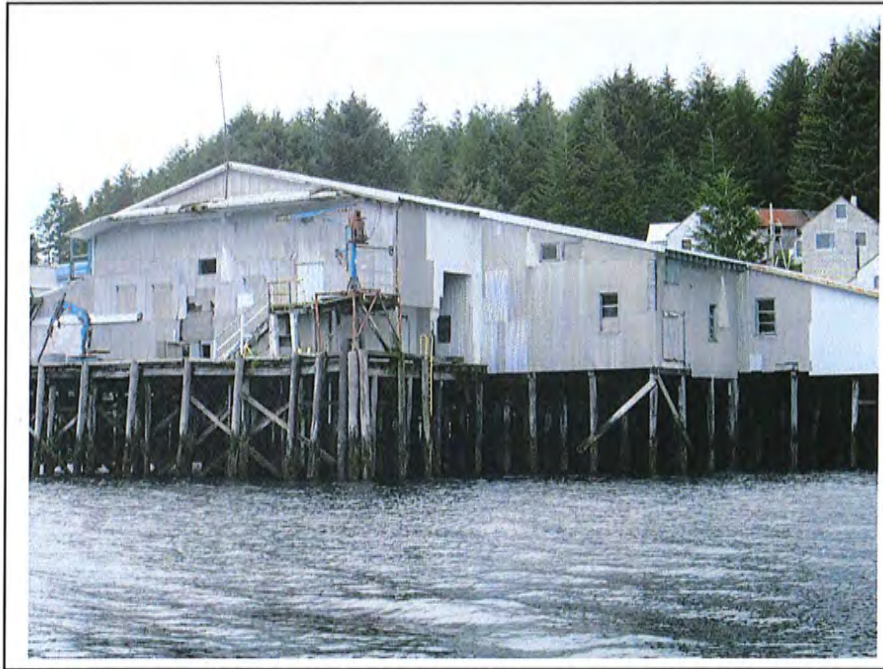
The Crab Plant is a two story, 12,178 square foot structure that operated as a crab processing facility (Photo 1 and Figures 3 and 4). The Crab Plant is on pilings above Lisianski Inlet and is connected to a boardwalk on the north side. Currently the structure is being used by the COP for storage of building materials and other items. The ground floor of the Crab Plant consists of a Storage Area (Photo 2), Crab Processing Area (Photo 3), Main Floor Open Area, Salt Room, Pipe Room, Eating Area, Kitchen, Dry Storage, Recreation Room, Reading Room, Egg Room (Photo 4), Office, Crab Office, Carpenter Shop, Marine Hardware Store, Compressor Room (Photo 5), Boiler Room (Photo 6), Lumber Storage Area (Photo 7), Restrooms, and the Dock (See Figure 3).

Photo 1: Crab Plant, looking northwest. (September 15, 2014)

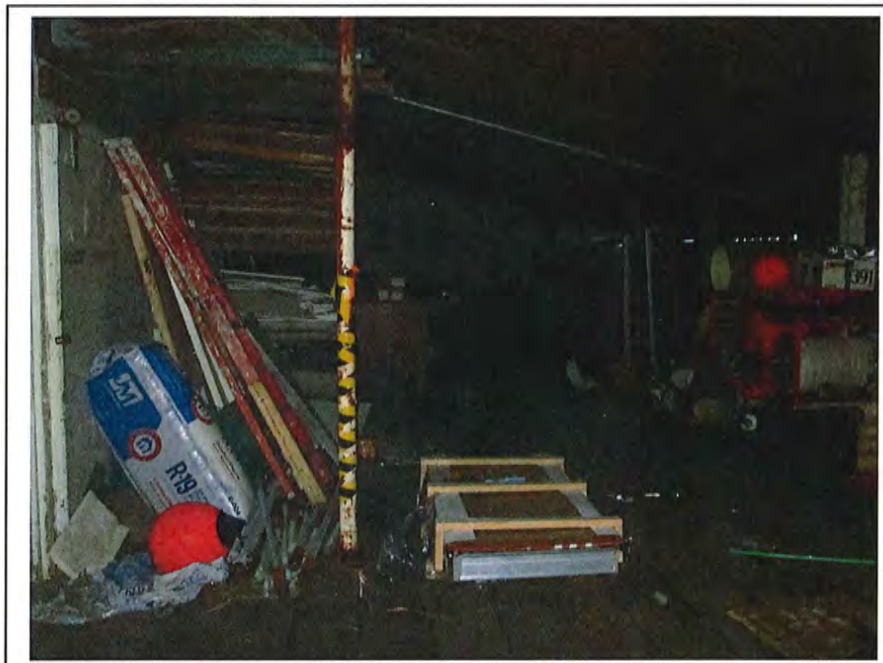
Photo 2: The Storage Area in the Crab Plant, looking south.  
(September 11, 2014)

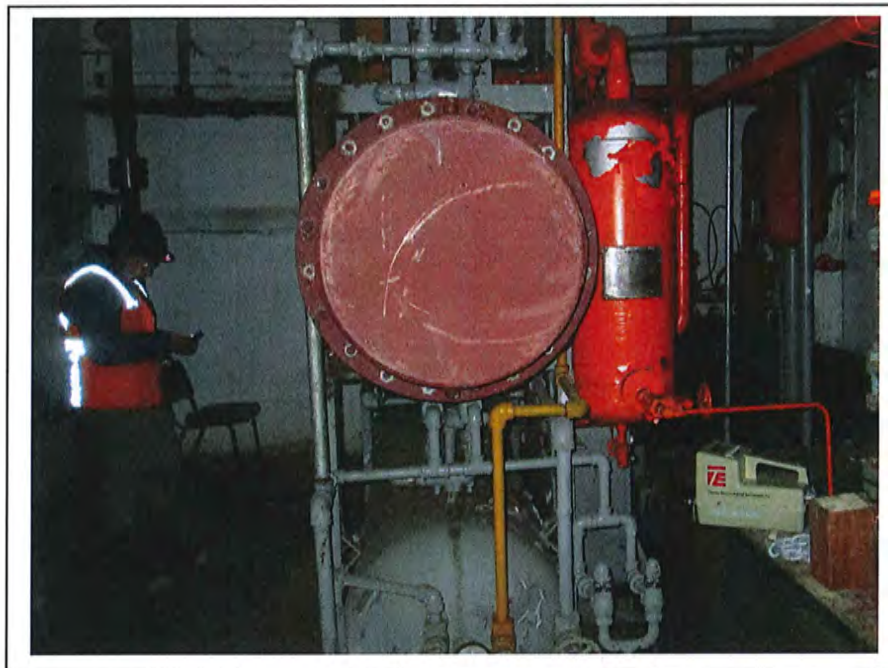
Photo 5: Compressor Room in the Crab Plant. (September 11, 2014)
