**Site Assessment and Remediation Plan  
Pelican Seafood Processing Facility  
Pelican, Alaska**

May 2015

By:  
**Shannon & Wilson, Inc.**  
5430 Fairbanks Street, Suite 3  
Anchorage, Alaska 99518  
Phone: 907-561-2120  
FAX: 907-561-4483

32-1-17673

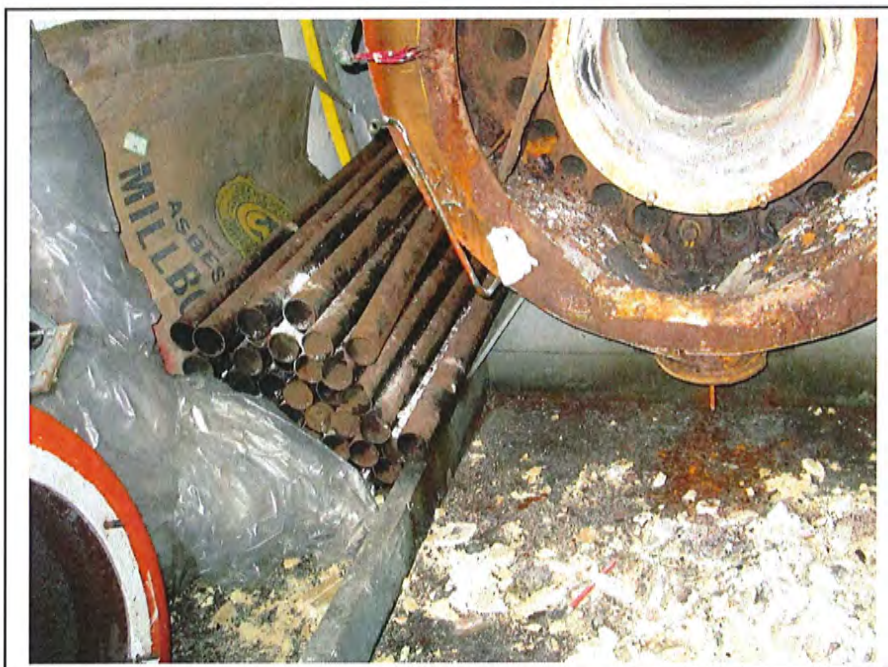
Photo 6: Boiler Room and potential ACM in the Crab Plant. (September 11, 2014)

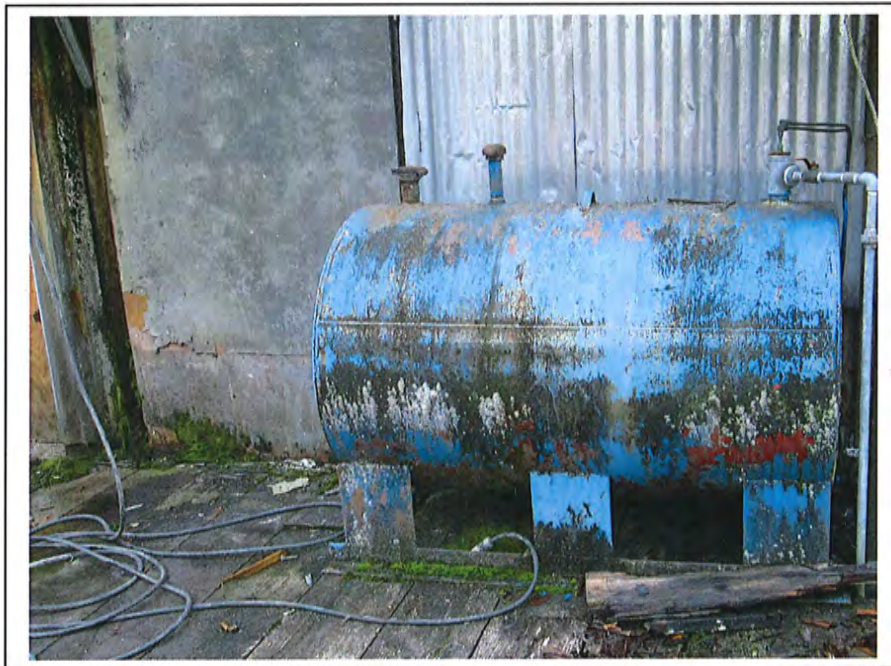
Photo 8: Active 500-gallon heating oil tank on north exterior wall  
of the Crab Plant, looking south. (September 12, 2014)

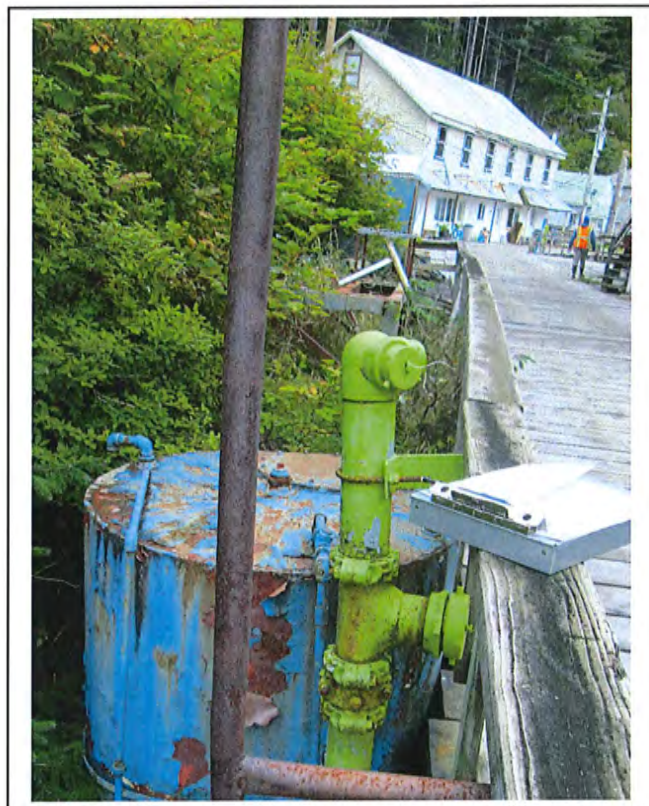
Photo 9: 1,000-gallon tank  
north of the Crab Plant.  
(September 12, 2014)

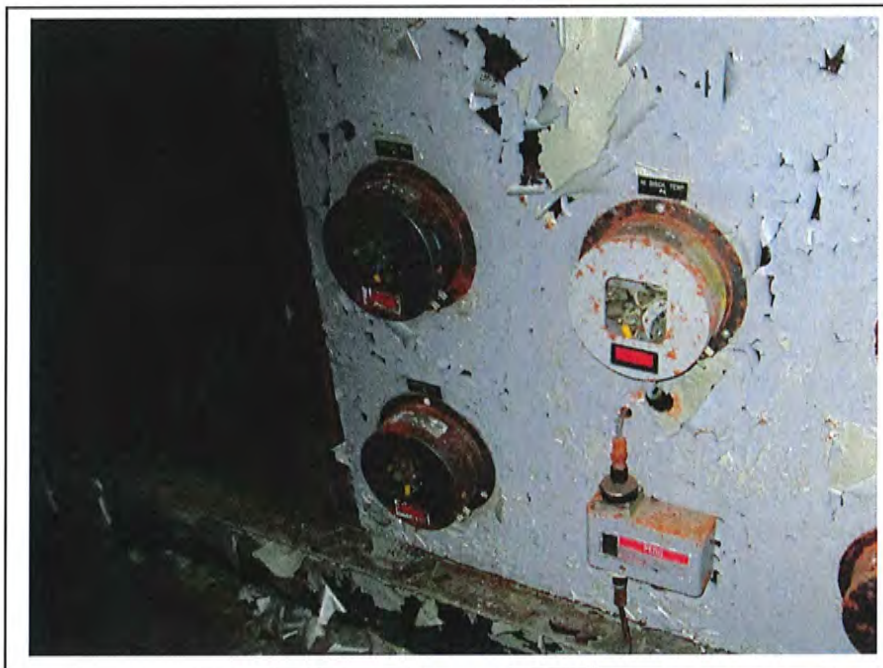
Photo 13: Mercury switches in the Compressor Room of the Engine Room. (September 12, 2014)

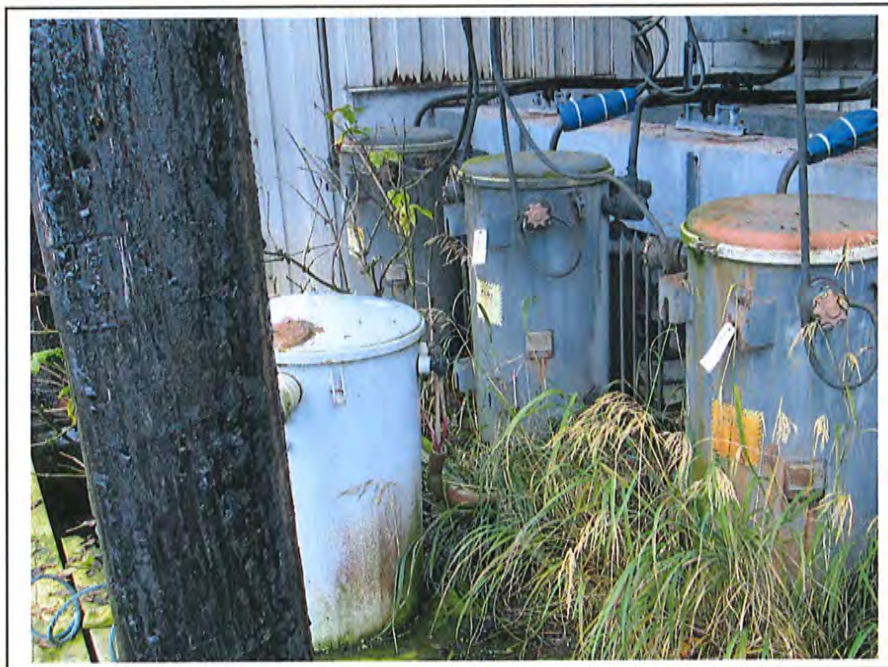
Photo 22: Transformers on the Transformer Pad. (September 13, 2014)

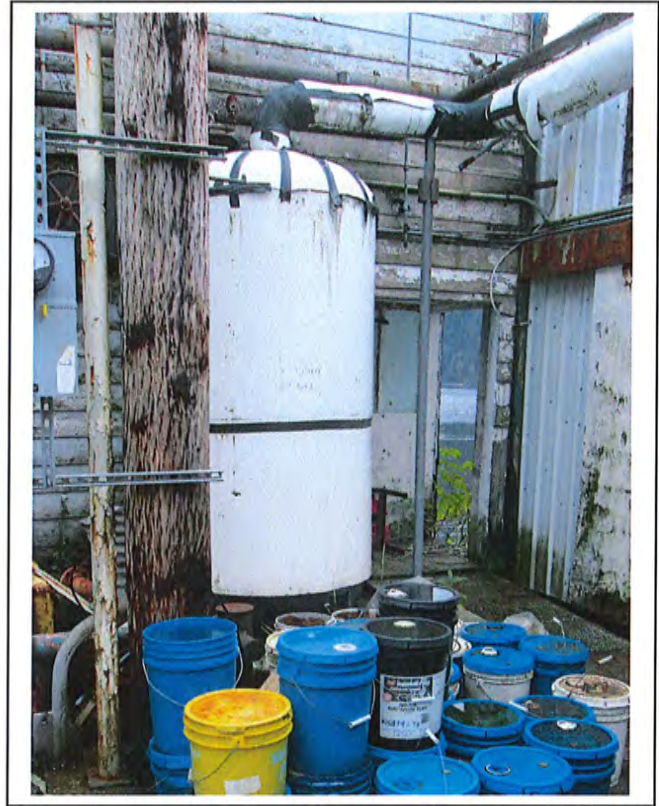
Photo 23: Former slosh tank and buckets in the Courtyard.  
(September 12, 2014)

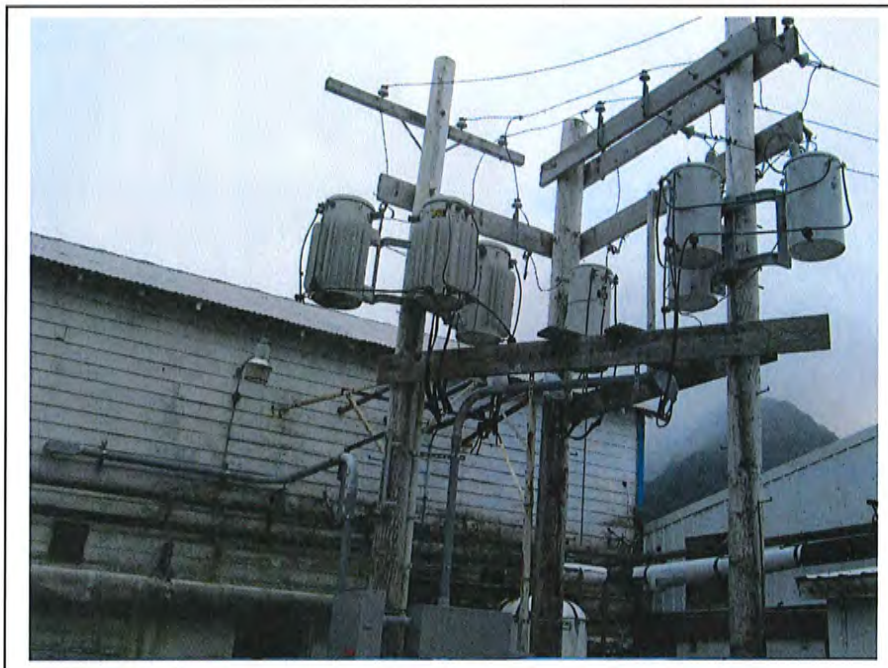
Photo 24: Pole-mounted transformers above the  
Courtyard, looking south. (September 13, 2014)

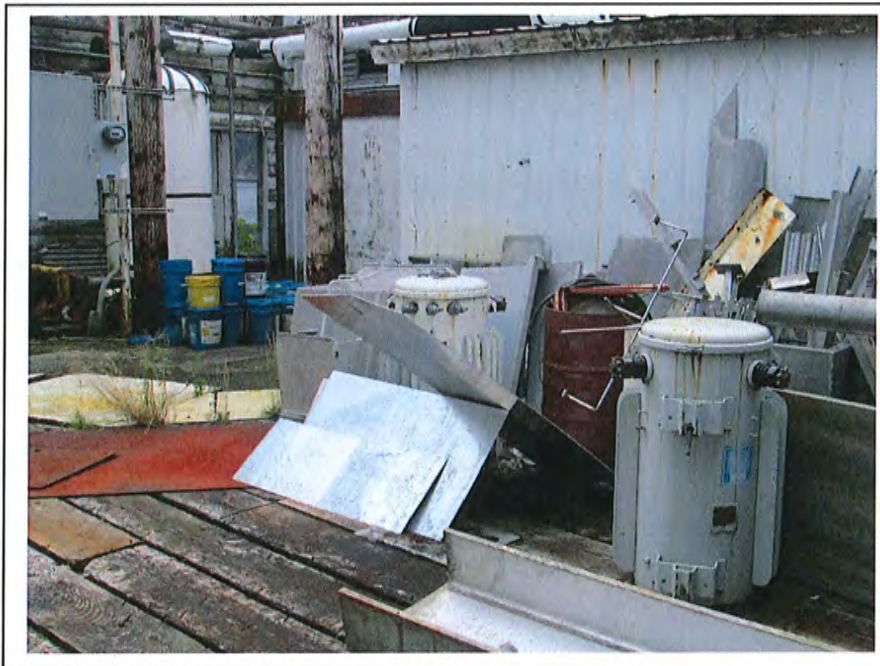
Photo 25: Transformers in the Courtyard, looking southwest.  
(September 13, 2014)

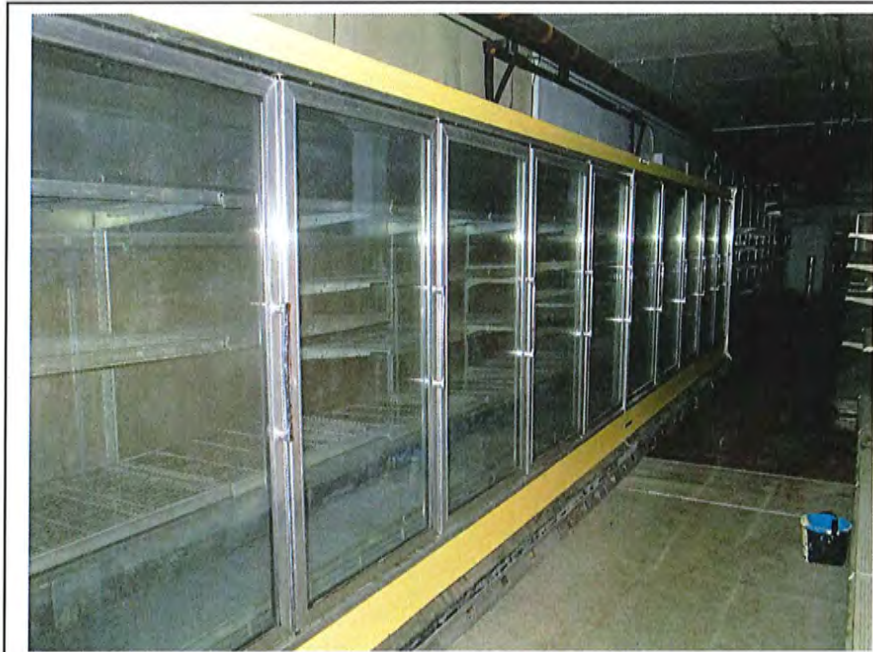
- Several refrigerators, two 6-volt batteries, and several paint cans in the west portion of the first floor (Photo 29 and Figure 5) of the Store;
- Four refrigeration units were observed on an outdoor platform against the north wall of the Store building;
- An electric hot water heater and a heating oil furnace with a 5-gallon day tank were observed in the furnace room;
- An AST on the boardwalk, situated above the high tide line, adjacent to the east side of the Store; and
- Unopened containers of paints and adhesives were observed on the second floor of the Store, observed during NRC Alaska's (formerly Emerald, Alaska) visit to the Property.

Photo 29: Refrigerators in Store. (September 15, 2014)

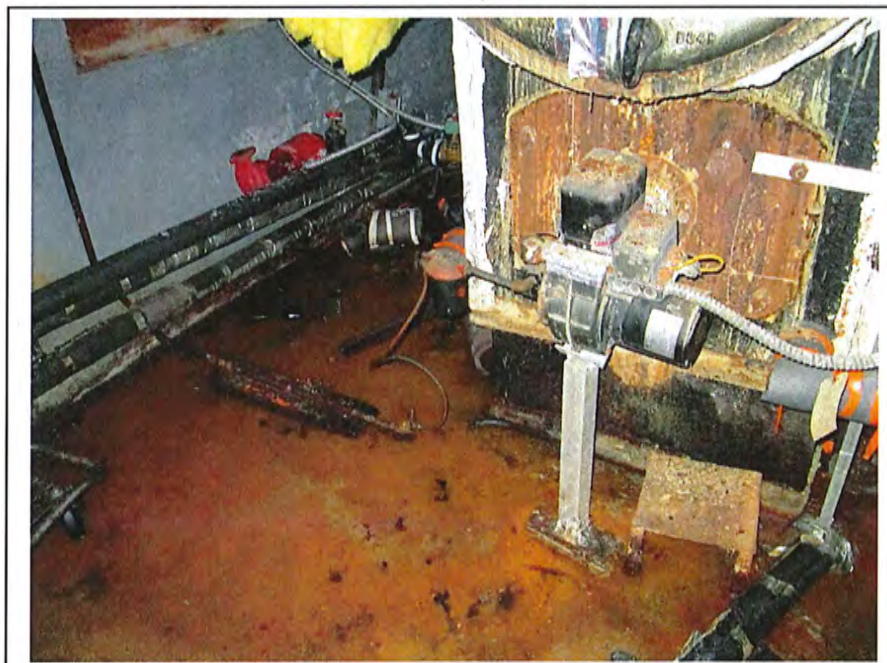
Photo 30: Fuel lines in the Store. (September 15, 2014)

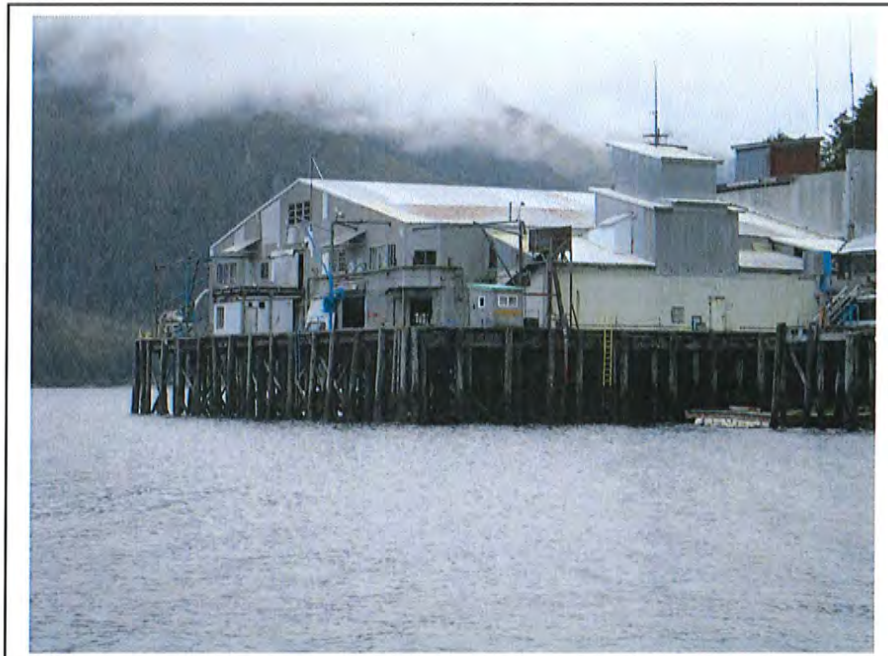
The Fish House is a three-floor structure located on pilings over Lisianski Inlet (Photo 31). The first floor of the Fish House is currently used as a fish receiving facility. The Fish House is no longer used for fish processing. A large portion of the second floor is being used for ice-making by the COP. A quality control laboratory and a salt room are located on the second floor of the Fish House. The third floor is largely storage of miscellaneous items and part of the current ice making operation. The layout of the Fish House is illustrated in Figures 5 through 7. Although not included in the PHM inventory; the following items were noted during the site visit:

Photo 31: Fish House, looking northwest. (September 15, 2014)

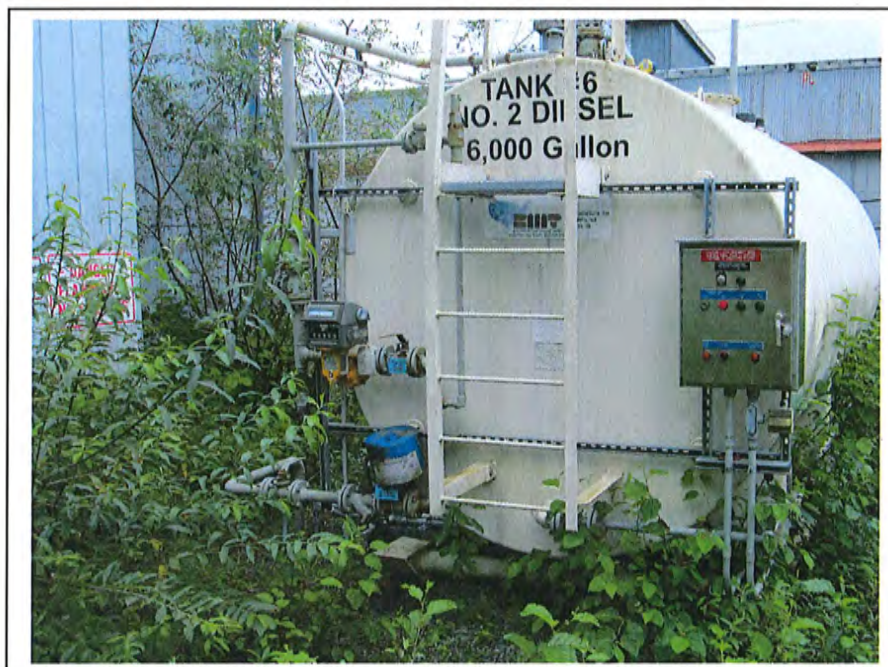
Adjacent west of the New Bunkhouse is an active 6,000-gallon diesel tank (Photo 32). A welded steel fuel 1.5-inch line was observed on the west side of the AST and then becomes buried. According to the URS Phase I ESA this line connects to distribution system for the generators

Photo 32: Fuel lines in the Store. (September 13, 2014)
