Brownfield Assessment

Property Assessment and Cleanup Plan
Spenard Road Development Area
Anchorage, Alaska

By:
Shannon & Wilson, Inc.
5430 Fairbanks Street, Suite 3
Anchorage, Alaska 99518

June 2014

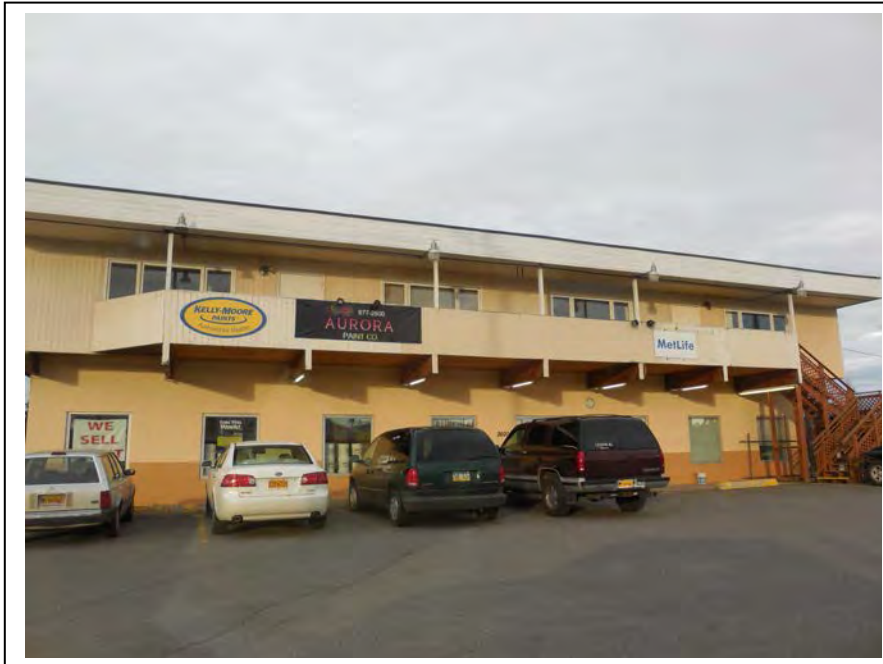
Photo 1: Representative multi-story commercial structure along Arctic Boulevard; looking west. (October 16, 2013)

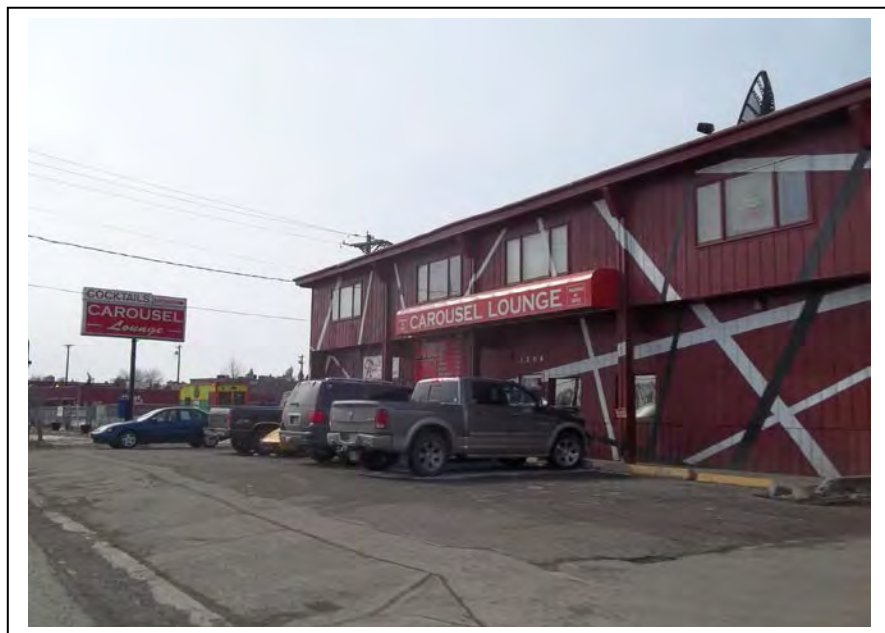
Photo 4: Representative multi-story commercial structure along Spenard Road; looking south/southwest. (April 18, 2014)

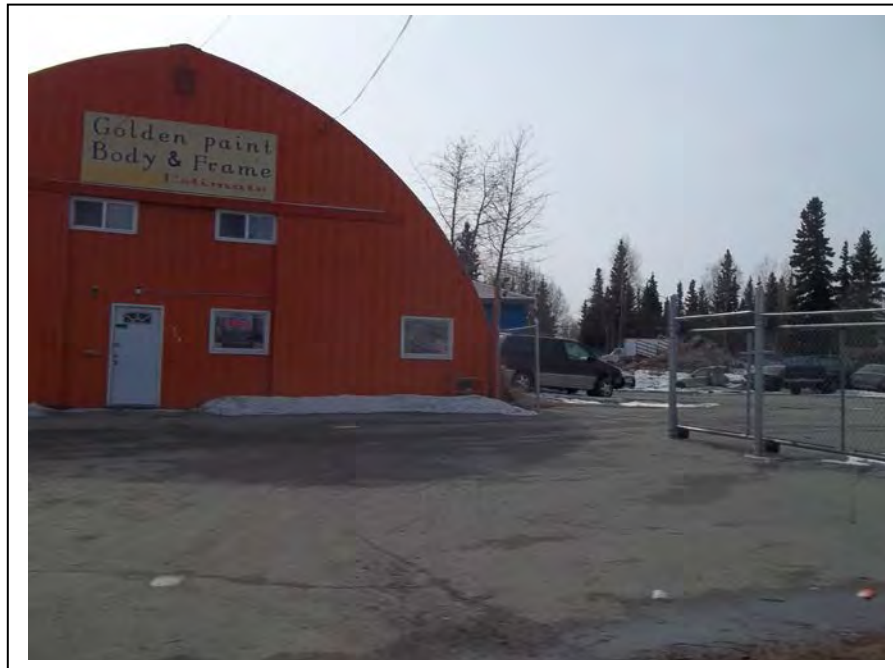
Photo 5: Representative commercial structure along Chugach Way; looking south. (April 18, 2014)

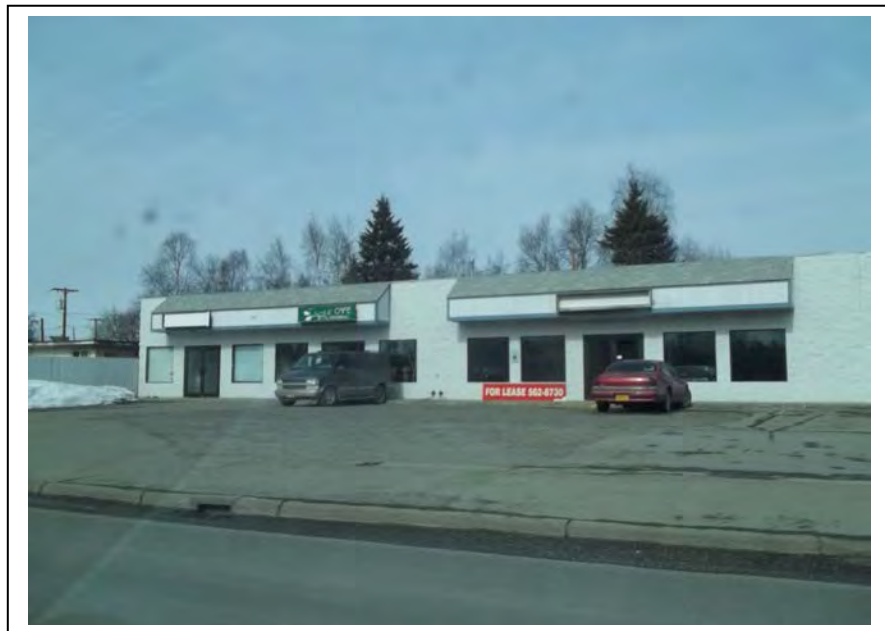
Photo 6: Representative commercial structure along 36th Avenue; looking north. (April 18, 2014)

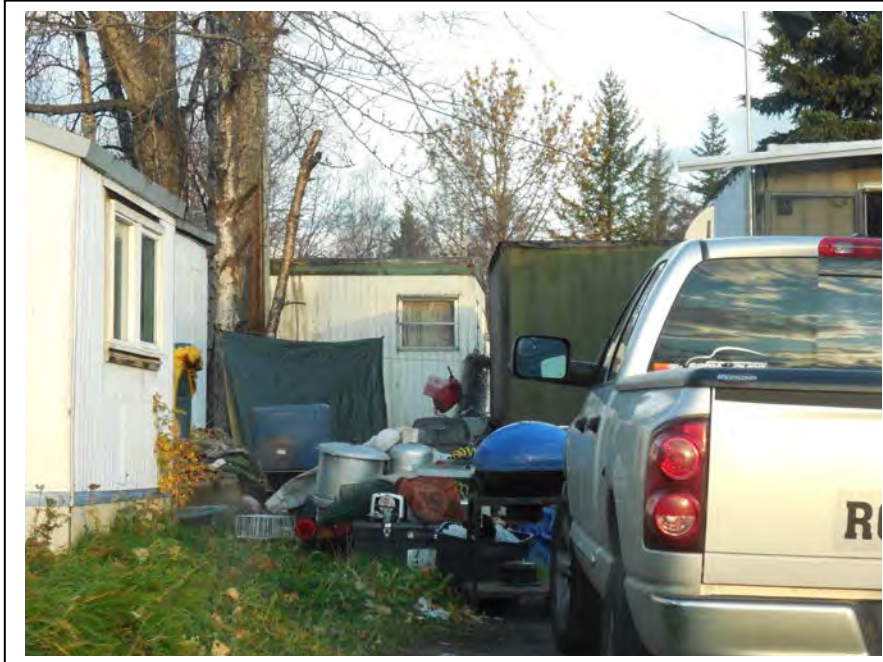
Photo 7: Representative trailer stall and yard at Idle Wheels Trailer Court; looking east. (October 16, 2013)

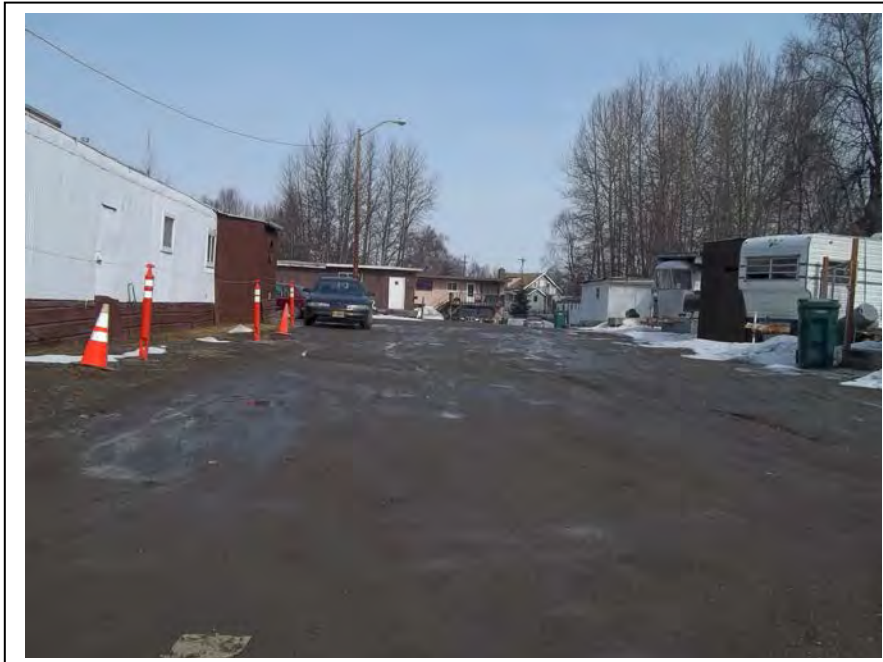
Photo 9: Chugach Way Trailer Court; looking northeast. (April 18, 2014)

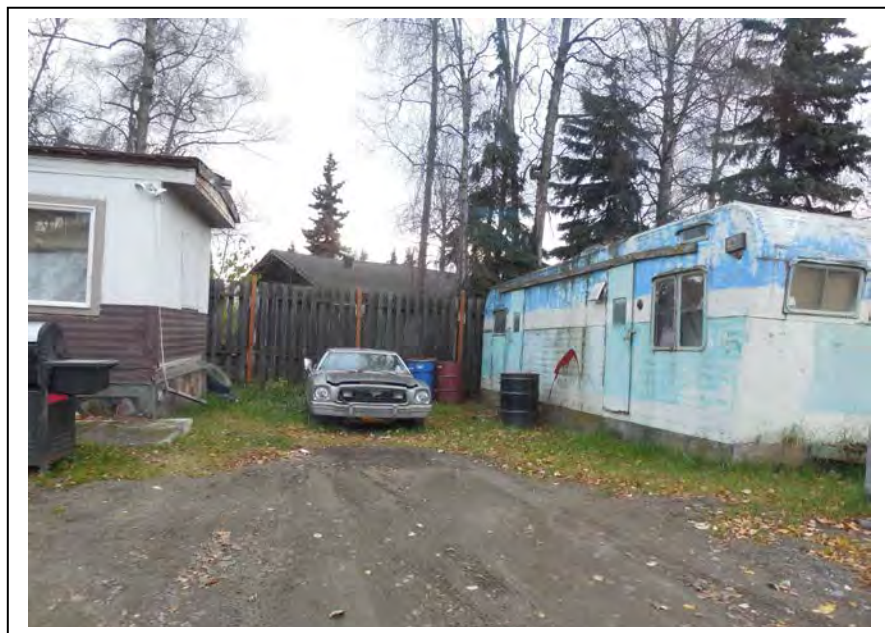
Photo 10: Representative trailers in Chugach Way Trailer Court; looking east. (October 16, 2013)

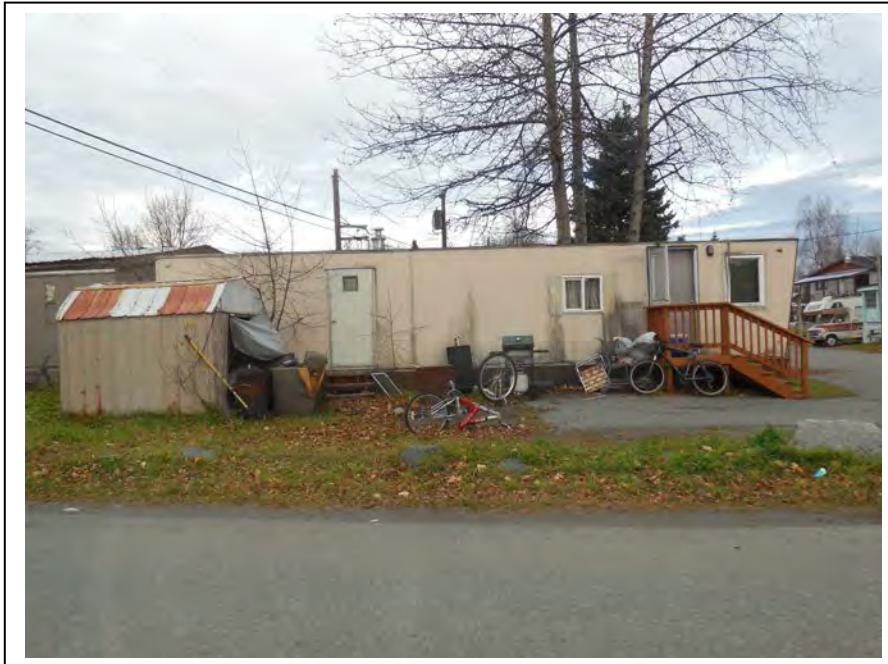
Photo 11: Representative trailer at Kathy O Estates Trailer Court; looking north. (October 18, 2013)

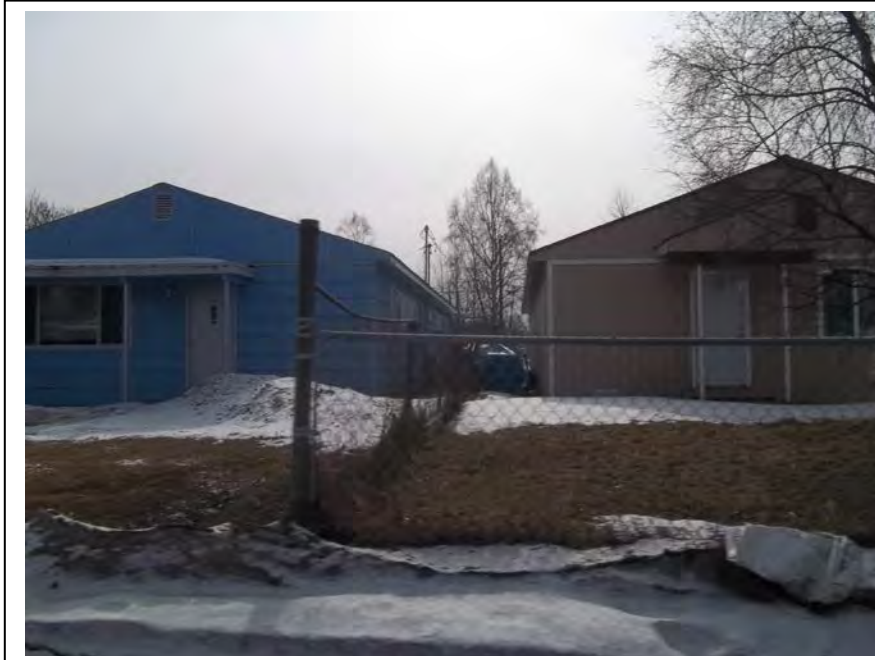
Photo 13: Representative single-family homes in the southern portion of the project area; looking south. (April 18, 2014)

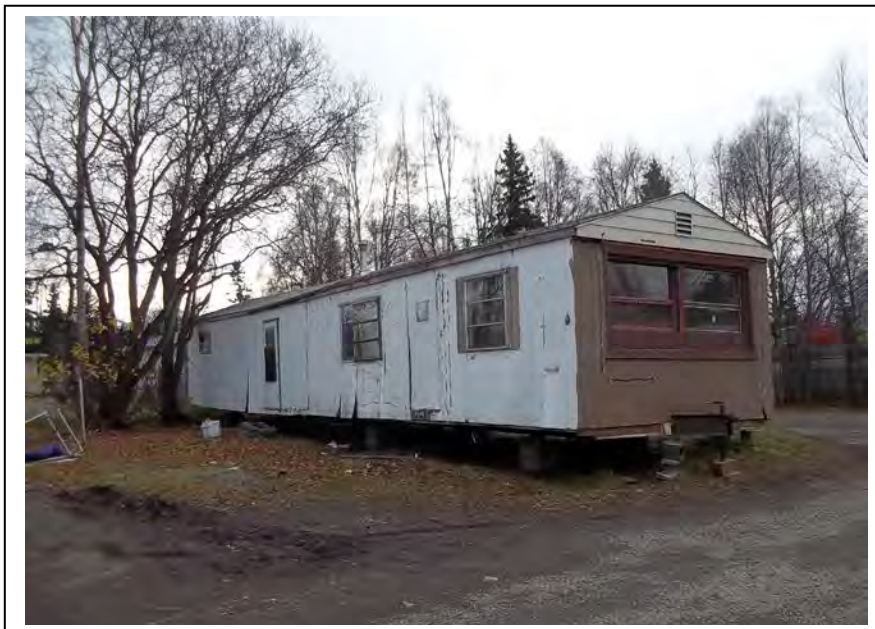
Photo 14: Representative trailer home in northern project area; looking southeast. (October 16, 2013)

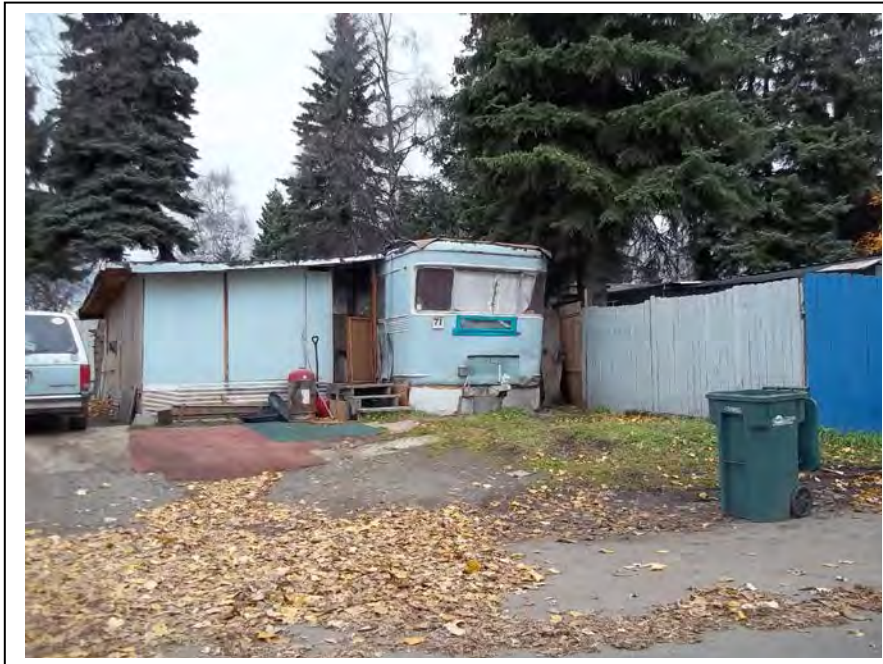
Photo 15: Representative trailer in northern portion of the project area; looking north. (October 16, 2013)

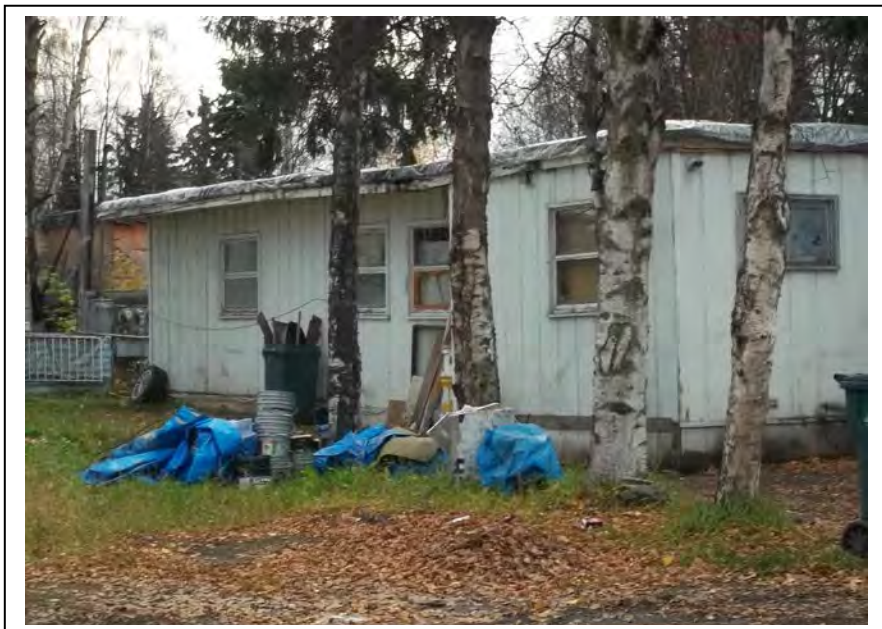
Photo 16: Representative trailer home in northern project area; looking southeast. (October 16, 2013)

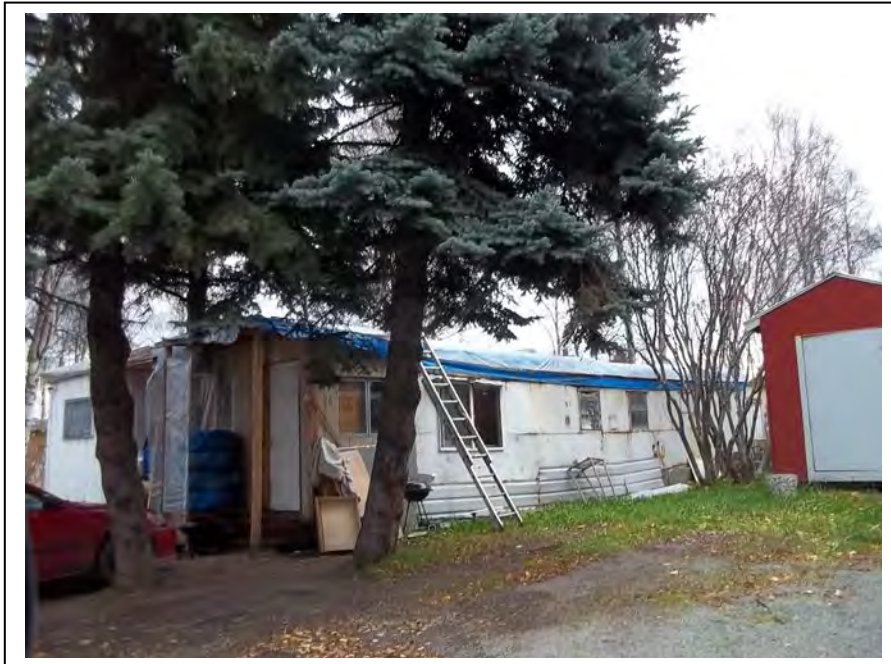
Photo 17: Representative trailer in northern portion of the project area; looking northeast. (October 16, 2013)

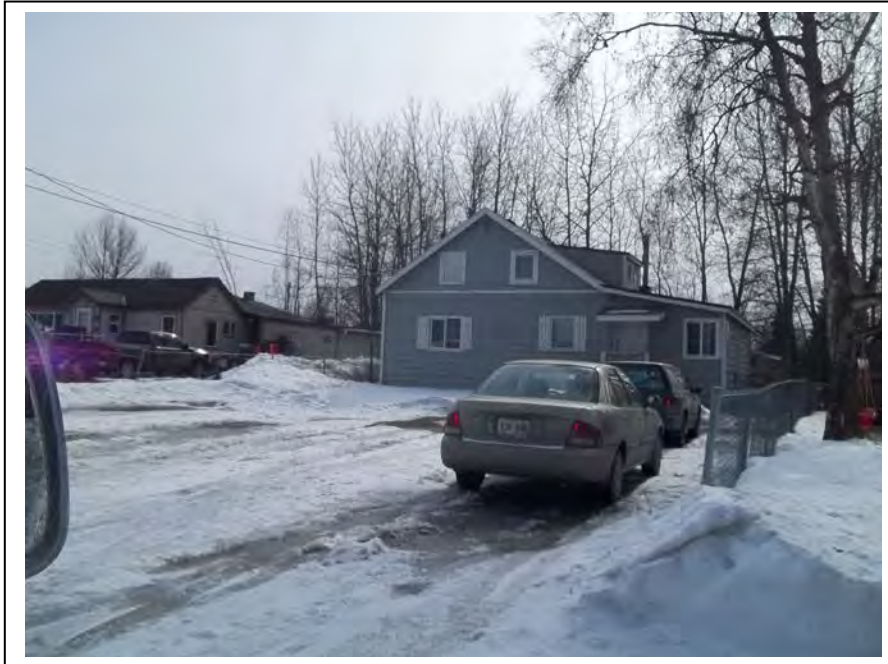
Photo 21: Representative single-family structure located south of 36th Avenue; looking southeast. (April 18, 2014)

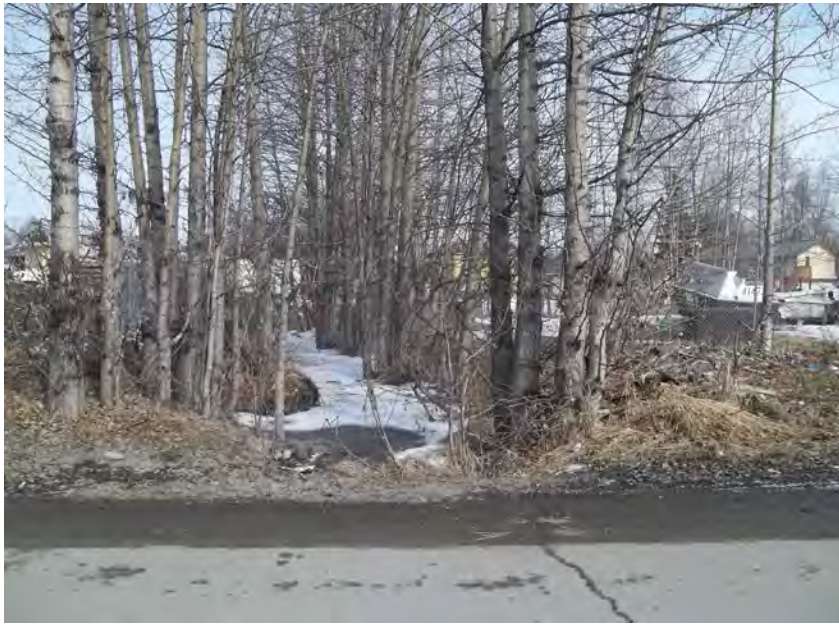
Photo 23: Fish Creek located in the southern portion of the project area; looking north. (April 18, 2014)

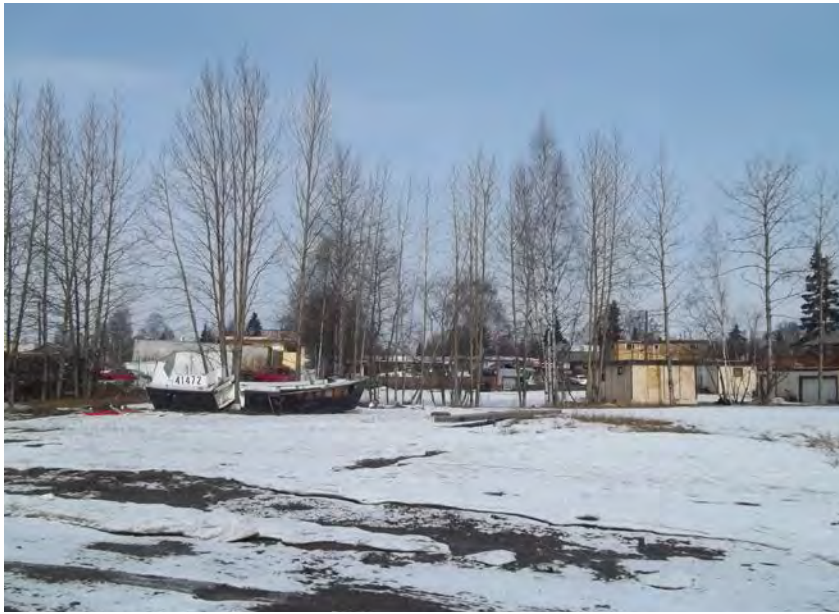
Photo 24: Vacant lot adjacent east of Fish Creek on Chugach Way; looking north. (April 18, 2014)

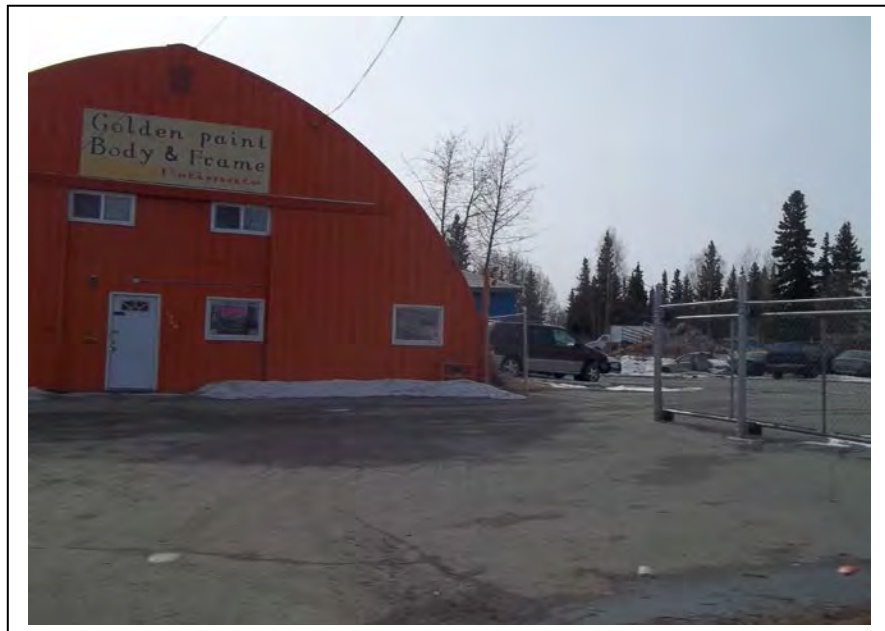
Photo 28: Golden Paint Body & Frame is located east of Hansen Transmission on Chugach Way; looking southwest. (April 18, 2014)
